Attachment A
SLCE Site Reconnaissance Photo Log

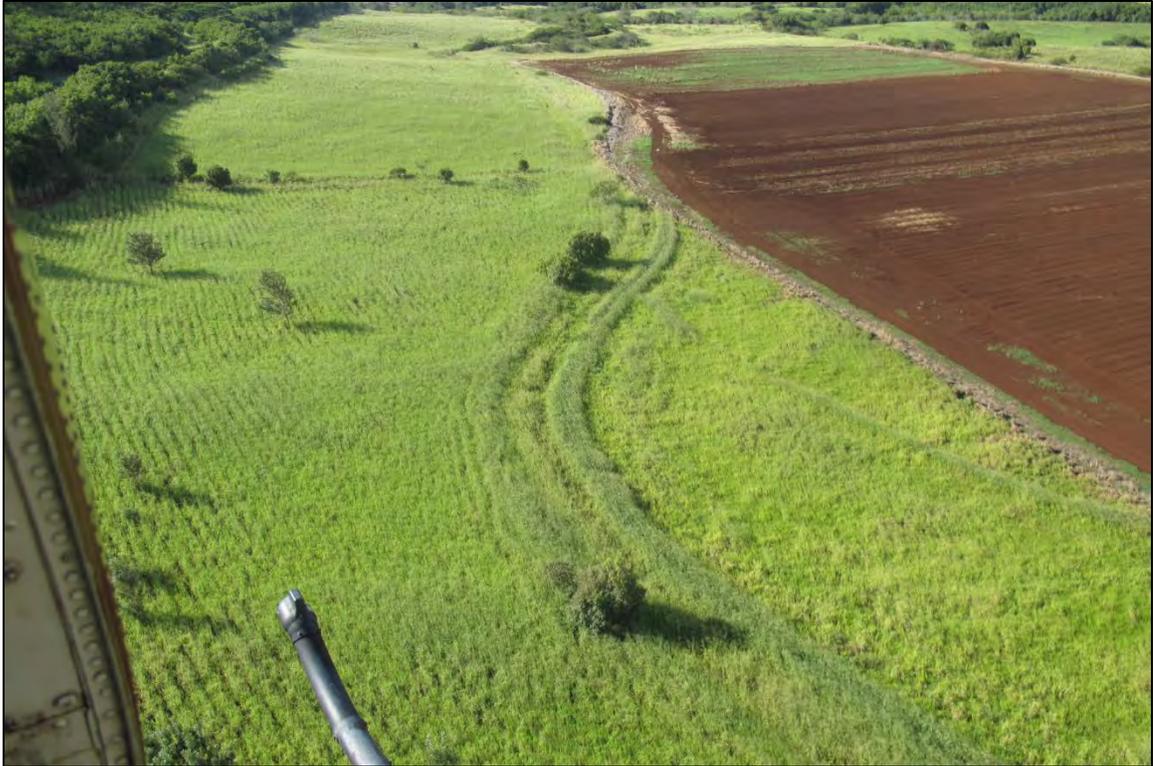
Photo 1. **Kalepa.** View of the eastern portion of the site, facing south, taken near the north edge of the site, with probable abandoned ditch.

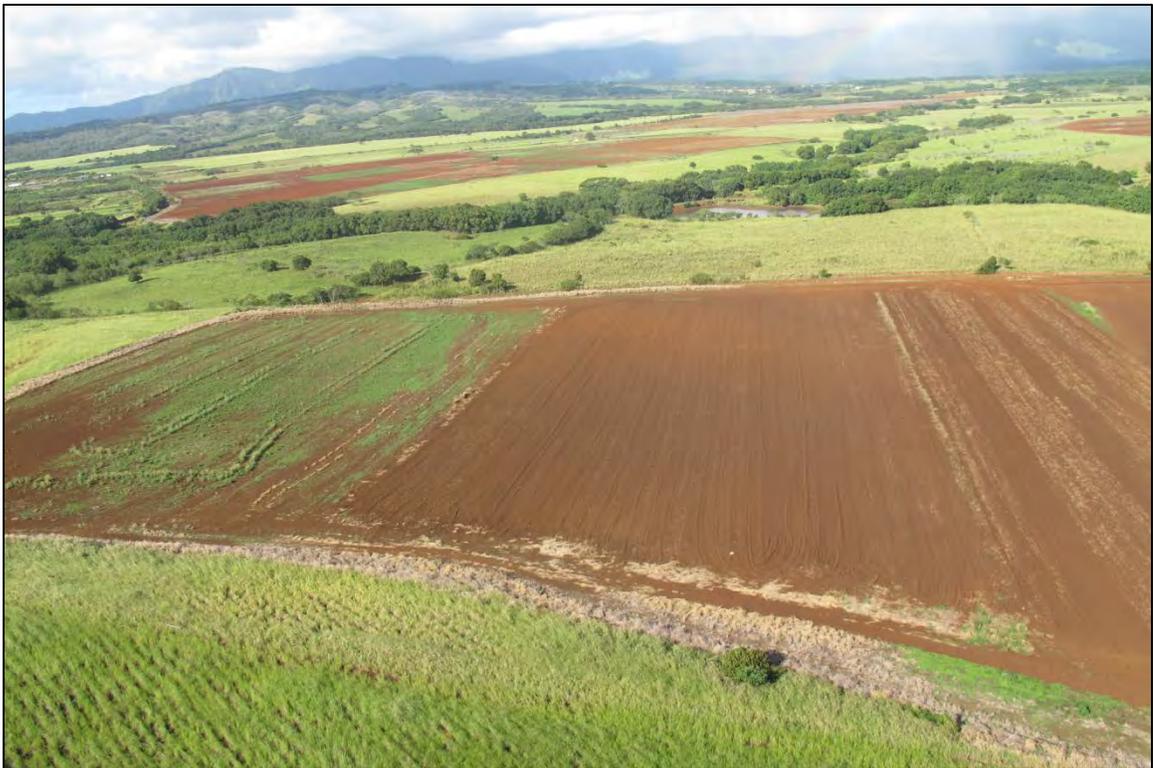
Photo 2. **Kalepa.** View of the southern section of the proposed landfill site, facing west, taken from the eastern border of the site. For reference, note the reservoir in the upper half of the image (outside the proposed site).

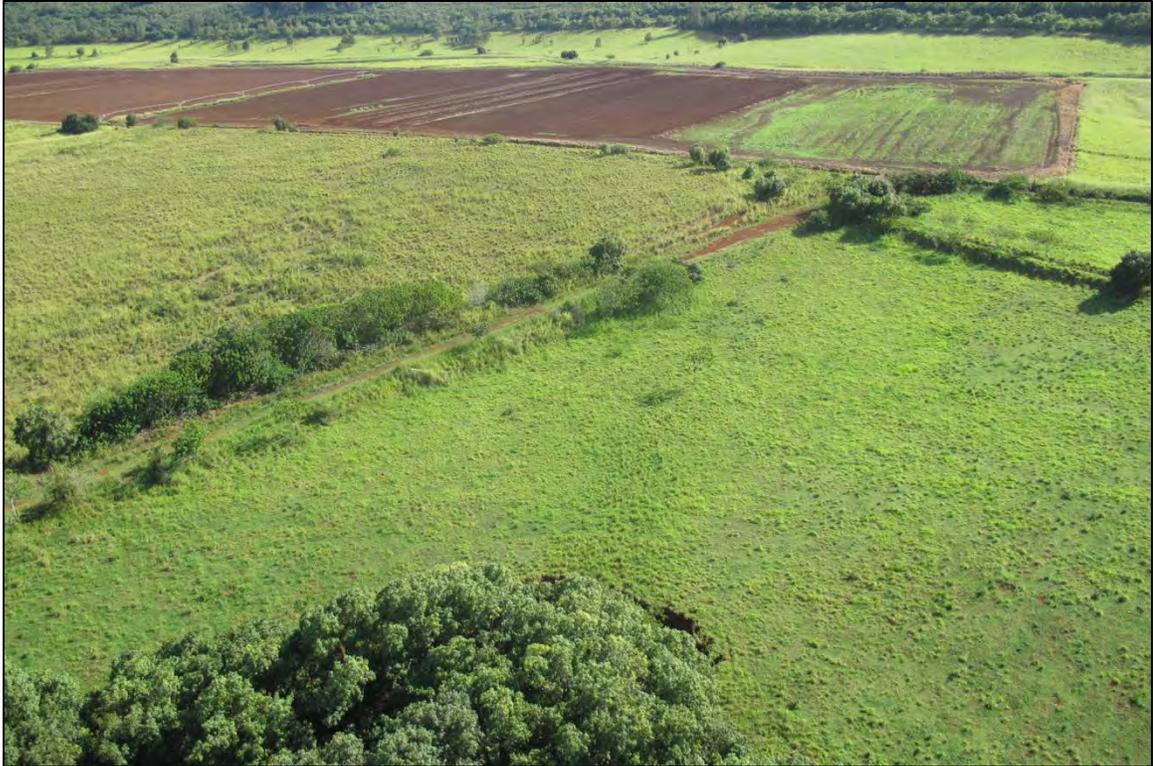
Photo 3. **Kalepa.** View of the southern section of the proposed landfill site, facing east, taken west of the southwest corner of the site. The offsite fields in the foreground are a buffer between the reservoir and the proposed landfill site (tilled soil).

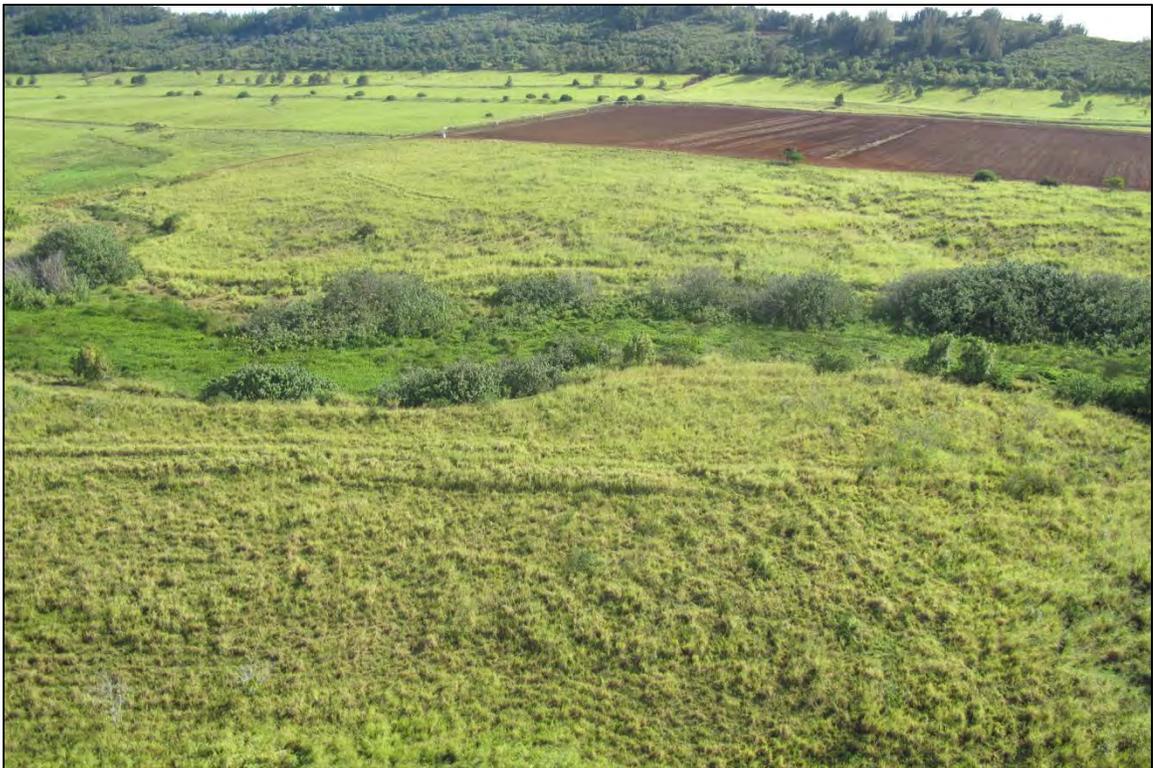
Photo 4. **Kalepa.** View of the of the proposed landfill site (tilled soil, upper half of photo), facing east, taken from west of the western border of the site. Included in the image foreground is a possible offsite wetland feature.

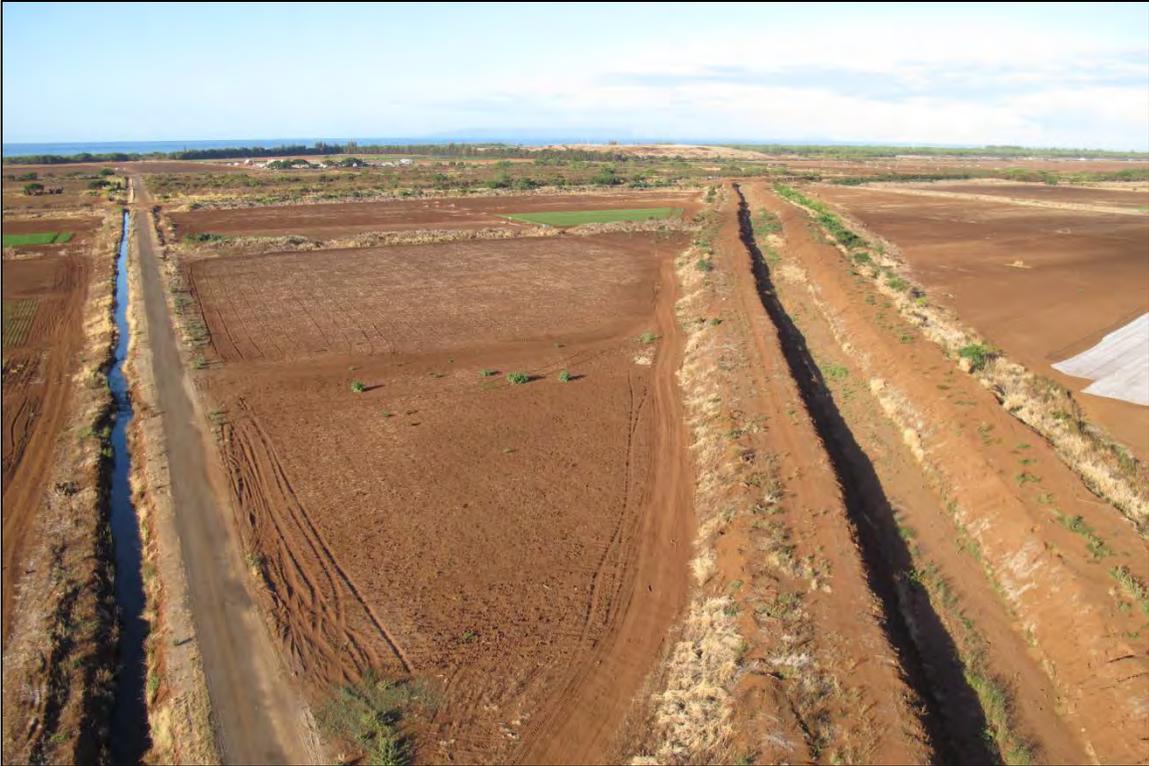
Photo 5. **Kekaha Mauka.** Taken from mauka corner, facing makai. Note active irrigation ditch on left, and stormwater drainage ditch on right.

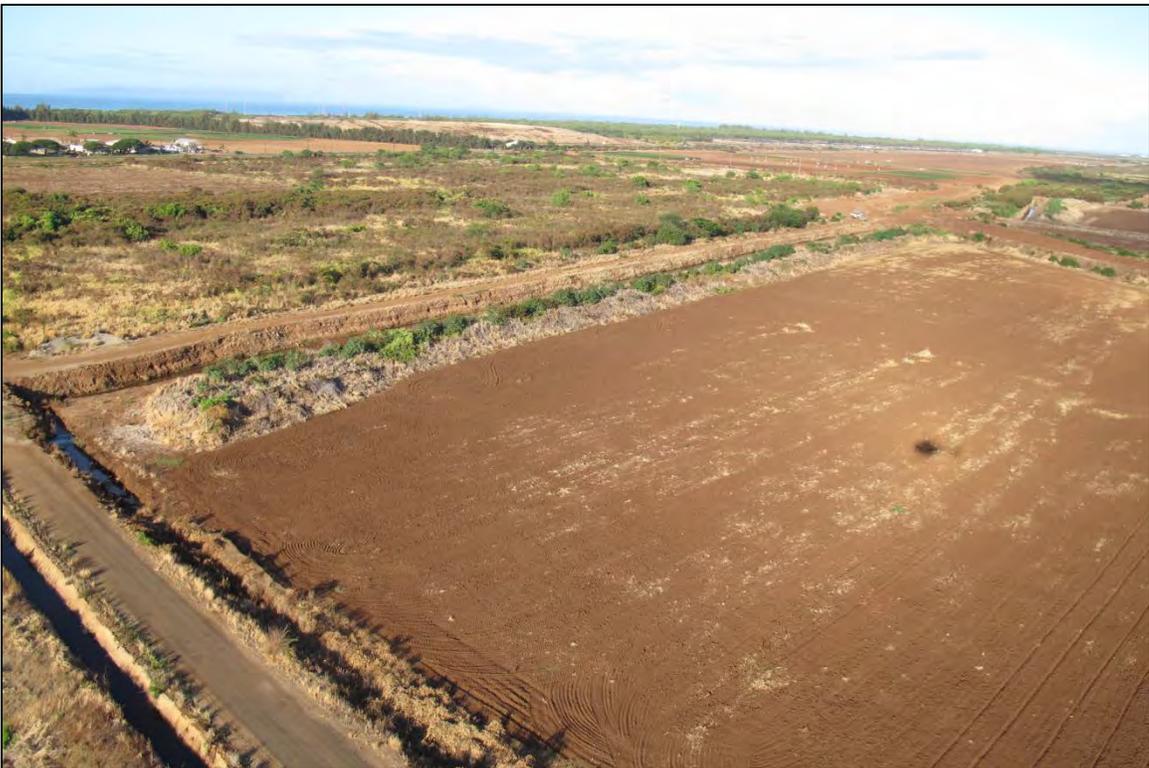
Photo 6. **Kekaha Mauka.** Taken from midway along eastern border, facing west. Note the change in the irrigation ditch flow direction. Existing Kekaha landfill site is left of center on the horizon,

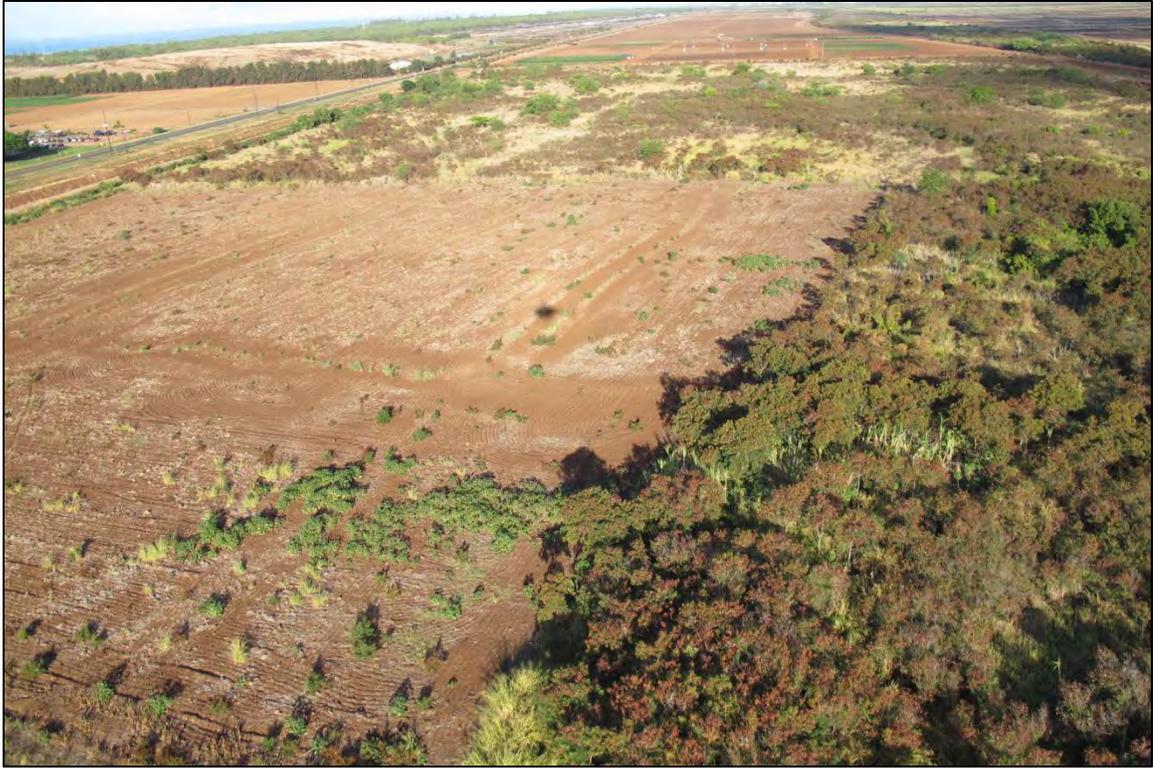
Photo 7. **Kekaha Mauka.** Taken from southeast corner, facing west. Existing Kekaha landfill site is at top of photo on left on the other side of the highway.

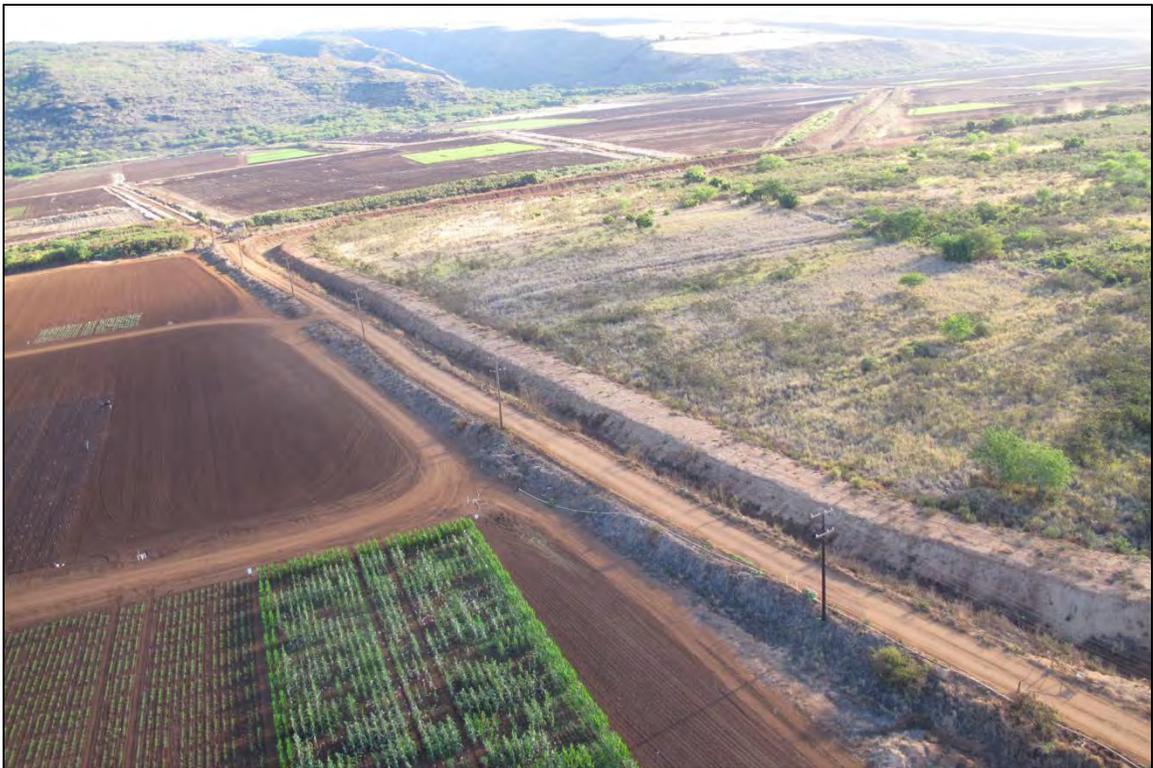
Photo 8. **Kekaha Mauka.** Taken from midway along southern border, facing mauka. Note the stormwater drainage bisecting the site. Active agricultural fields extend beyond the photo to the left.

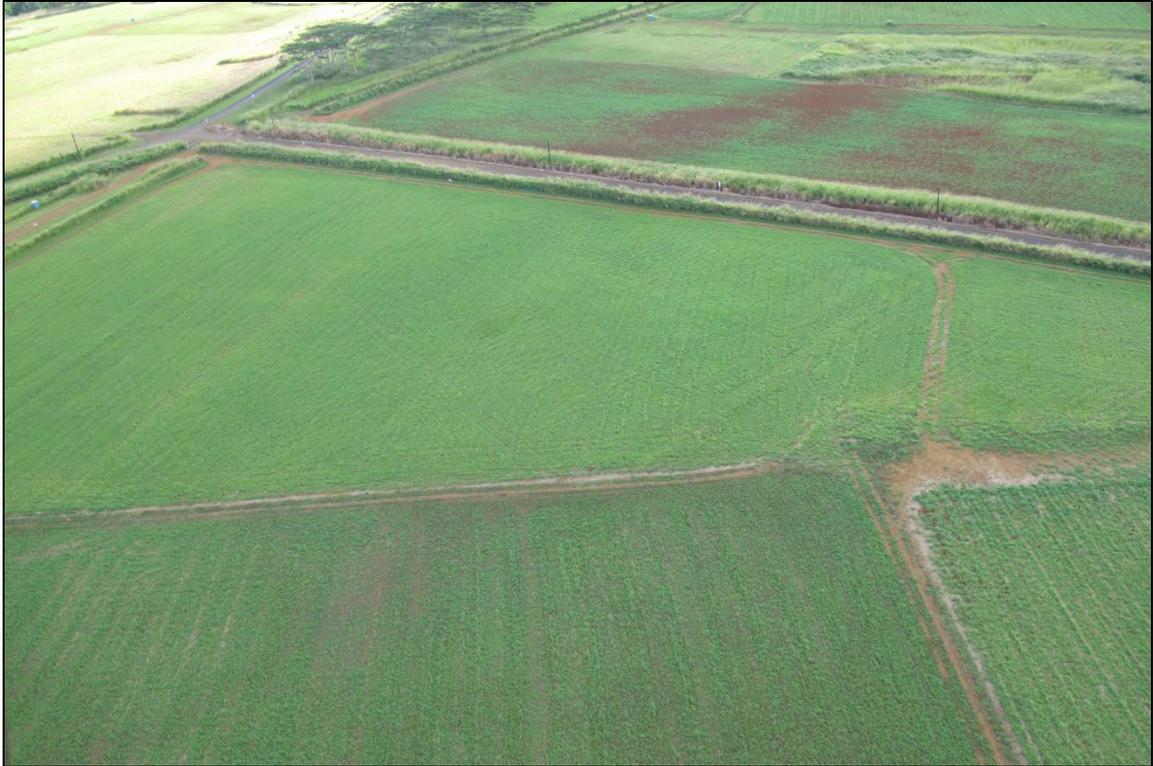
Photo 9. **Kipu.** Typical view of most of the proposed Kipu site.

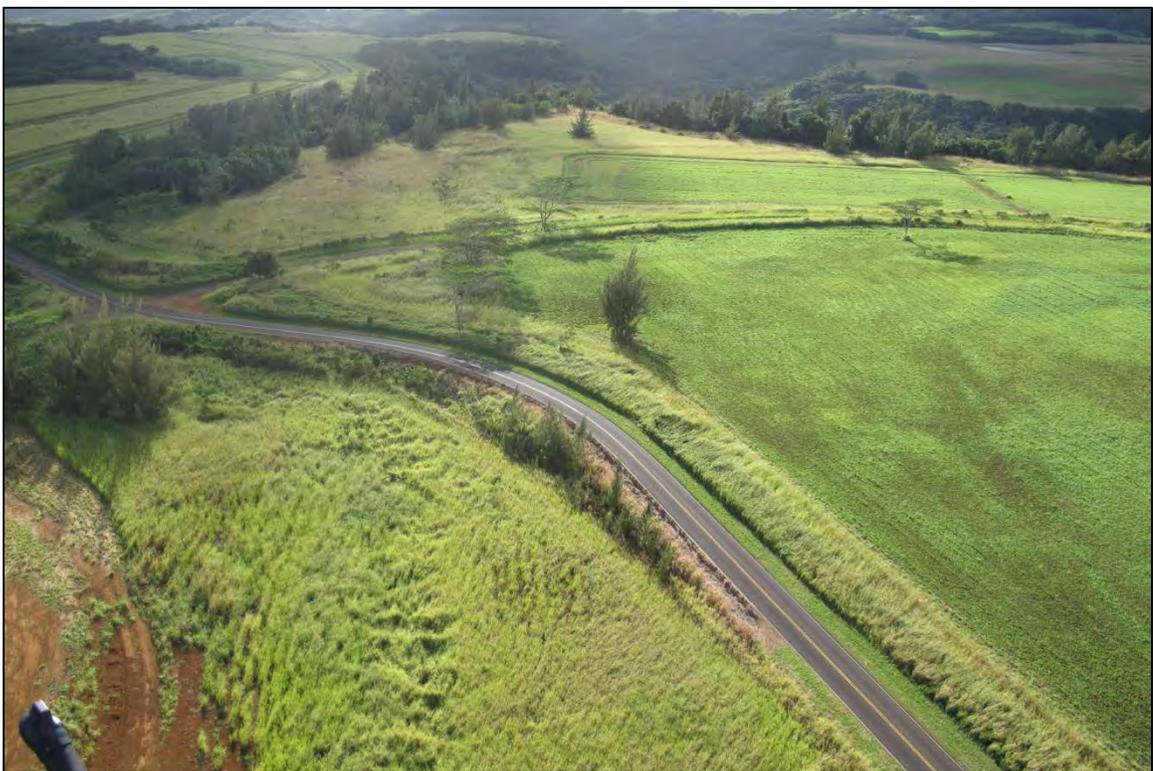
Photo 10. **Kipu.** View of the eastern most border of the proposed landfill site. Note the valley on the upper right of the photo, which runs the length of the proposed project site to the south.

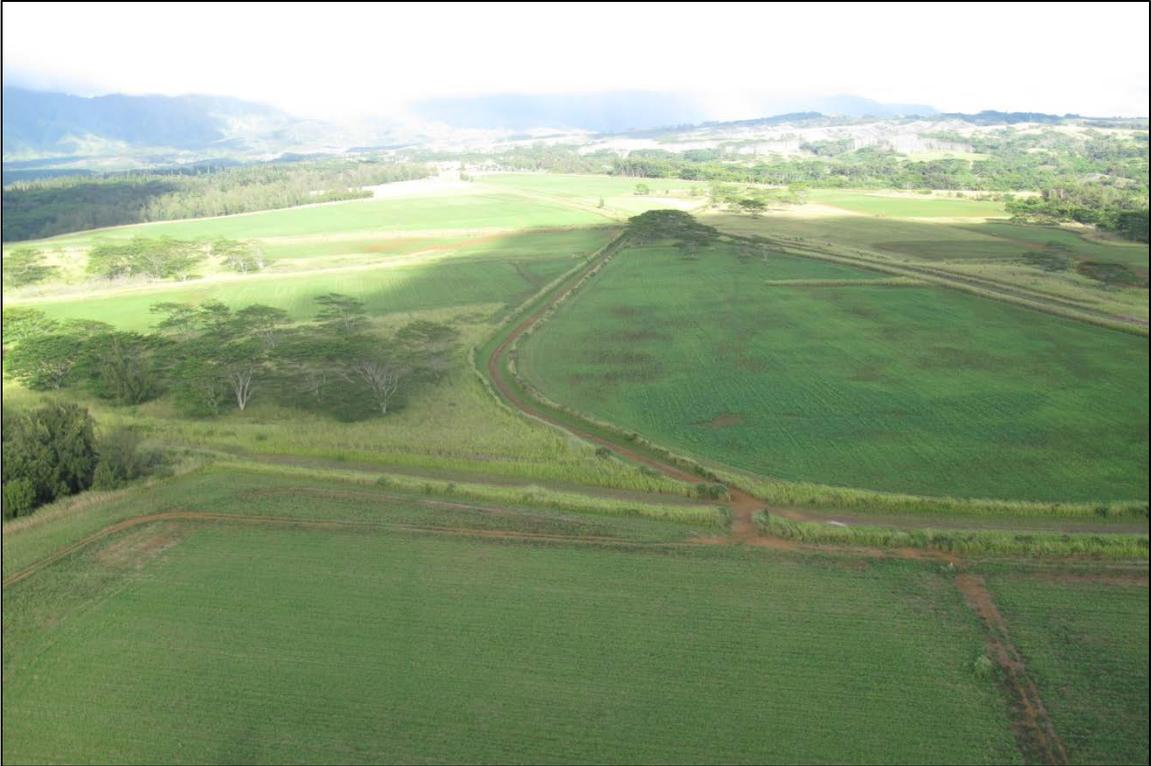
Photo 11. **Kipu.** View facing north of the western portion of the proposed landfill site. Note occasional patches of albezia trees. Areas in upper portion of image, beyond the cloud shadow, are in what is proposed for a resource recovery park.

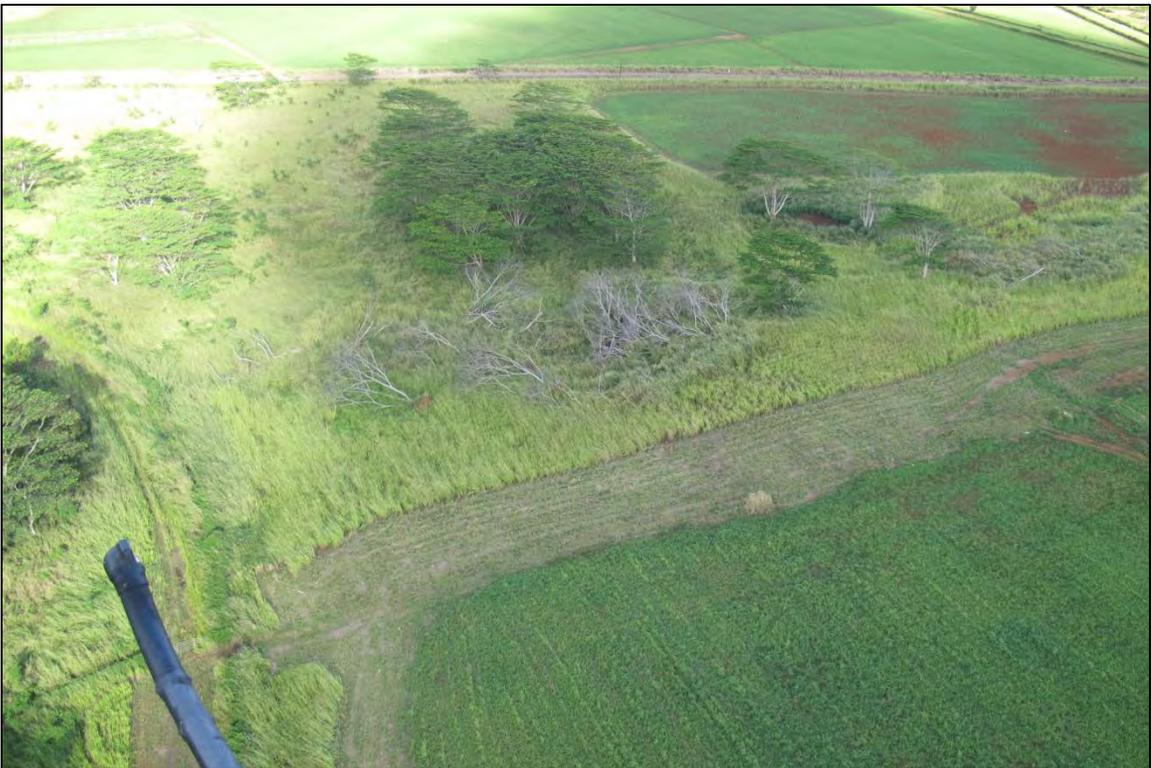
Photo 12. **Kipu.** View of typical patch of albezia trees and guinea grass surrounded by prepped agricultural fields.

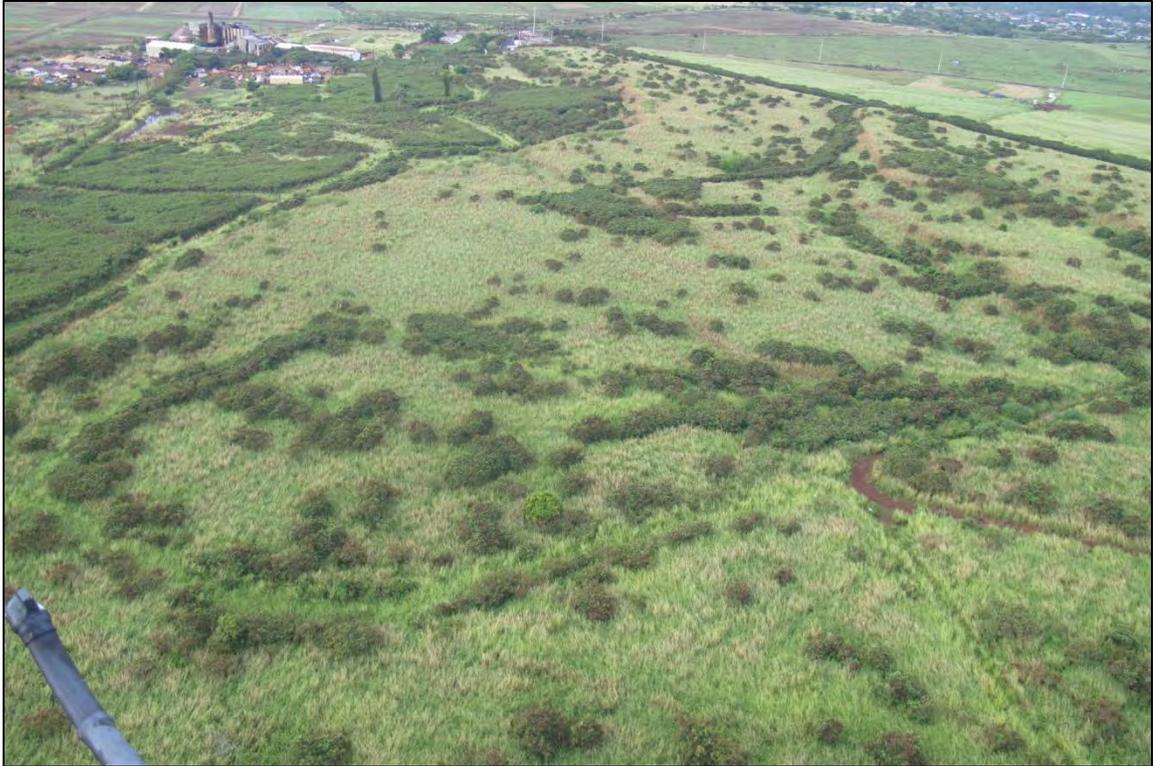
Photo 13. **Koloa.** View of the lower portion of the proposed landfill site, from the eastern border, facing west. Note the old mill facility in upper left. A ditch forms the makai border (left in photo), where the grassy area transitions to short, dense trees.

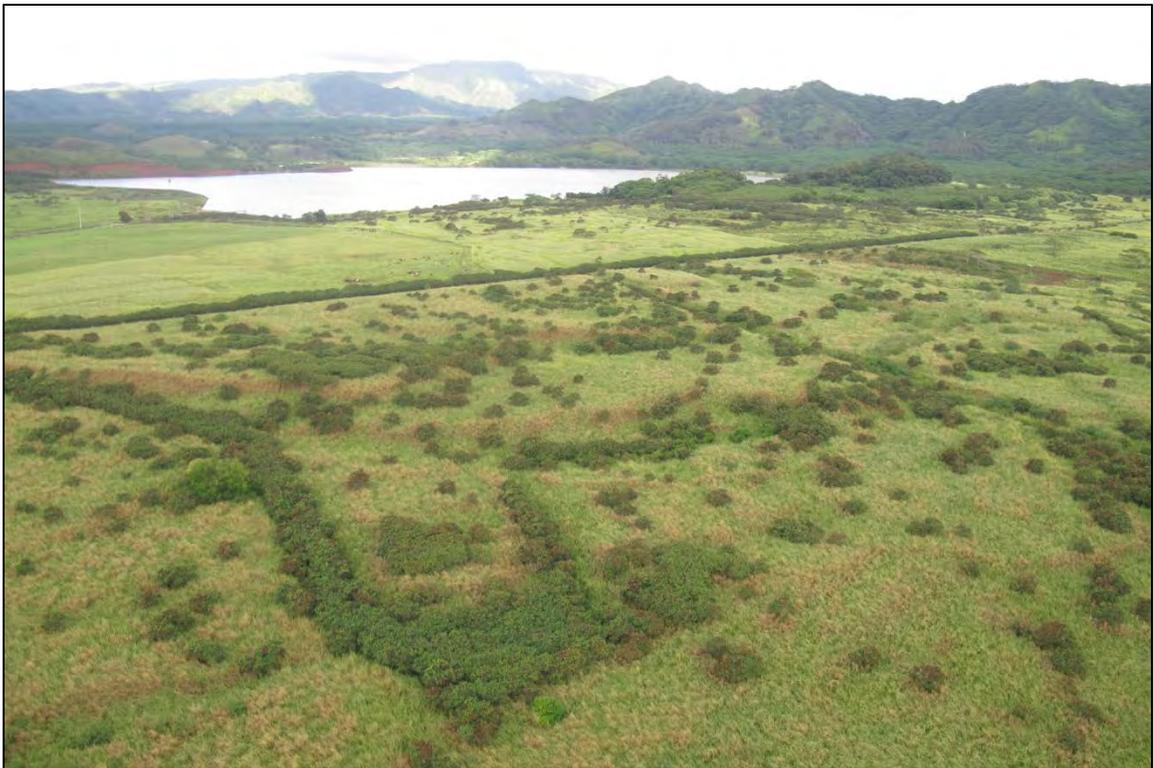
Photo 14. **Koloa.** View of the lower half of the proposed landfill site, from the southern border, facing northwest. Note the Waita reservoir beyond Kaluahonu Rd. and proposed resource recovery park site.

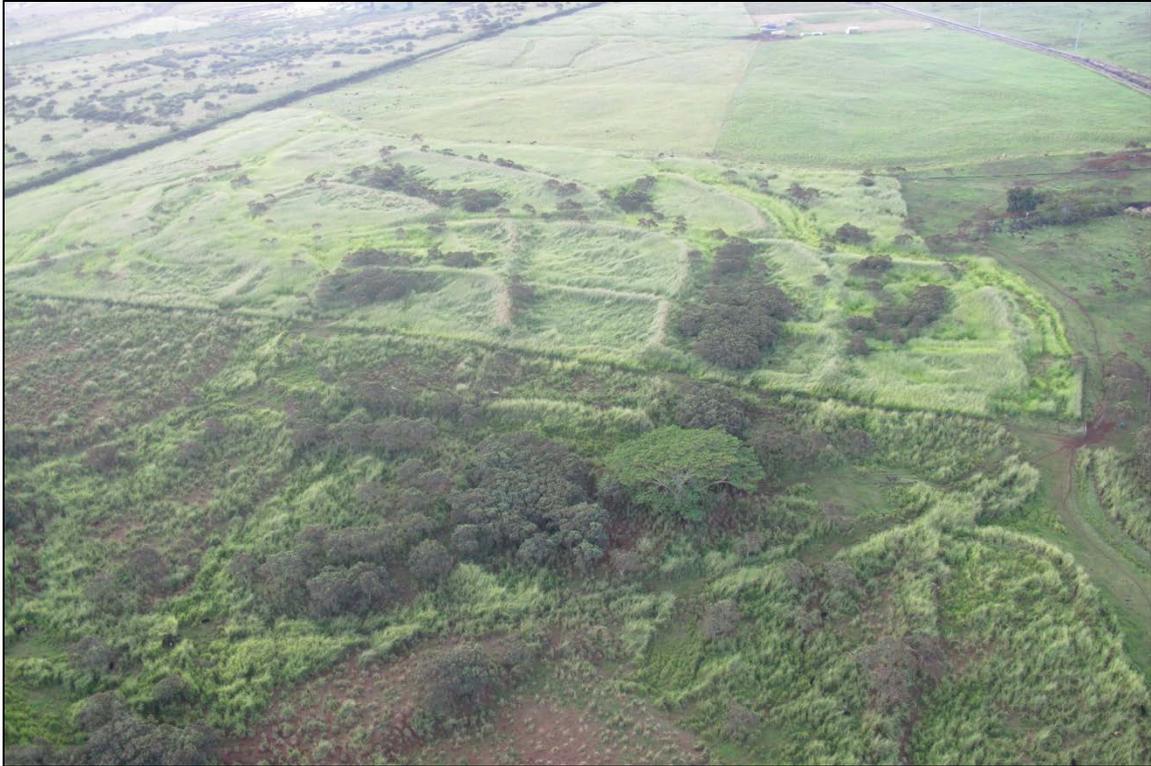
Photo 15. **Koloa.** View, from the midpoint of the proposed resource recovery park, facing makai. Straight line of trees in upper left indicates route of Kaluahonu Rd.

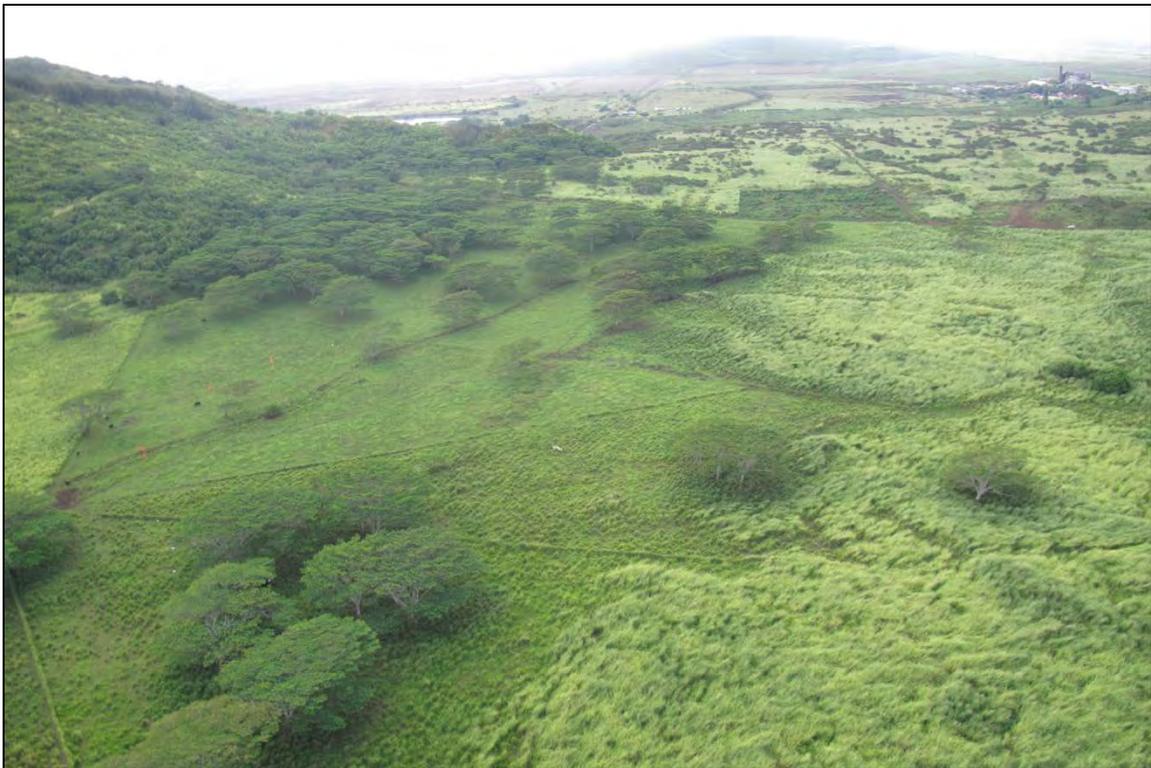
Photo 16. **Koloa.** View, from the mauka end of the proposed landfill site, facing makai. Grassed areas with occasional albezia trees in foreground and right are in the proposed project area. Slopes and forested area on left are outside the proposed project area.
