Final Environmental Assessment For 'Aliomanu Road Repair

**Department of Public Works
County of Kaua'i**

September 2009

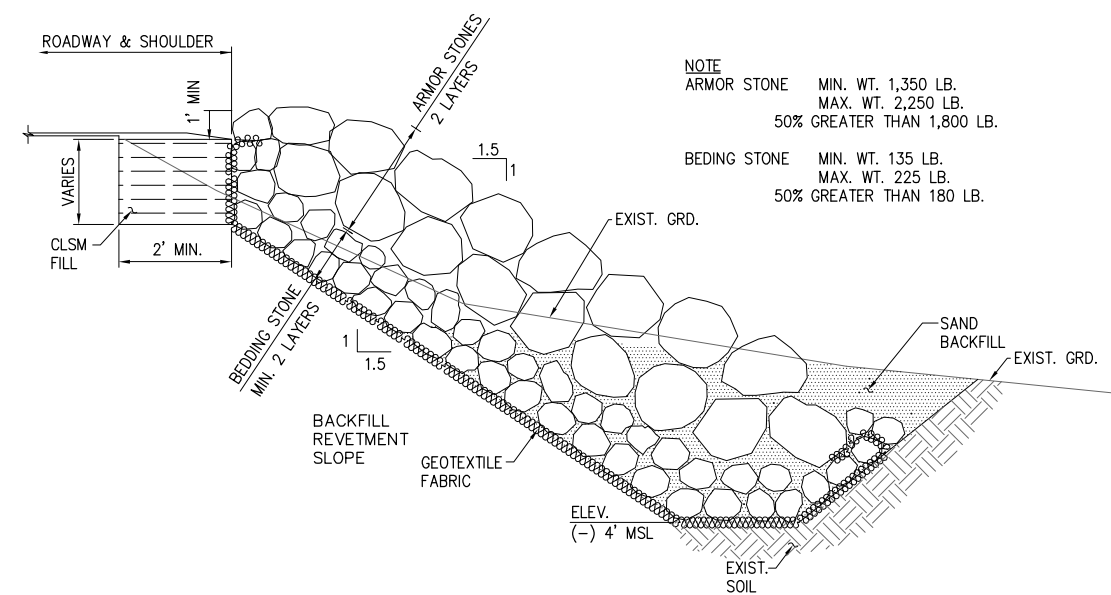
TYPICAL PROFILE
NOT TO SCALE

NOTE
 ARMOR STONE MIN. WT. 1,350 LB.
 MAX. WT. 2,250 LB.
 50% GREATER THAN 1,800 LB.
 BEDDING STONE MIN. WT. 135 LB.
 MAX. WT. 225 LB.
 50% GREATER THAN 180 LB.

The scope of the repair work is to reconstruct the damaged portion of the road to pre-erosion conditions. Therefore, the proposed project is to rebuild the existing roadway to include a 2-foot wide paved shoulder to pre-erosion conditions and stabilize the road with a new rock revetment to prevent future erosion of the roadway (see Figure 3-1). The rock revetment was designed using Corps of Engineers' methods given in the Shore Protection Manual (U.S. Army Corps of Engineers, 1984).

The estimated design life of a rock revetment is 50 years with maintenance. Maintenance of the revetment will be needed the first five years because settling could dislodge a few armor stones that would have to be placed back onto the revetment. However, once the settling has occurred periodic inspection is recommended, especially after high wave events.

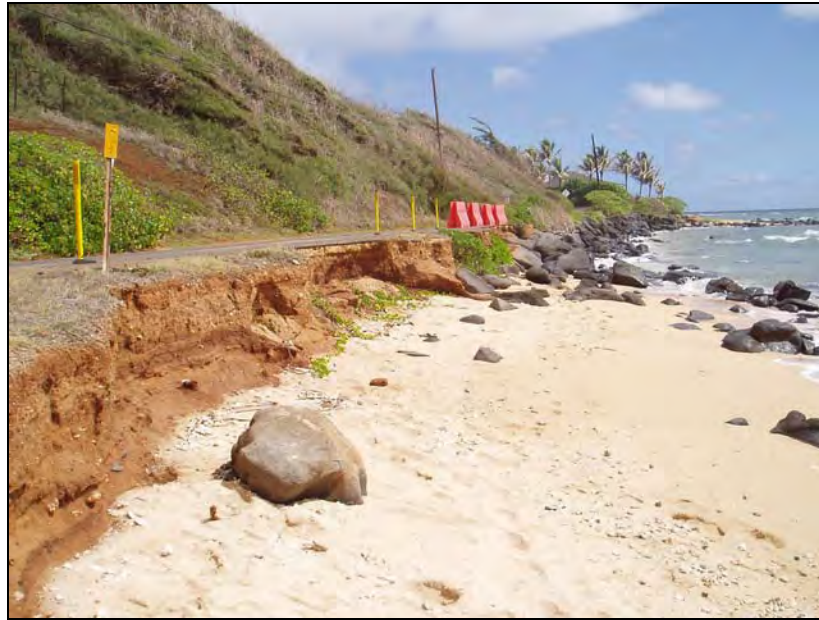
Figure 11. General view of the wave cut bank *makai* of 'Aliomanu Road, view to north-northwest

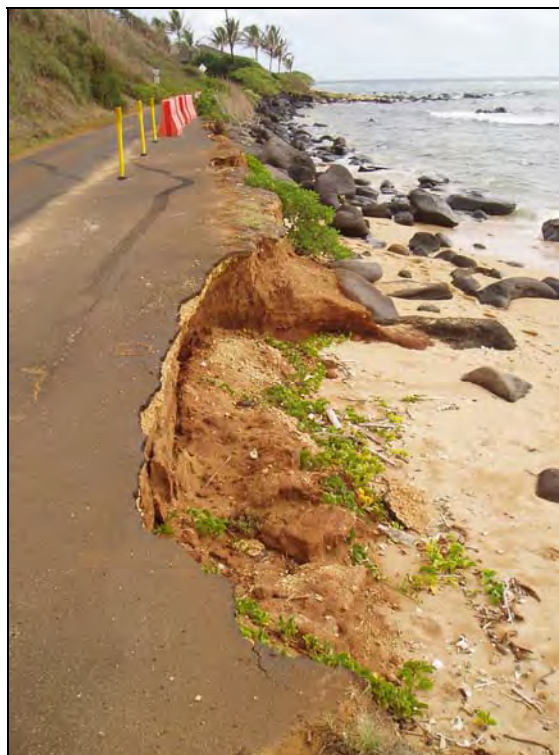
Figure 12. 'Aliomanu Road showing asphalt damage, view to north

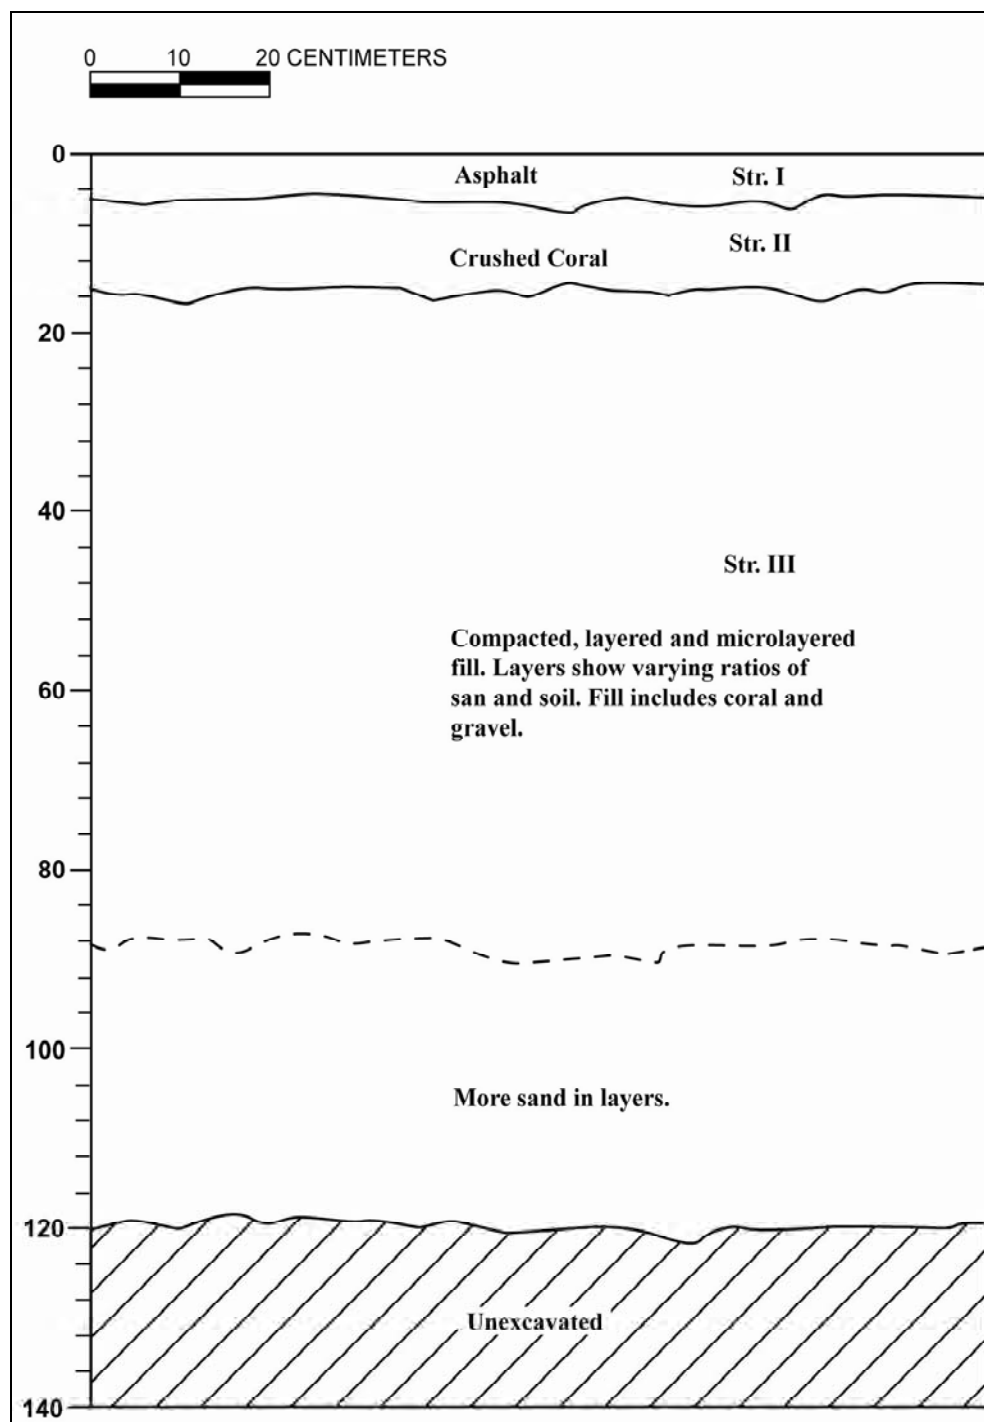
Figure 13. Stratigraphy of Profile 1

Table 3. Stratigraphy Descriptions for Profile 1

Strata	Depth (cmbs)	Description
Stratum I	0-6	Asphalt
Stratum II	5.0-16	Fill Horizon; crushed coral base course
Stratum III	15-90	Compacted layered and micro-layered fill that appears to be compacted. Layers show varying ratios of sand and soil with various colors. Various textures, strong grade, various sizes, dry very hard consistency, strong cementation, mixed origin of sediments, abrupt boundary distinctness, smooth topography

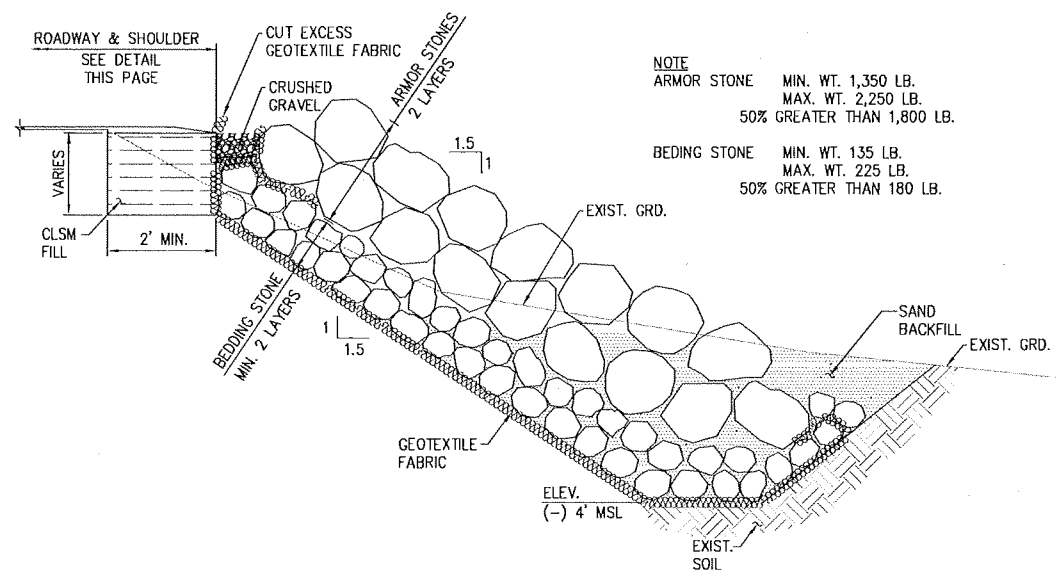
TYPICAL PROFILE
NOT TO SCALE

NOTE
ARMOR STONE MIN. WT. 1,350 LB.
MAX. WT. 2,250 LB.
50% GREATER THAN 1,800 LB.
BEDDING STONE MIN. WT. 135 LB.
MAX. WT. 225 LB.
50% GREATER THAN 180 LB.
