Section 4 Results of Fieldwork

4.1 Survey Findings

This archaeological inventory survey was conducted under archaeological permit number 09-20 issued by the Hawai'i State Historic Preservation Division (SHPD), Department of Land and Natural Resources (DLNR), per Hawai'i Administrative Rules (HAR) Chapter 13-282. CSH archaeologists Gerald K. Ida, B.A., Nancine 'Missy' Kamai, B.A., Kaipo Akana, and Kendy Altizer, B.A. Fieldwork was conducted intermittently between May 21 and February 16, 2010, under the general supervision of Hallett H. Hammatt, Ph.D. (principal investigator). The field work required approximately 29 person-days to complete.

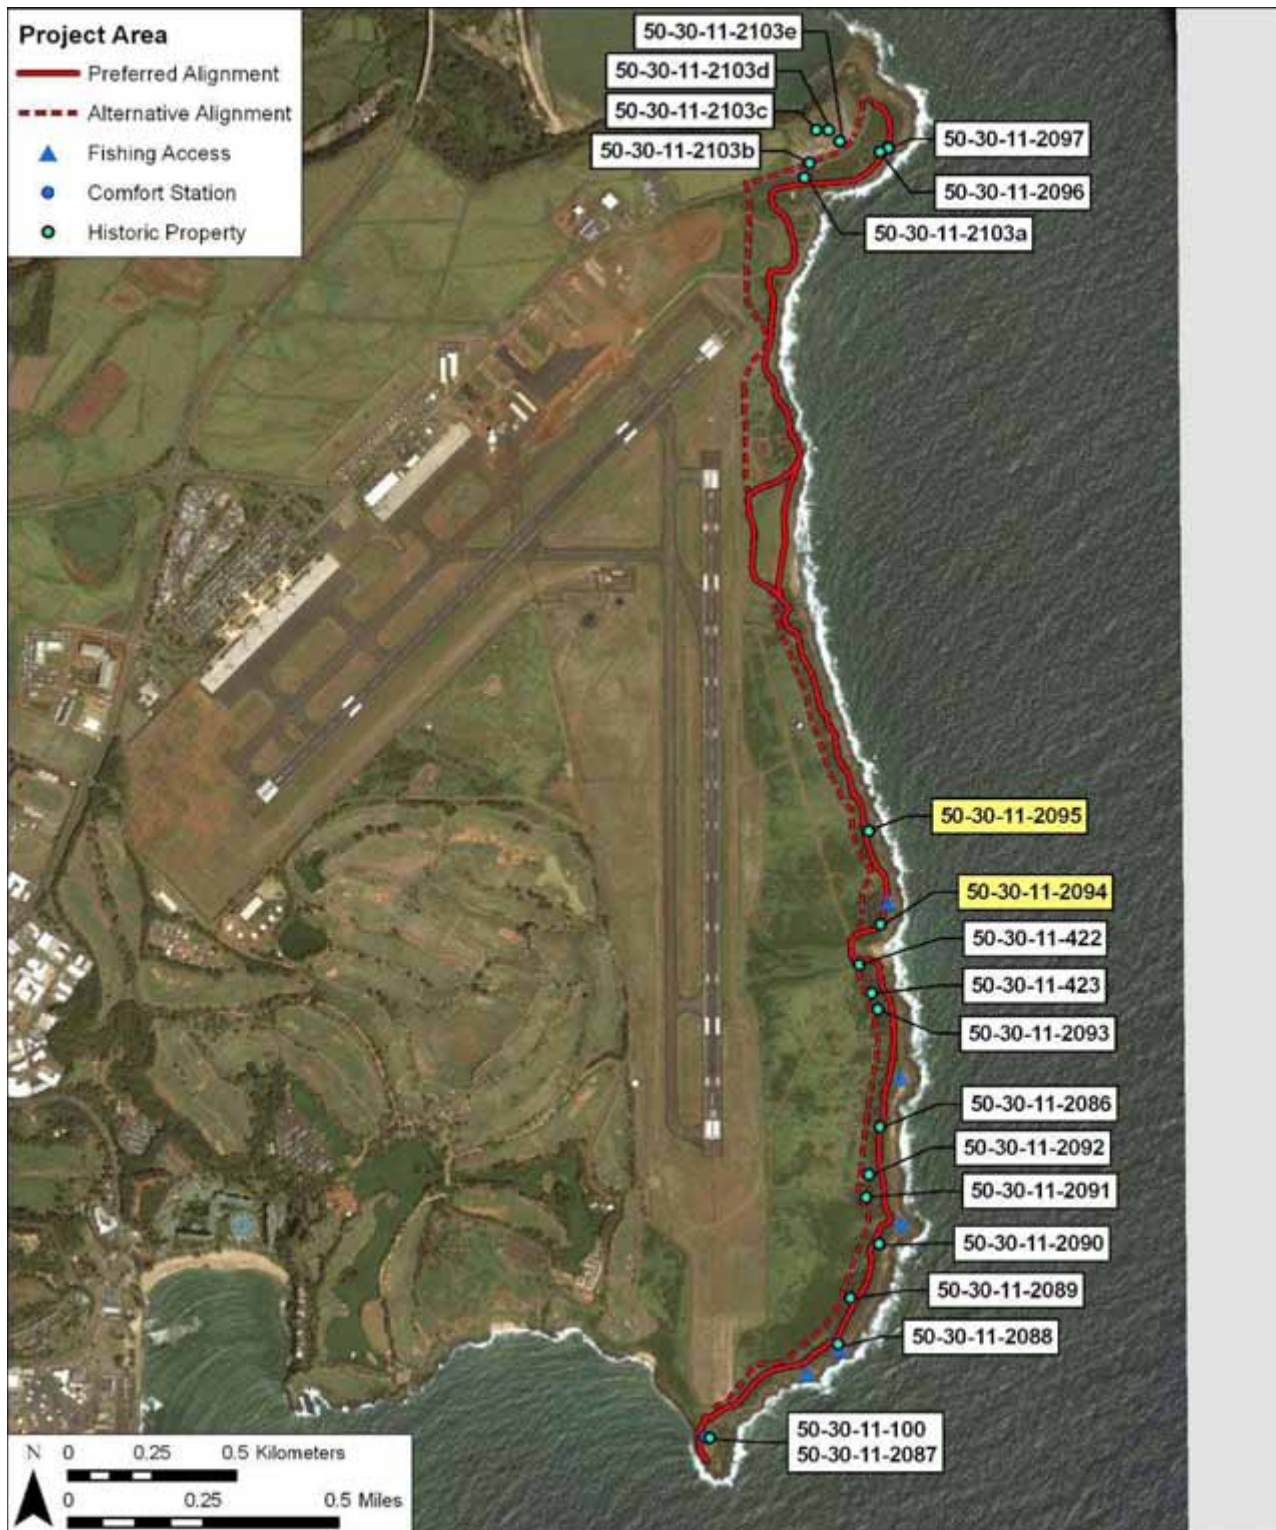
A total of 15 sites were recorded as a result of the current inventory survey (Figure 23, Figure 24, and Figure 25). Of these sites, two were documented as part of a previous survey (Hammatt 1990) and have already been given state site numbers. These sites were revisited and updated as part of the current inventory. Of the sites recorded within the current project area by Hammatt in 1990, two were not relocated and are thought to have been destroyed by Hurricane 'Iniki in 1993. Sites documented during the current inventory survey include 2 walls related to plantation-era sugar cane cultivation and/or ranching activities (Site 50-30-11-422 [CSH 1] and Site 50-30-11-423 [CSH 2]); 2 pre-contact habitation terraces (Site 50-30-11-2086 [CSH 3] and Site 50-30-11-2094 [CSH 12]); Nāwiliwili Harbor Light and associated features (Site 50-30-11-2087 [CSH 5]); the remains of a historic communications tower (Site 50-30-11-2088 [CSH 6]); a possible burial mound Site 50-30-11-2089 [CSH 7]); a military gun emplacement (Site 50-30-11-2090 [CSH 8]); 2 sites related to historic residences (Site 50-30-11-2091 [CSH 9] and Site 50-30-11-2092 [CSH 10]); 1 plantation-era earthen drainage ditch (Site 50-30-11-2093 [CSH 11]); 1 pre-contact activity area (Site 50-30-11-2095 [CSH 13]) and 2 historic concrete drainage ditches (Site 50-30-11-2096 [CSH 14] and Site 50-30-11-2097 [CSH 15]). A brief summary of each site is listed below.

Figure 25. 2009 Google Earth aerial photo showing sites located during the current inventory survey; sites in yellow were tested.

The proposed project will potentially affect historic properties recommended eligible to the Hawai'i Register. To reduce the proposed project's potential adverse effect on significant historic properties, the following mitigation measures are recommended (summarized in Table 3 above, also see Figure 23-Figure 25). The mitigation measures should be completed prior to commencement of ground disturbing activities within the project area.

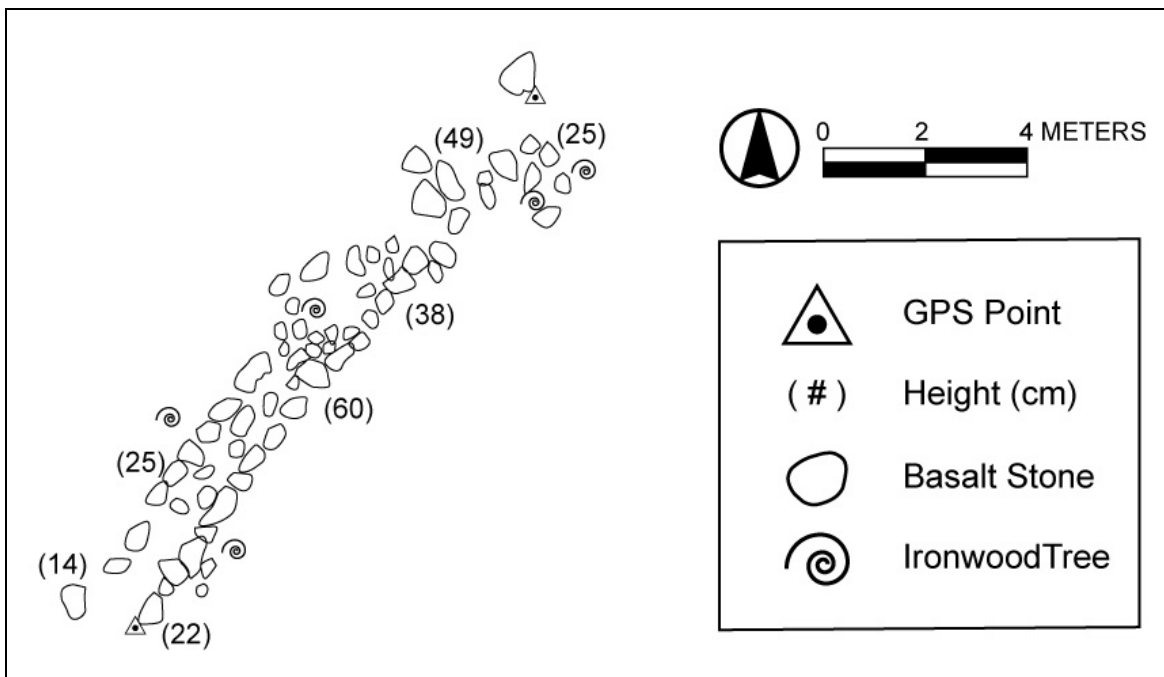
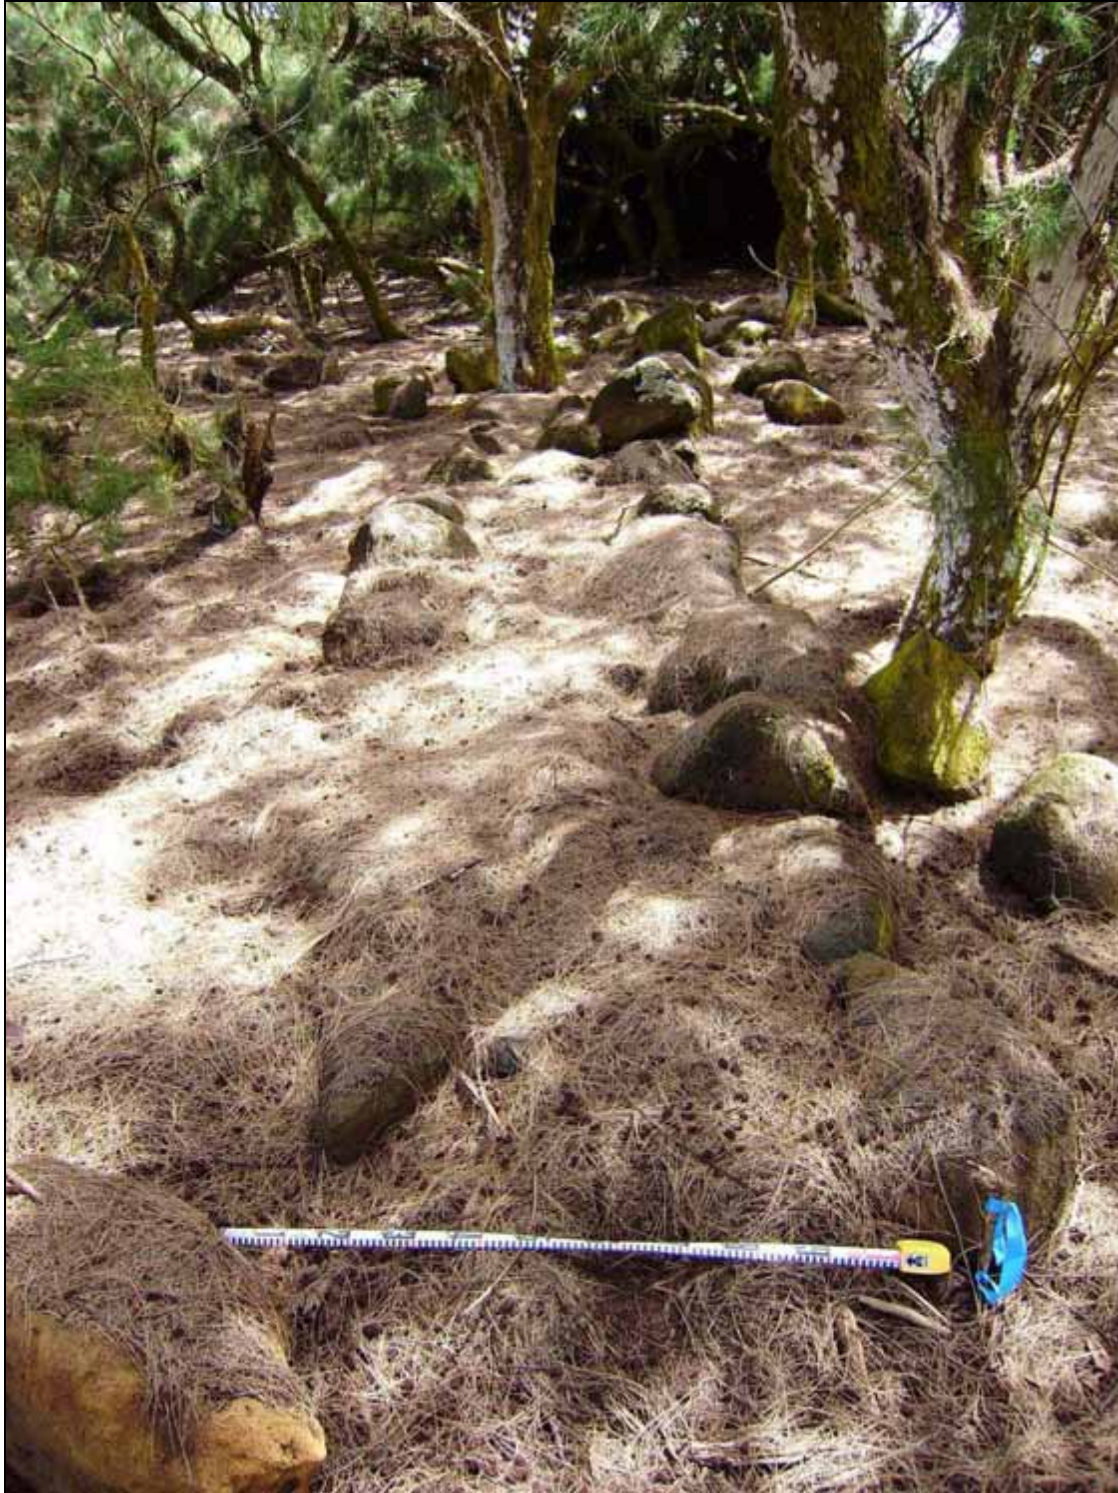
Figure 26. Plan view map of Site 50-30-11-422 (CSH 1)

Site 50-30-11-422 is the remnants of a plantation-era wall measuring 13 m northeast-southwest. Remnants of the wall consist of 2 aligned basalt boulders and a small amount of stacking on the southwestern end of the alignment. Random cobbles and boulders are present in between, indicating the wall has deteriorated over time. No artifacts or features were observed on site. The site is located on a level area under a canopy of ironwood trees, approximately 62 m west of the *makai* project alignment and 10 m east of the *mauka* project alignment. Because of its style and proximity to what were formerly sugar cane fields, Site 50-30-11-422 is likely the remnants of a plantation-era field divider (Figure 26 and Figure 27).

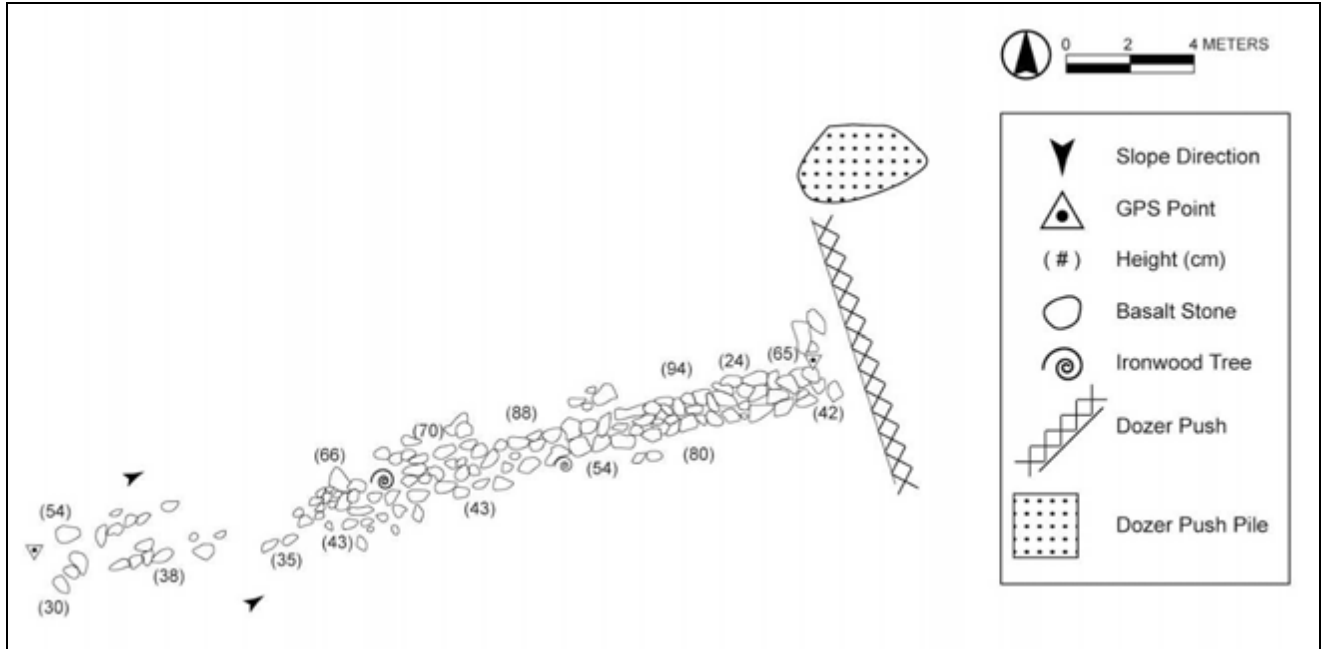
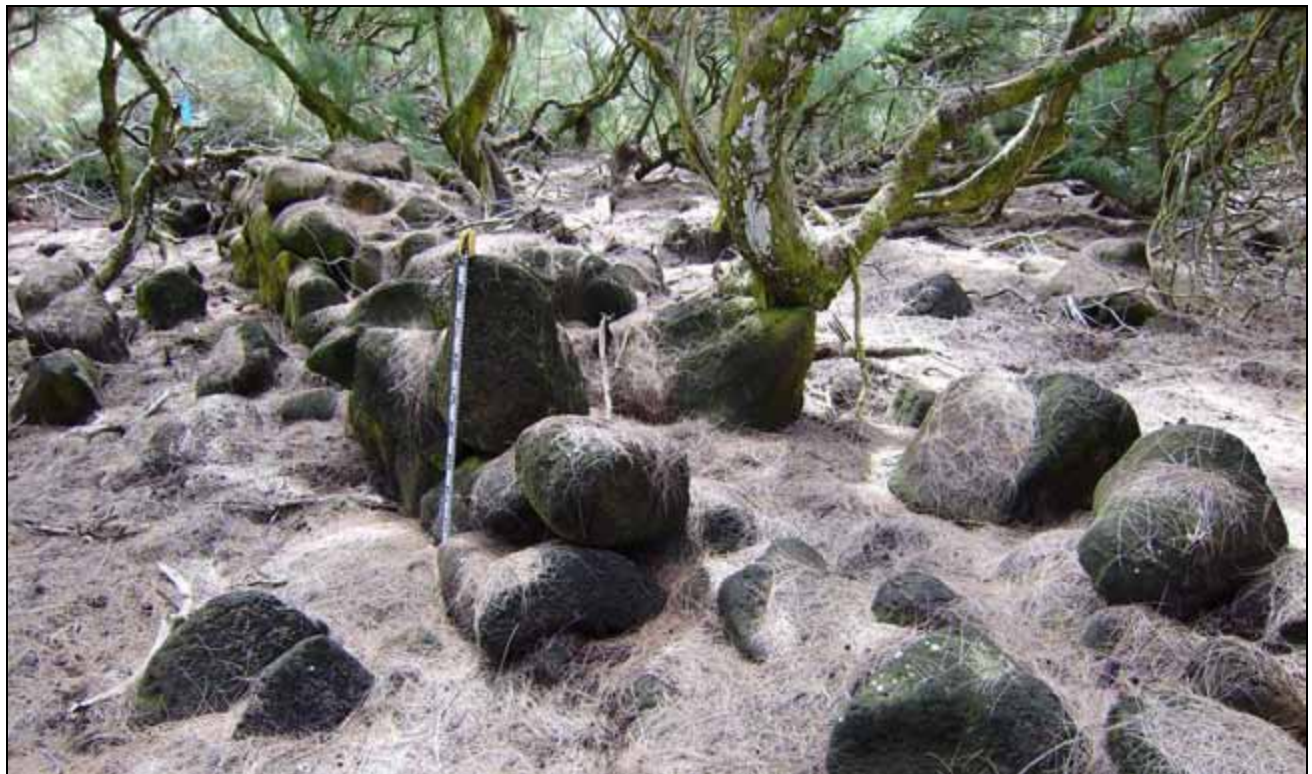
Figure 28. Plan view of Site 50-30-11-423 (CSH 2)

Site 50-30-11-423 is the remnants of a plantation-era wall measuring 24.5m long, northeast-southwest, and 1.6 cm wide. It is constructed of small-to-large basalt boulders stacked one-to-four courses high, with a maximum height of 0.88 m. The western portion of the wall is deteriorated and all that remains are a few scattered basalt cobbles and boulders. A bull dozer push pile of large basalt boulders is present just east of the alignment. The site is located on a gently sloping-to-level area, void of ground vegetation, under a canopy of ironwood trees. It is approximately 56 m west of the *makai* project alignment and 22 m east of the *mauka* project alignment. No artifacts were observed on site. Because of its style and proximity to what were formerly sugar cane fields, Site 50-30-11-423 is likely the remnants of a plantation-era field divider. Vegetation in the area includes ironwood trees (Figure 28 and Figure 29).

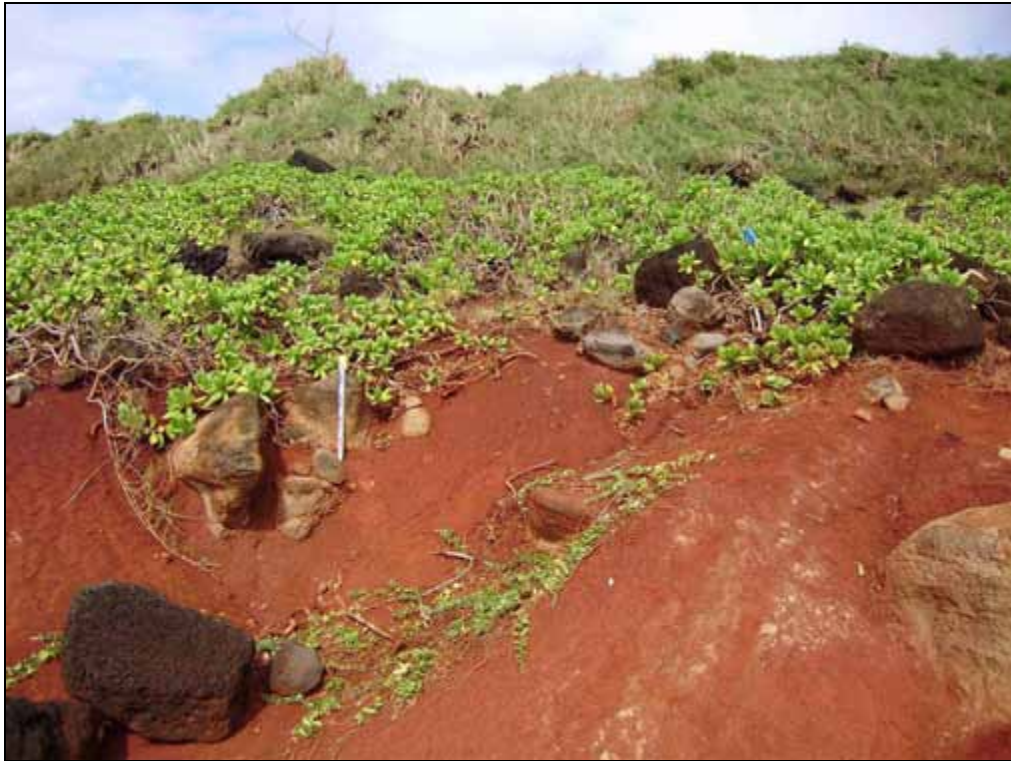
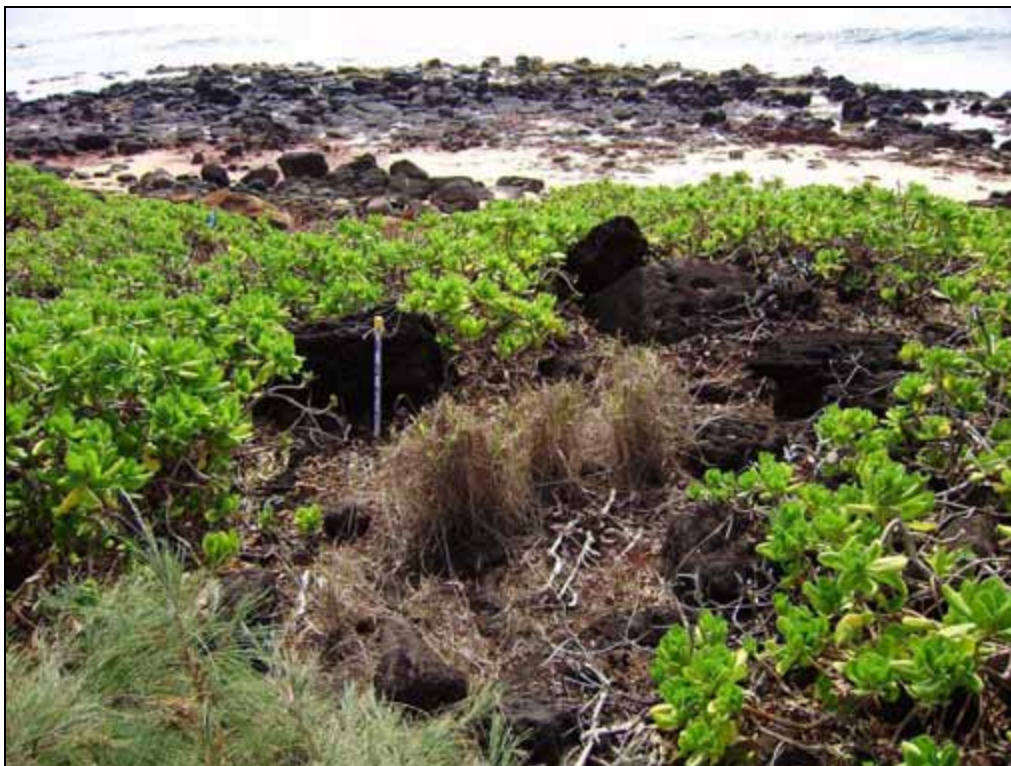
Figure 30. Plan view of Site 50-30-11-2086 (CSH 3)

Site 50-30-11-2086 (CSH 3) consists of the remnants of two terraces. The walls of the lower terrace have completely eroded away. The upper terrace is composed of an alignment of cobbles and boulders stacked one-to-three courses high on bedrock outcrop. The maximum height of the upper terrace is 0.70 m and its interior consists of a level area of stone. The terrace measures 3.0 m east-west by 4.0 m north-south. Coral and marine midden fragments were observed scattered about the area; they include *Cellana sp*, *Cypraea sp*, and *Bivalvia*. Site 50-30-11-2086 is located on a gently sloping-to-sloping area, on the path of the *makai* project alignment and approximately 20 m from the ocean (Figure 30-Figure 32). Vegetation consists of ironwood trees, various grasses, *'ilima*, *pa'u o lu 'iakea*, and *naupaka*.

Figure 31. Site 50-30-11-2086 (CSH 3), eroded lower terrace, view southwest

Figure 32. Site 50-30-11-2086 (CSH 3), upper terrace, view northeast

1. Site 50-30-11-2086 (CSH 3), a pre-contact habitation terrace, was documented with a detailed written description, photographs, and accurately located with GPS survey equipment. The proposed project may have an adverse effect on the remaining structure. Preservation, in the form of avoidance by a 20 ft buffer and educational signage, is recommended for Site 50-30-11-2086.

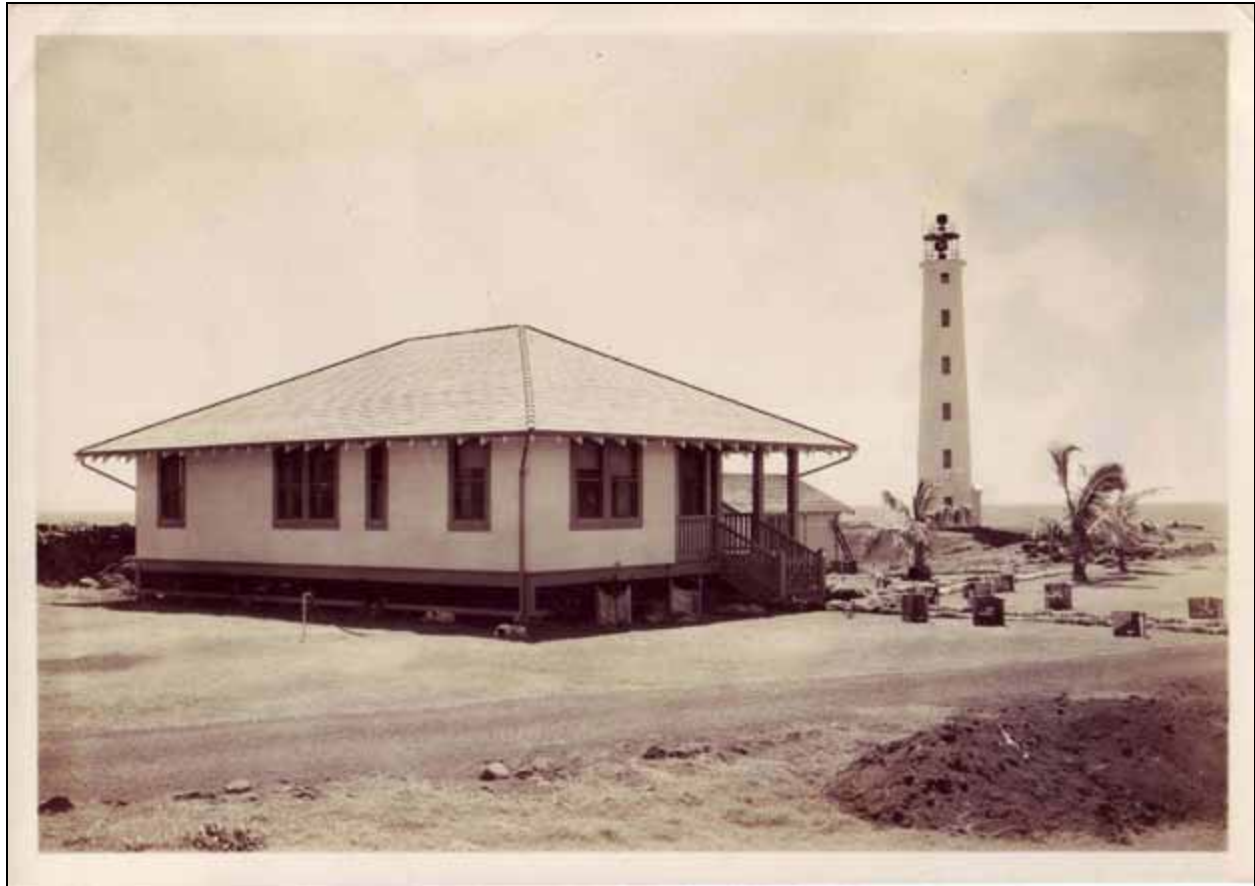
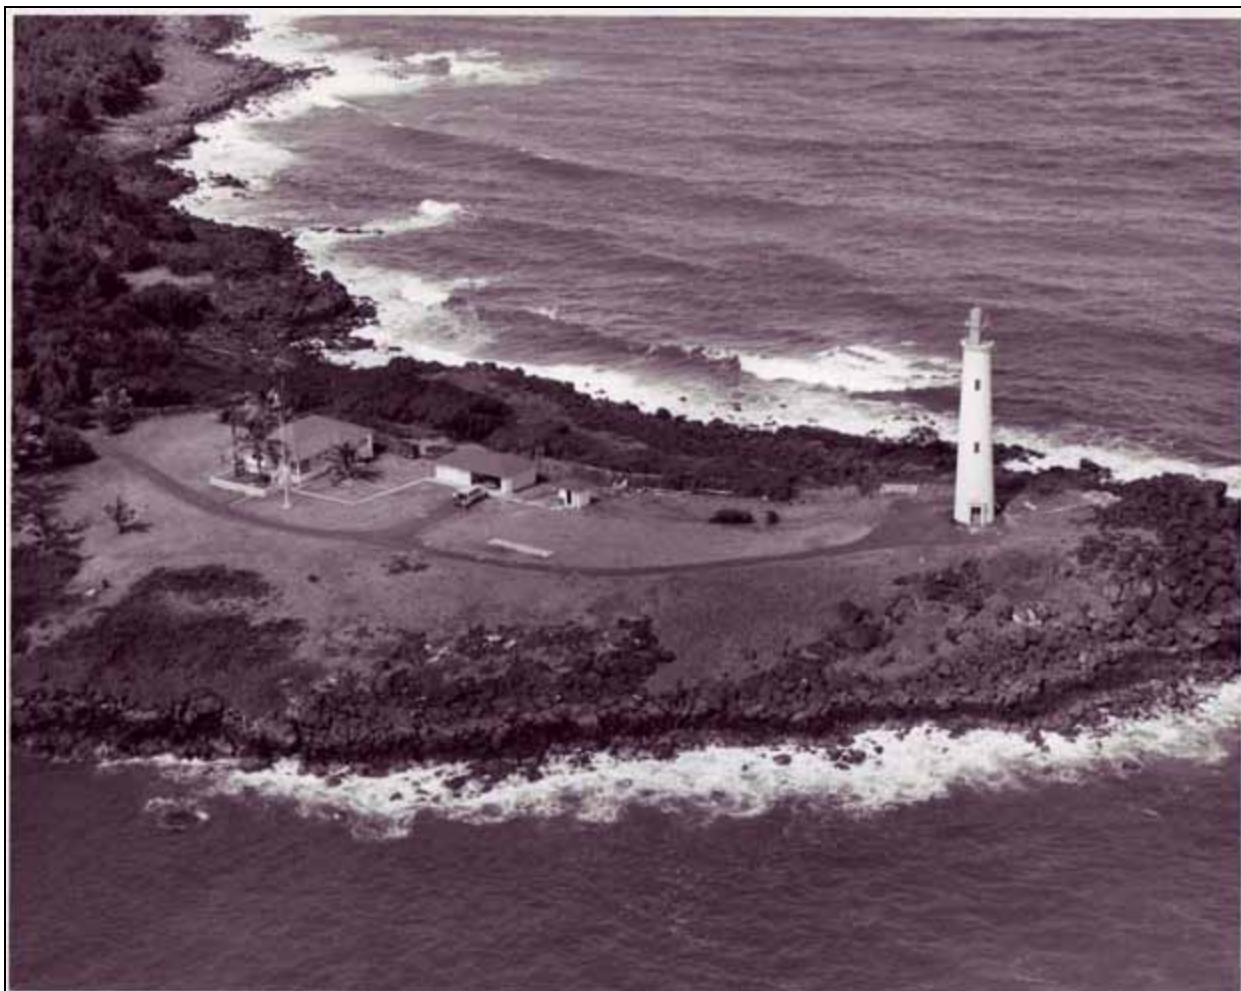
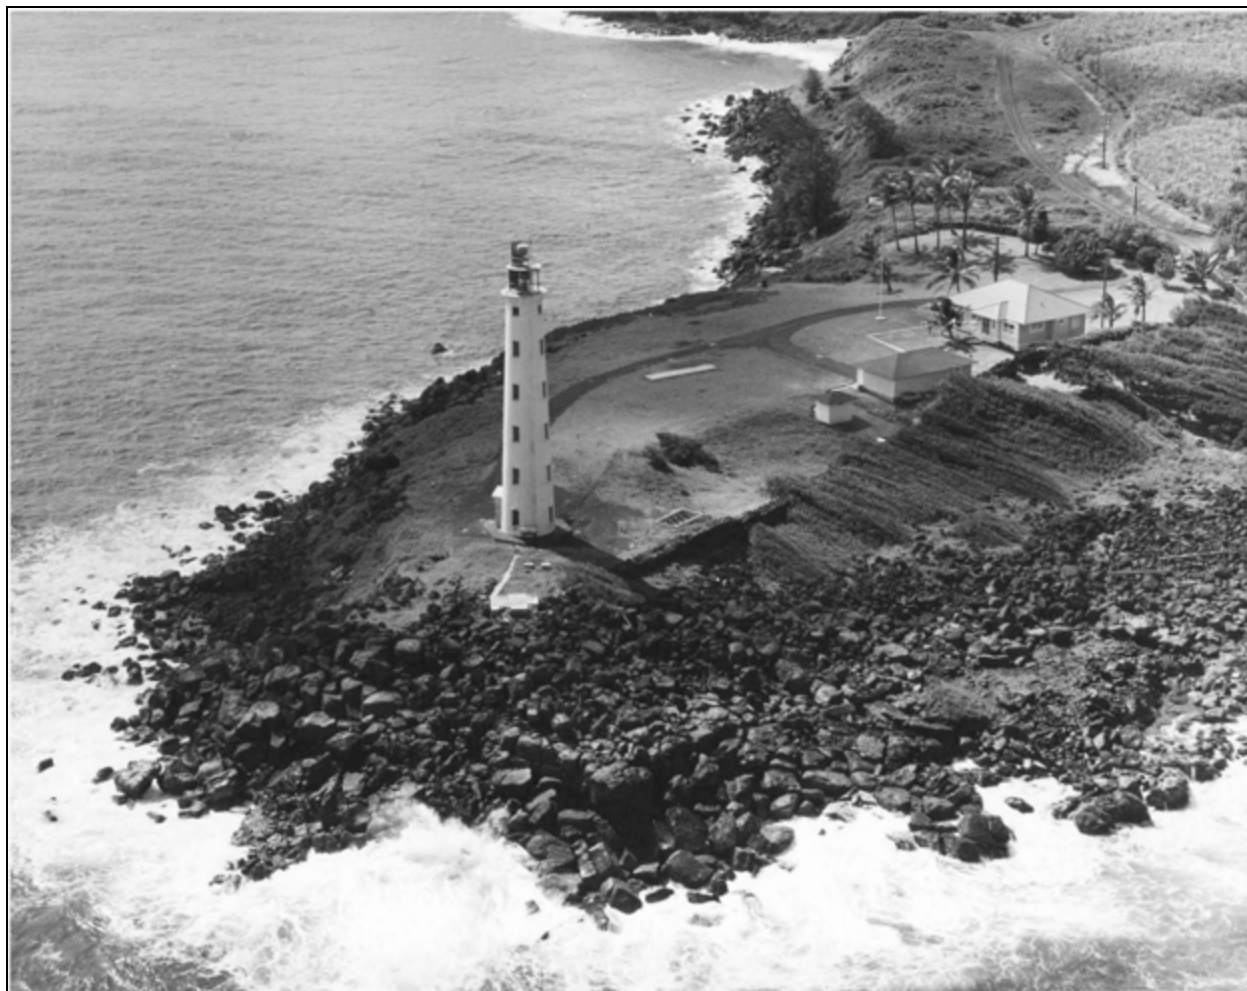
Figure 33. Plan view of Site 50-30-11-2087 (CSH 5)

Site 50-30-11-2087 consists of three walls (Features A, B, and C), Nāwiliwili Harbor Light (Feature D), and associated structural remnants related to the lighthouse caretaker's residence (Features E, F, and G; Figure 33-Figure 42). The site is located on Ninini Point and the U.S. Coast Guard manages the upkeep of the lighthouse and surrounding area. Feature A, the longest wall, begins along the east side of Nāwiliwili Harbor Light and measures 120 m long, north-southeast, with varying thicknesses between 0.5 m and 0.9 m; its height also varies between 0.5 m and 2.2 m. There is a break in the northern portion of Feature A and a concrete walkway is present perpendicular to the wall. Figure 36 clearly shows the sidewalk and the break in Feature A. The smallest of the three walls, Feature B, is present approximately 20 m north of the southern terminus of Feature A. It is attached to Feature A on the west side and measures approximately 10 m long, northeast-southwest, is 0.5 m thick, and 1.3 m high. A utility pole is present approximately 2 m northwest of Feature B, and a concrete footing is present approximately 1 m southeast of Feature B. Feature C is present approximately 4 m north of Feature A and measures 24 m northwest-southeast, is 1 m thick, and has a maximum height of 1.2 m. The northwest portion of Feature C is not standing but remnants of boulders and cobbles from the wall are present in the area. All three walls are constructed of small-to-large sized boulders stacked two-to-eight courses high. Mortar is present in some areas of the walls, while others are dry-stacked. Of particular note is evidence of curbing present in the wall construction, observed in Feature A (Figure 39). This is typical of historic street features in Lihū'e.

Nāwiliwili Harbor Light (Feature D) is the only remaining fully functional structure on site. It consists of a concrete foundation, 86-ft tall cylindrical tower, and an automated lens. This structure was built in 1933 (Dean 1991). There is a concrete foundation (Feature E) present in the northeast corner of Features A and B. A depression (Feature F), measuring approximately 20 m northwest-southeast by 10 m east-west, is present northwest of Feature B and west of Feature A. The function of the depression is unknown, however the paint storage shed was once located in the depression and stairs were present on its north side (Figure 34). A concrete foundation (Feature G) is present approximately 2 m southwest of the northwest end of Wall C. Its function is unknown.

Figure 34. 1978 revision of the light house complex plans which were traced from a 1943 drawing by the U.S. Coastguard

Figure 35, 1934 photo of portions of Site 50-30-11-2087, the caretaker's residence with Nāwiliwili Harbor Light in the background. Feature A is just visible to the left side of the house, view east. Original caption: "Nawiliwili Hbr. Lt. Station [;] Photo taken in March 1934 by Senda Studio. Tower accomplished [sic] in 1932, and lantern established in 1933. New dwelling constructed in 1933."; photo dated March, 1934; Photo No. "Book 9 Film No. 38"; photo by "Senda Studios" (photo courtesy of the U.S. Coast Guard)

2. Site 50-30-11-2087 (CSH 5), Nāwiliwili Harbor Light and associated features, was documented with a detailed written description, photographs, and accurately located with GPS survey equipment. The proposed project may have an adverse effect on these remnants. Adaptive re-use of the site using traditional Hawaiian methods and construction, and educational signage discussing the long history of Ninini Point is recommended for Site 50-30-11-2087. Consultation with SHPD/DLNR should take place to determine appropriate historic replication of structures.

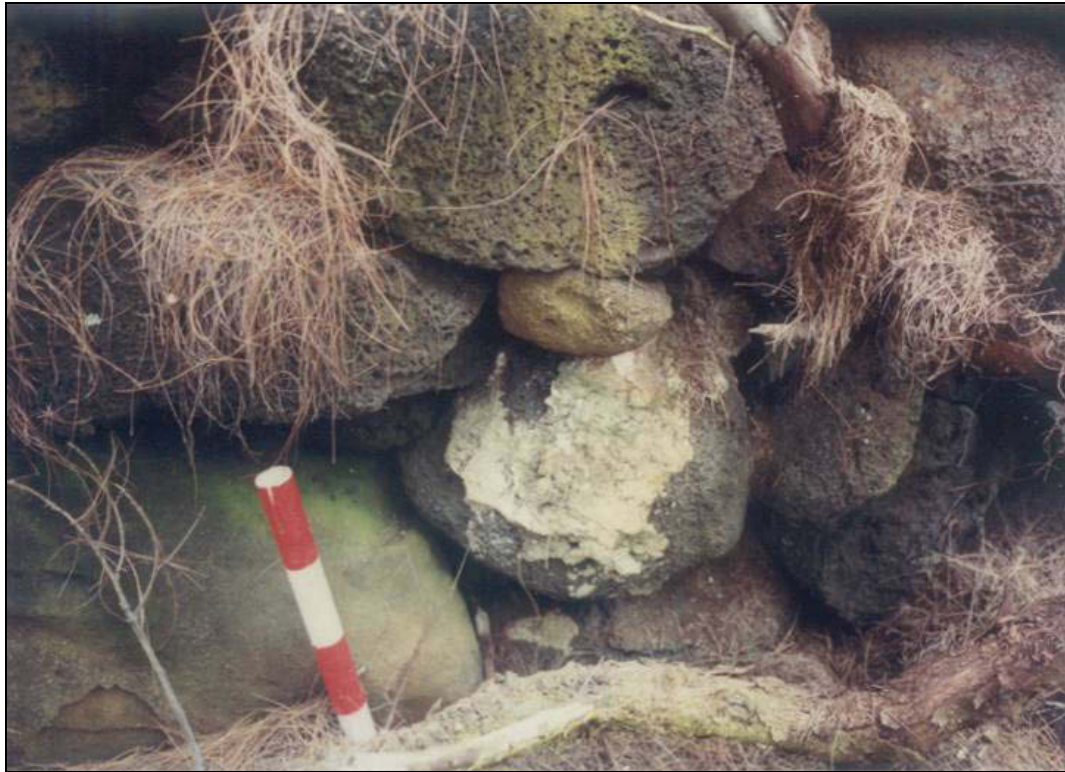
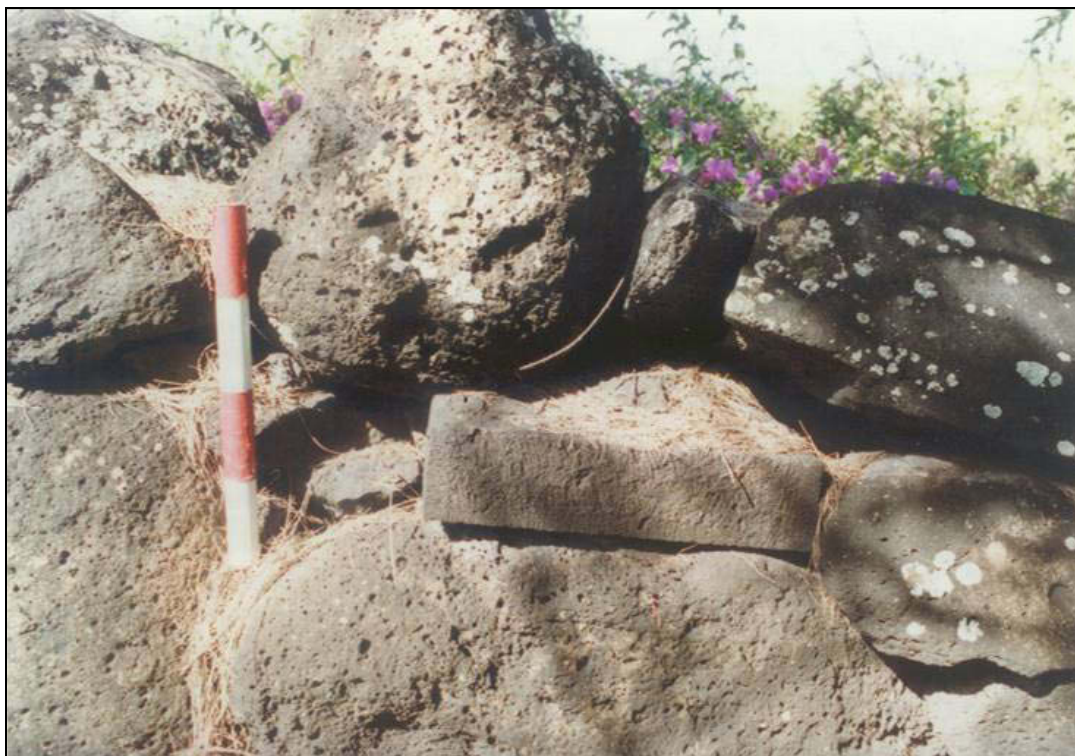
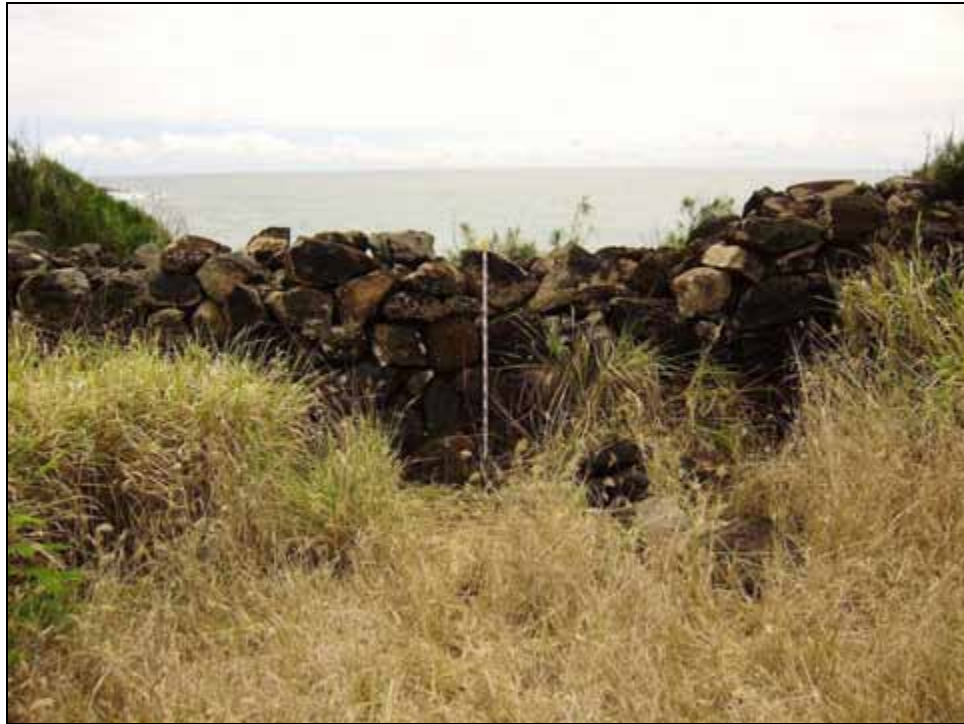
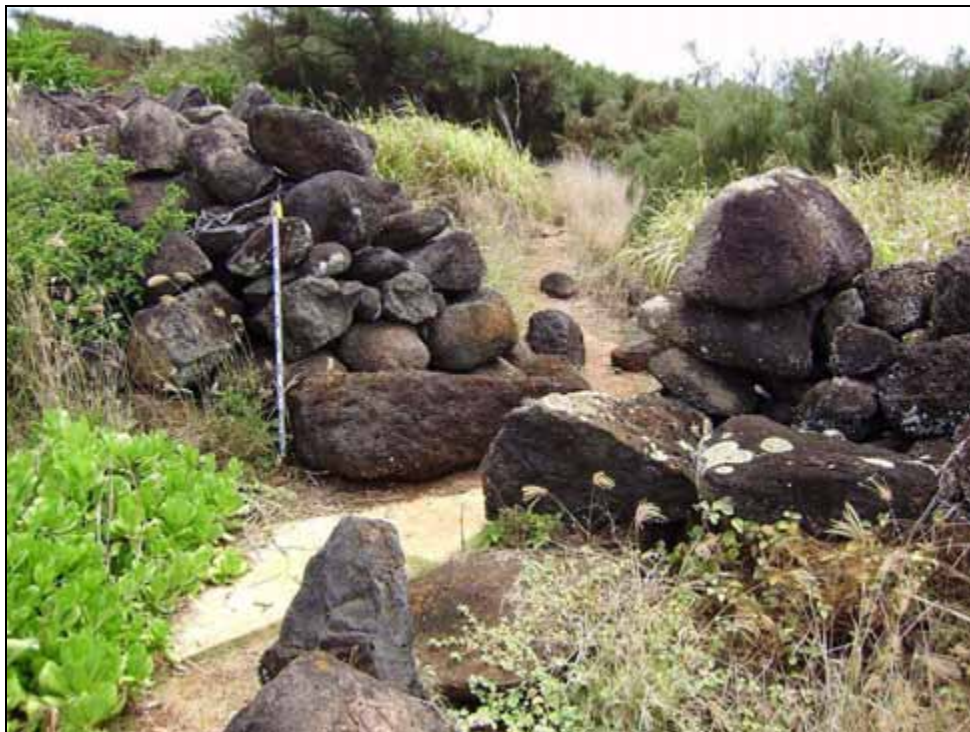
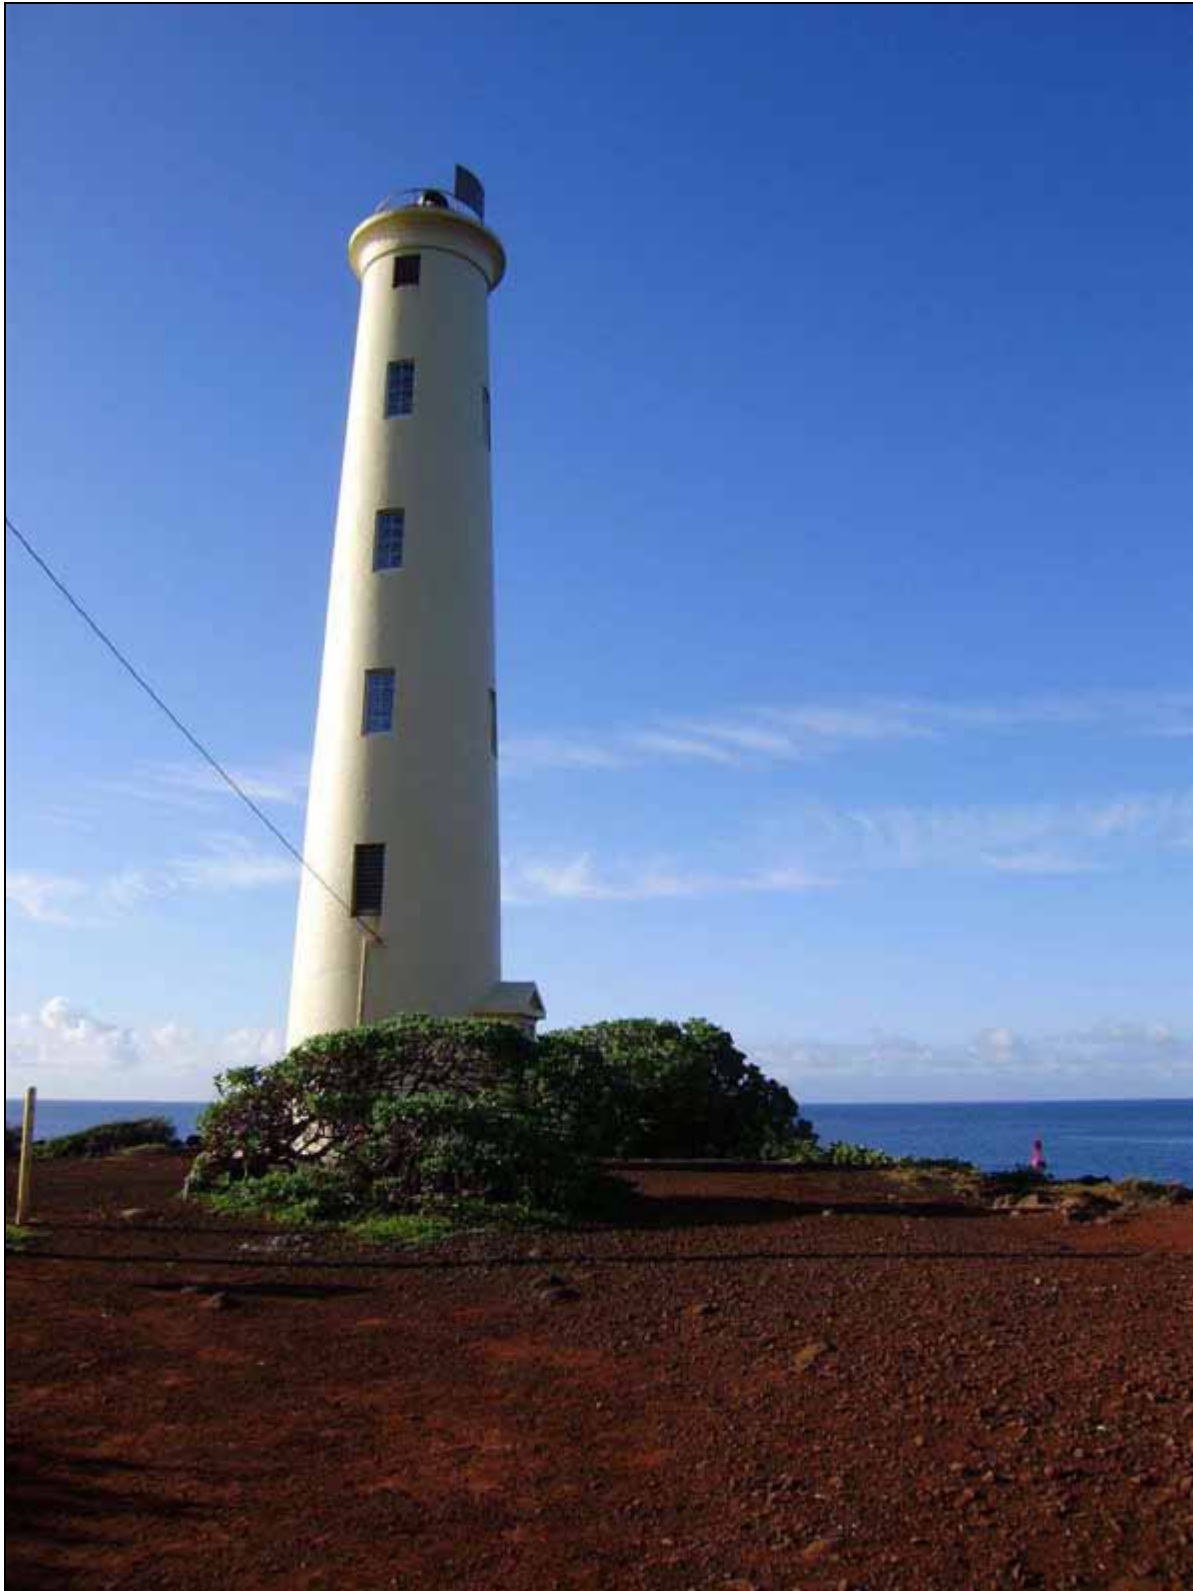
Figure 38. Site 50-30-11-2087, close up photo of mortar covered rock in Feature A

Figure 39. Site 50-30-11-2087, close up of curb stone present in Feature A

Figure 40. Site 50-30-11-2087, overview of Feature A, view east

Figure 41. Site 50-30-11-2087, break in Feature A with sidewalk present, view northeast

Figure 42. Site 50-30-11-2087 (CSH 5), Nāwiliwili Harbor Light, view east

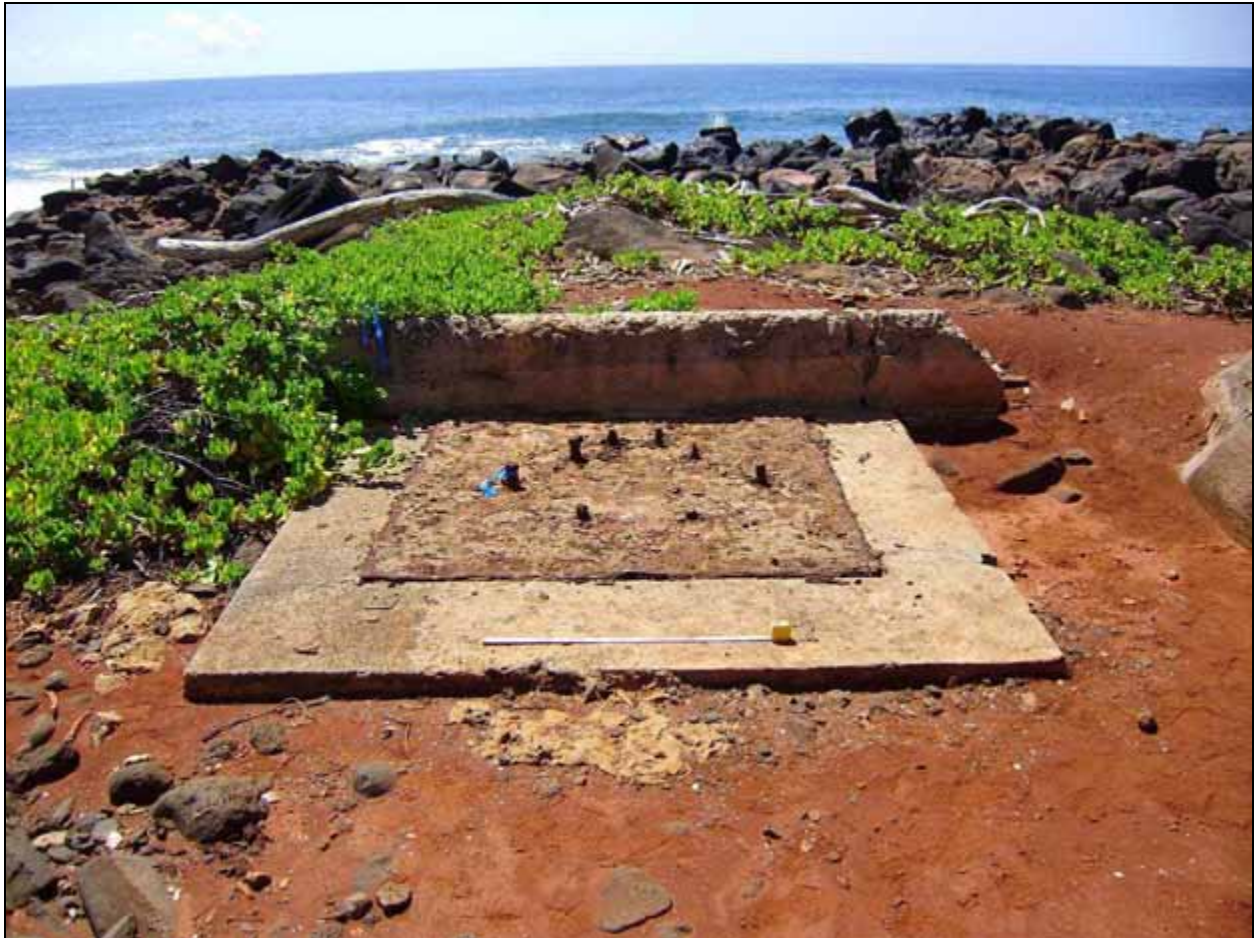
Figure 43. Plan view of Site 50-30-11-2088 (CSH 6)

Site 50-30-11-2088 is a concrete foundation measuring 3.0 m northeast-southwest by 2.6 m northwest-southeast. A rusted metal plate with the remnants of metal bolts is present in the center of the foundation and measures 2.0 m northeast-southwest by 1.8 m northwest-southeast. A concrete wall is present on the southwestern edge of the foundation measuring 4.3 m long by 0.28 m thick. The wall varies in height between 0.54 m on the northwest end and 0.22 m on the southeast end. The wall appears broken at both ends; its original length and function is unknown. Cultural material observed on site includes corroded metal of unknown function, wire, and fragments of glass. Marine shell is also present and includes *Cypraea sp*, Turbinidae, *Cellana sp*, Neritidae, and Bivalvia. The foundation is likely the remains of a communication tower and is possibly the same as depicted on the 1910 U.S. Geological Survey topographic map (Figure 16). The site sits on a level plane approximately 15 m from the ocean, approximately 25 m southeast of the *makai* project alignment, and is surrounded by bedrock outcrop on the northwest and southwest sides (Figure 43 and Figure 44). Vegetation present in the area includes *naupaka*, and low lying ironwood trees.

3. Site 50-30-11-2088 (CSH 6), a possible communications tower foundation, was documented with a detailed written description, photographs, scale drawings, and accurately located with GPS survey equipment. The proposed project may have an adverse effect on the foundation. No further work is recommended for Site 50-30-11-2088. Sufficient information regarding the location, function, age, and construction methods of the foundation has been generated by the current inventory survey investigation to mitigate any adverse effect caused by proposed development activities.
