Section 4 Results of Fieldwork

4.1 Survey Findings

This archaeological inventory survey was conducted under archaeological permit number 09-20 issued by the Hawai'i State Historic Preservation Division (SHPD), Department of Land and Natural Resources (DLNR), per Hawai'i Administrative Rules (HAR) Chapter 13-282. CSH archaeologists Gerald K. Ida, B.A., Nancine 'Missy' Kamai, B.A., Kaipo Akana, and Kendy Altizer, B.A. Fieldwork was conducted intermittently between May 21 and February 16, 2010, under the general supervision of Hallett H. Hammatt, Ph.D. (principal investigator). The field work required approximately 29 person-days to complete.

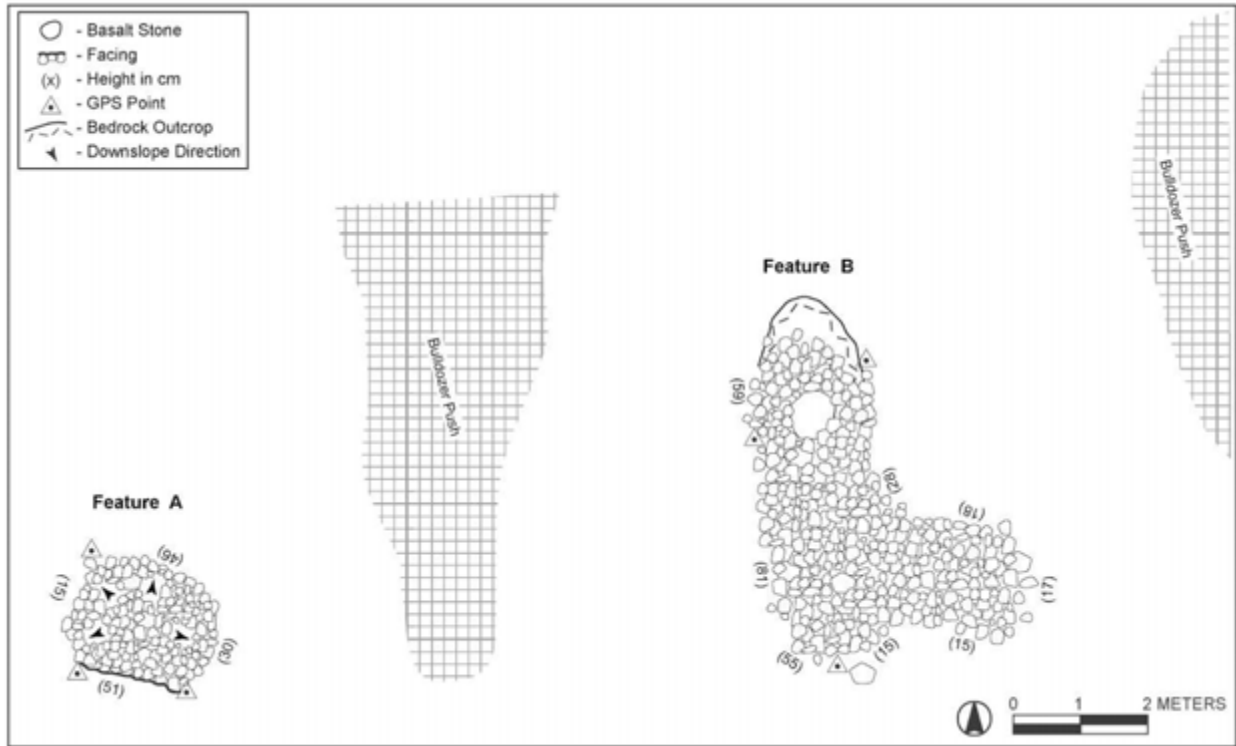
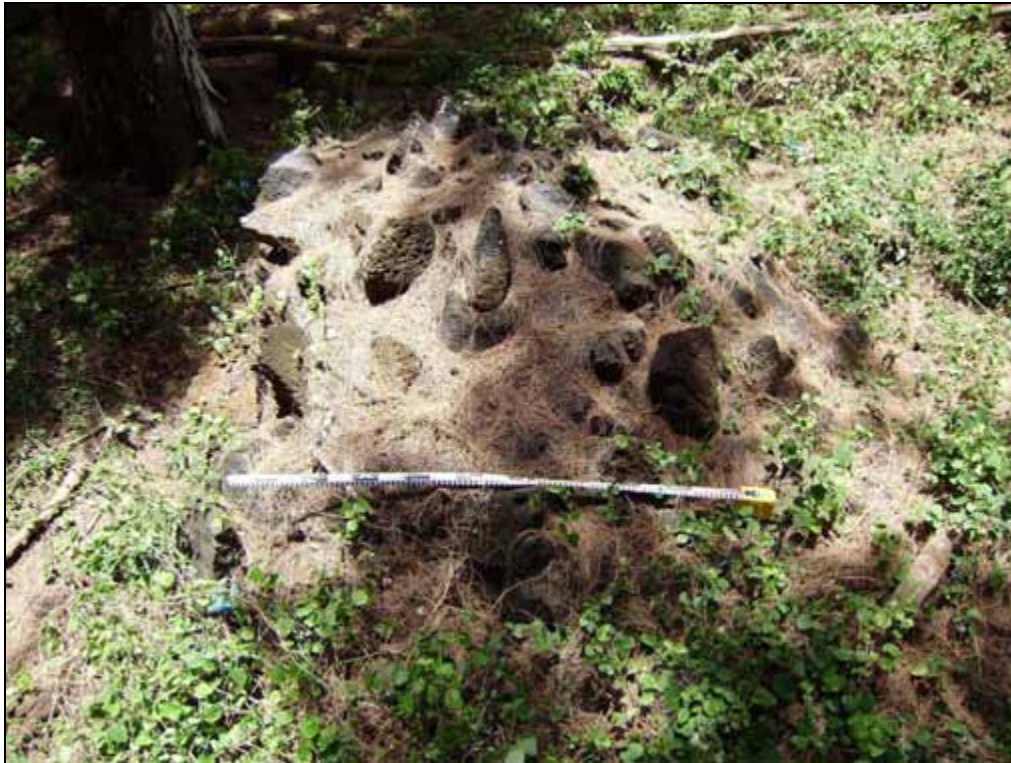
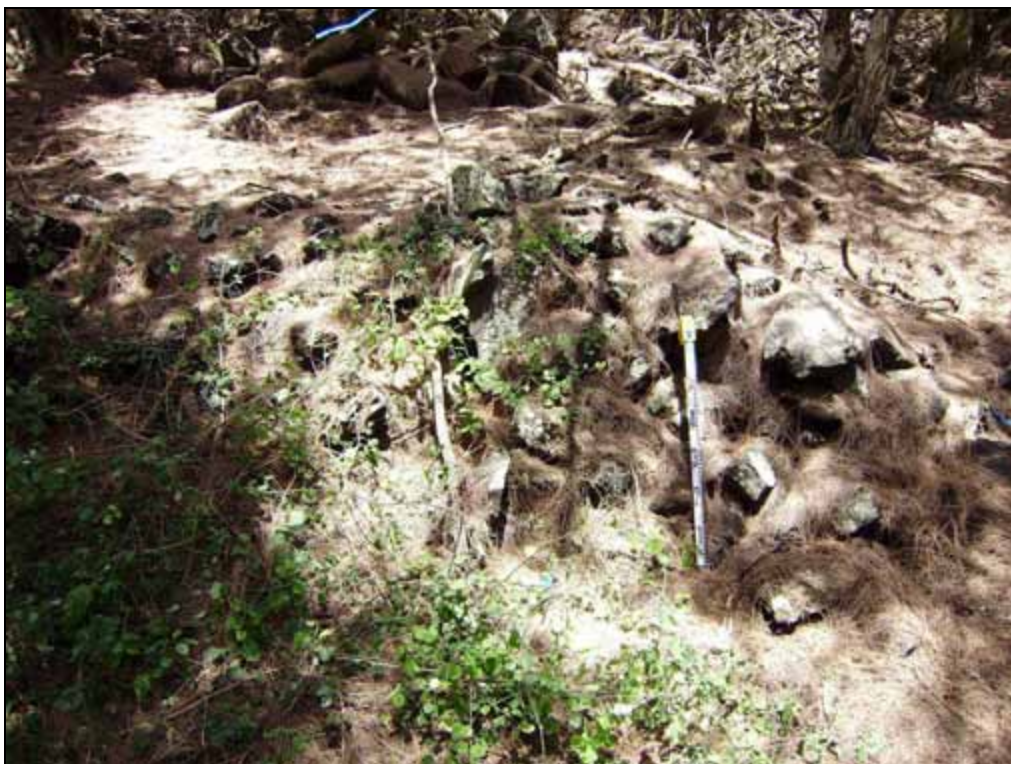
Figure 45. Plan view of Site 50-30-11-2089 (CSH 7)

Site 50-30-11-2089 consists of two mounds separated by a bulldozed push pile (Figure 45-Figure 47). The mounds are constructed of smaller basalt cobbles and are more tightly stacked, differentiating them from the push pile of other cobbles and boulders in the area. Mound A measures 2.0 m north-south by 2.3 m east-west and is constructed of small boulders and large cobbles stacked three-to-five courses high, with a maximum height of 0.51 m. The north end of the mound is faced, while other portion slopes gently south. The style of construction indicates Mound A is likely a burial, but because it's relatively small size, may be a pet burial or that of a small child.

Mound B is located 9.7 m east of Mound A and consists of an L-shaped mound measuring 5.4 m north-south by 1.4 m east-west. The north end of the mound is constructed on a large bedrock boulder. The mound itself is constructed of large cobbles and a few smaller boulders stacked two-to-six courses high to a maximum height of 0.81 m. The cobbles of Mound B are smaller than those observed in the push pile, but are not as tightly stacked as Mound A. This indicates the feature is likely a clearance mound. Site 50-30-11-2089 is located under a canopy of ironwood trees approximately 15 m west of the *makai* project alignment and 30 m east of the *mauka* project alignment, and is approximately 40 m from the ocean.

Figure 46. Site 50-30-11-2089 (CSH 7), Mound A, view west

Figure 47. Site 50-30-11-2089 (CSH 7), Mound B, view northeast

4. Site 50-30-2089 (CSH 7), a possible burial mound, was documented with a detailed written description, photographs, and accurately located with GPS survey equipment. The proposed project may have an adverse effect on the mound. Preservation, in the form of avoidance and protection, is recommended for Site 50-30-2089. A buffer of 50 ft is recommended and would ensure public avoidance of the site. An archaeological data recovery program is also recommended for this site prior to commencement of construction activities.

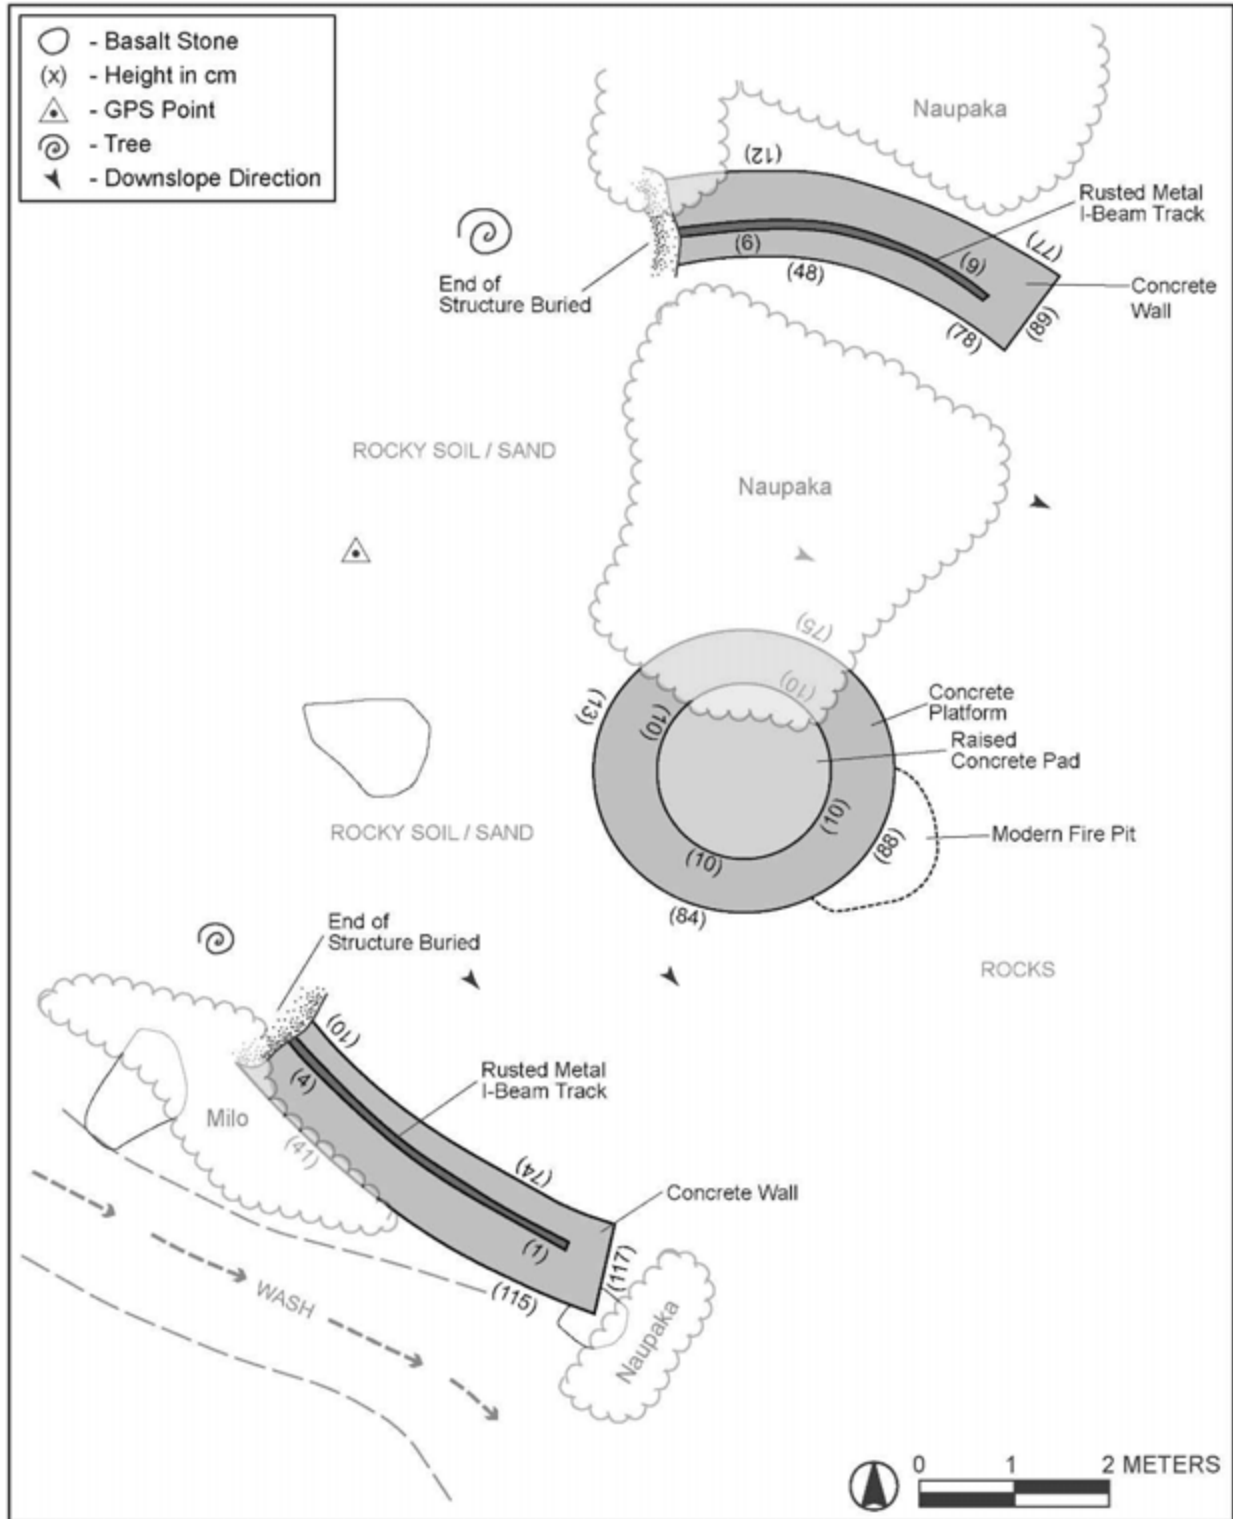
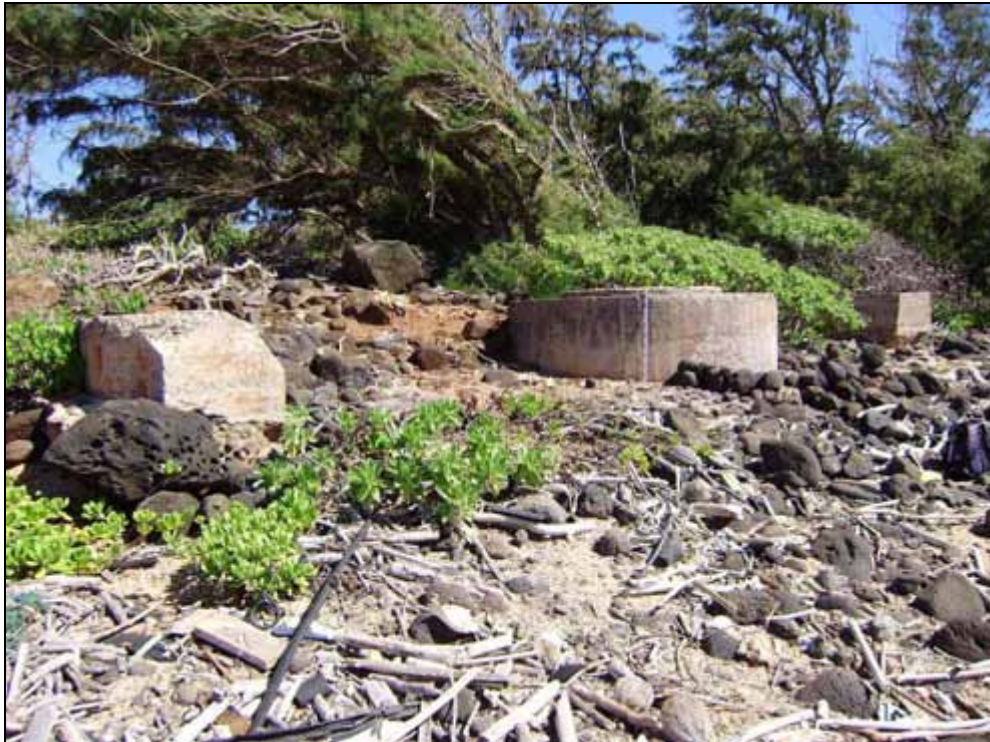
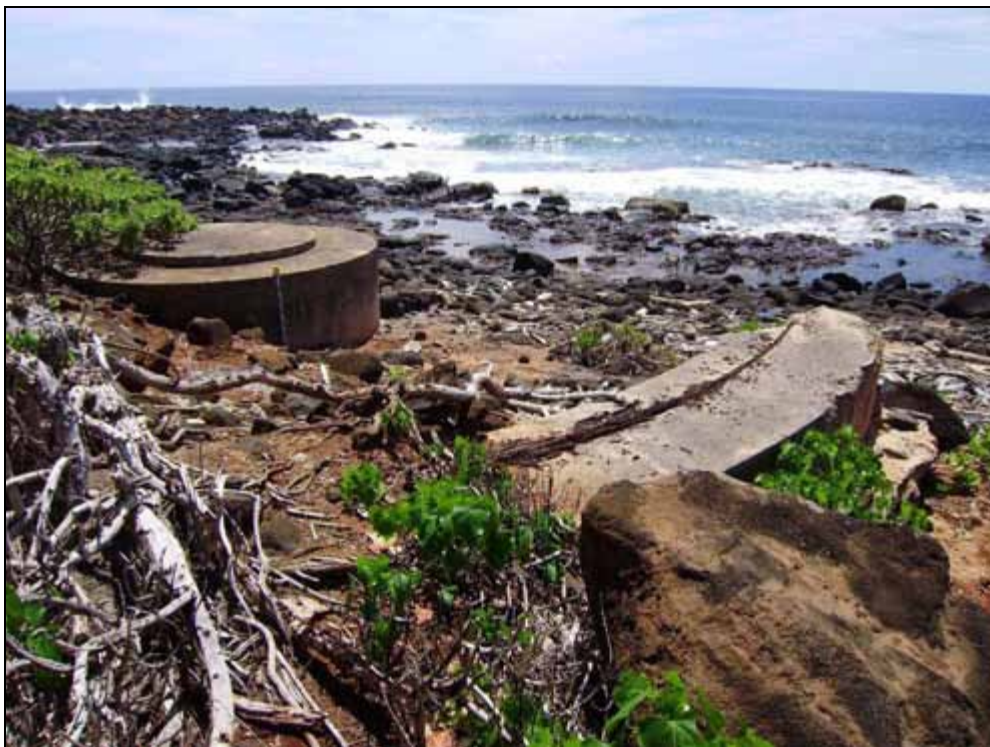
Figure 48. Plan view of Site 50-30-11-2090 (CSH 8)

Site 50-30-11-2090 is an artillery gun emplacement likely related to World War II military infrastructure (Figure 48-Figure 50). The gun emplacement consists of three features: Feature A is a circular concrete base measuring 2.48 m in diameter by 0.84 m high. There is a smaller circular concrete base in the center of the larger base which measures 1.88 m in diameter by 0.11 m high. A modern fire pit is present on the southeastern side of Feature A. Features B and C are curved concrete walls of identical construction present on the northeast and southwest sides of Feature A. Feature B, located approximately 4 m northeast of Feature A, measures 4.15 m long by 0.93 m thick by 0.92 m high. Feature C, located approximately 3 m southwest of Feature A, measures 4.0 m long by 0.92 m thick by 1.22 m high. Both walls have a metal track embedded on top which is mostly eroded away. Features B and C may have originally been one complete structure, however, it appears the northwest part of the structure has been bulldozed and partially buried. Artifacts observed on site include rusty nails and miscellaneous pieces of corroded metal. Vegetation observed in the area includes *naupaka*, *milo*, ironwood trees, and wild spinach. Site 50-30-11-2090 is located approximately 12 m east of the *makai* project alignment.

5. Site 50-30-11-2090 (CSH 8), a World War II era military gun emplacement related to the defense of Kaua'i Island, was documented with a detailed written description, photographs, and accurately located with GPS survey equipment. The proposed project may have an adverse effect on the remaining structure. Preservation, in the form of avoidance by a 20 ft buffer and educational signage, is recommended for Site 50-30-11-2090.

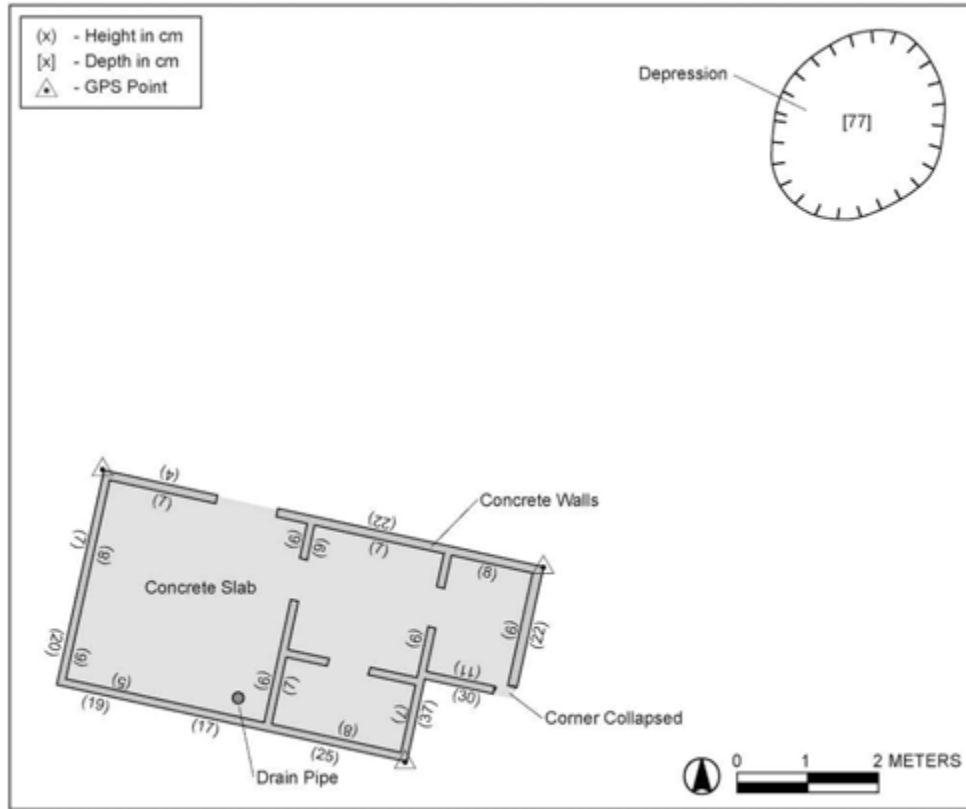
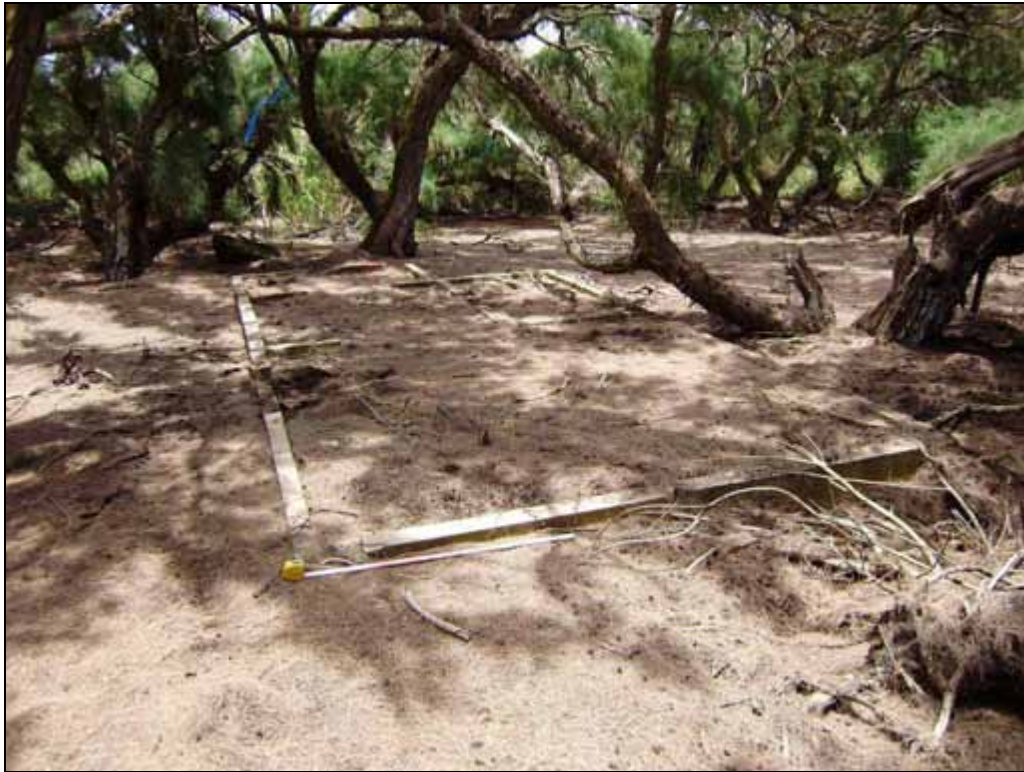
Figure 51. Plan view of Site 50-30-11-2091 (CSH 9)

Site 50-30-11-2091 is a concrete building foundation measuring 6.3 m east-west by 3.1 m north-south (Figure 51-Figure 53). The foundation appears to be the remains of a small, one-bedroom house. Partial walls are still present and consist of formed concrete. Rooms observed include a larger room with a drain pipe that was likely a living room/ kitchen combination, a smaller bedroom with closet, and a bathroom or smaller bedroom. A depression is present approximately 5 m southeast of the foundation and measures 2.9 m northeast-southwest by 2.4 m northwest-southeast. The depression is 0.77 m deep. Its depth and proximity to the structure indicate it is likely the remains of an outhouse. Marine midden, consisting of *Cellana sp.*, and roofing material were observed on site. Site 50-30-11-2091 is located in a level area surrounded by ironwood trees approximately 62 m west of the *makai* project alignment and 23 m east of the *mauka* project alignment.

Figure 52. Site 50-30-11-2091 (CSH 9), building foundation, view southeast.

Figure 53. Site 50-30-11-2091 (CSH 9), depression, view northeast

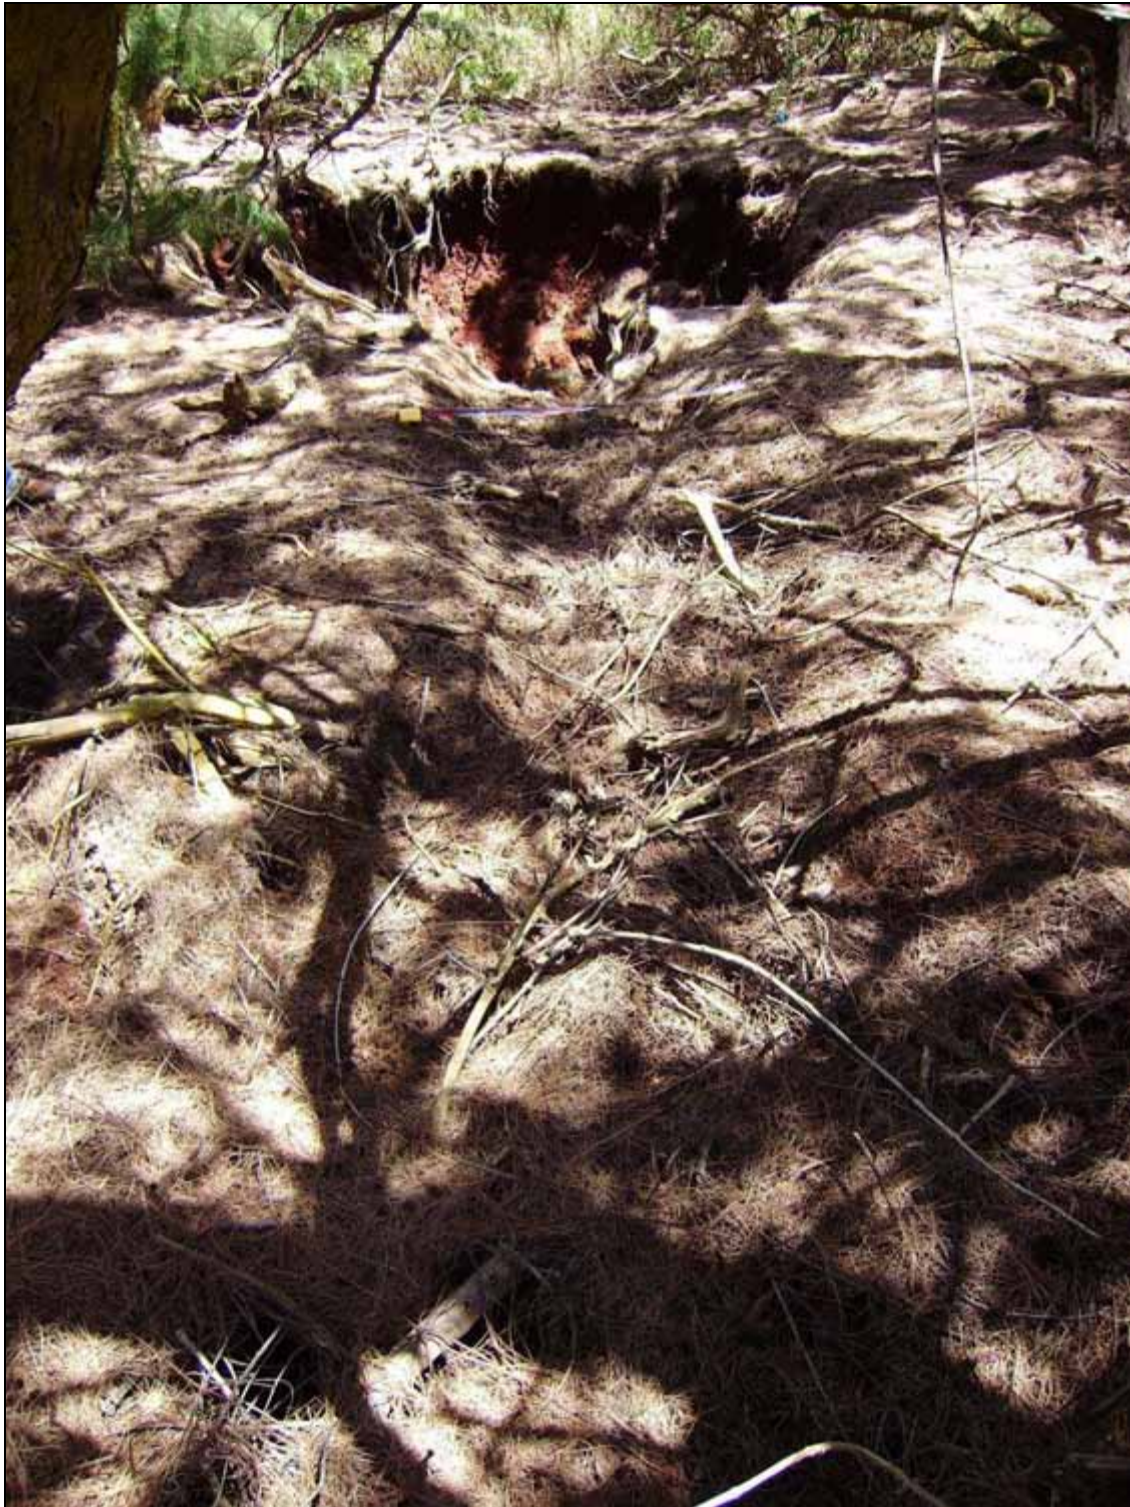
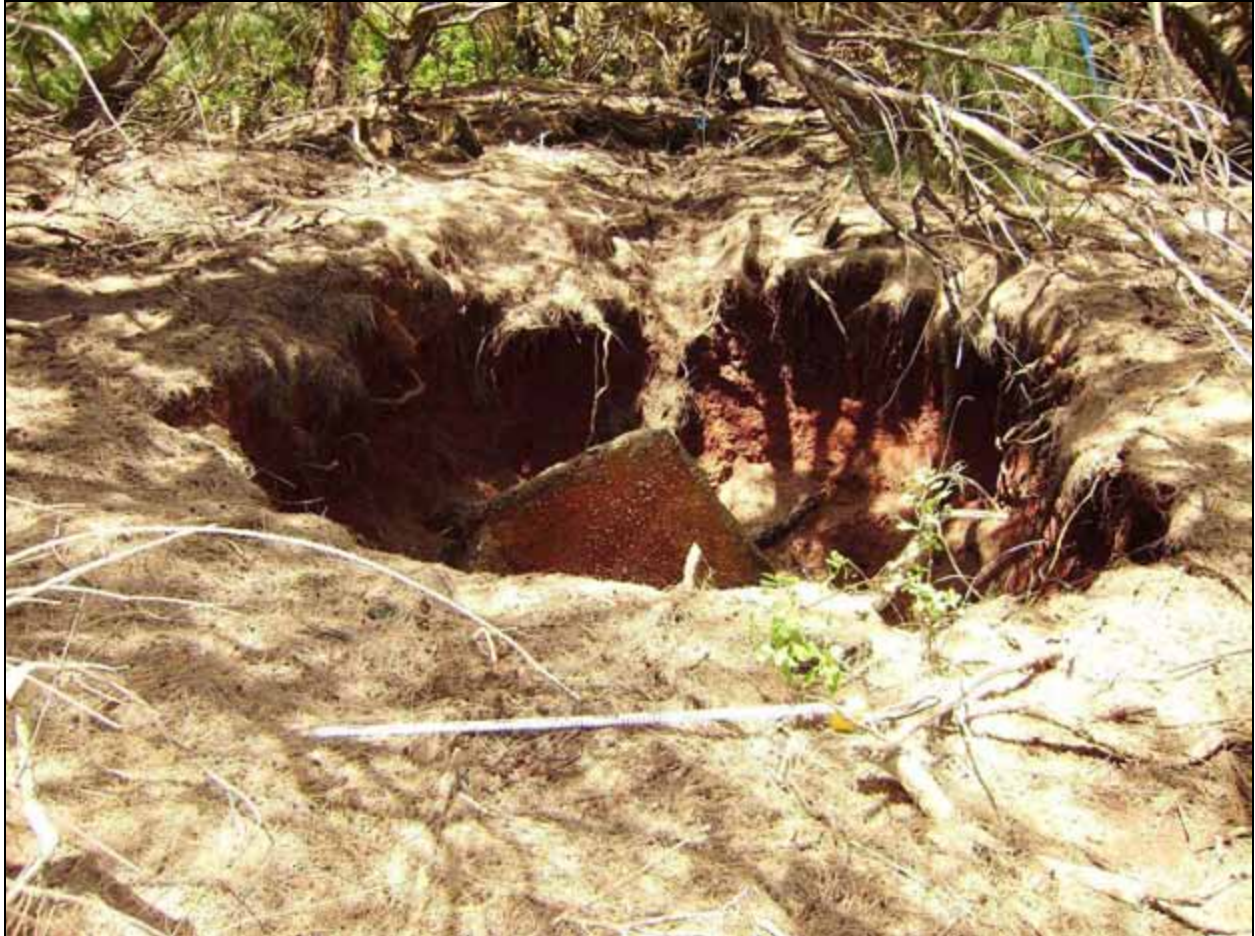
Figure 54. Plan view of Site 50-30-11-2092 (CSH 10)

Site 50-30-11-2092 is the remains of an outhouse and cesspool connected by a shallow ditch (Figure 54-Figure 56). The cesspool is located at the northern end of the site and measures 4.0 m northwest-southeast by 3.1 m northeast-southwest by 2.2 m deep. A total of three large concrete slabs are present in the depression, which are likely collapsed walls of the original structure. A shallow ditch is present at the southwest end of the cesspool which measures 3.5 m long by 1.0 m wide and connects to the outhouse remains, which are approximately 3.5 m southeast of the cesspool. The ditch varies in depth between 0.41 m at its northwest end and 0.27 m at its southeast end. The outhouse remains consist of a smaller, rectangular-shaped depression measuring 1.5 m northwest-southeast by 1.7 m northeast-southwest by 0.42 m deep. Fragments of roofing material were observed on site, however no other artifacts or cultural materials were identified. The site is located in a leveled area under a canopy of ironwood trees approximately 50 m west of the *makai* project alignment and 23 m east of the *mauka* project alignment.

Figure 55. Site 50-30-11-2092 (CSH 10), ditch and outhouse, view north

Figure 56. Site 50-30-11-2092 (CSH 10), cesspool, view east

6. Site 50-30-11-2092 (CSH 10), a historic outhouse and cesspool, was documented with a detailed written description, photographs, scale drawings, and accurately located with GPS survey equipment. The proposed project may have an adverse effect on these remnants. No further work is recommended for Site 50-30-11-2092. Sufficient information regarding the location, function, age, and construction methods of the the outhouse and cesspool has been generated by the current inventory survey investigation to mitigate any adverse effect caused by proposed development activities.

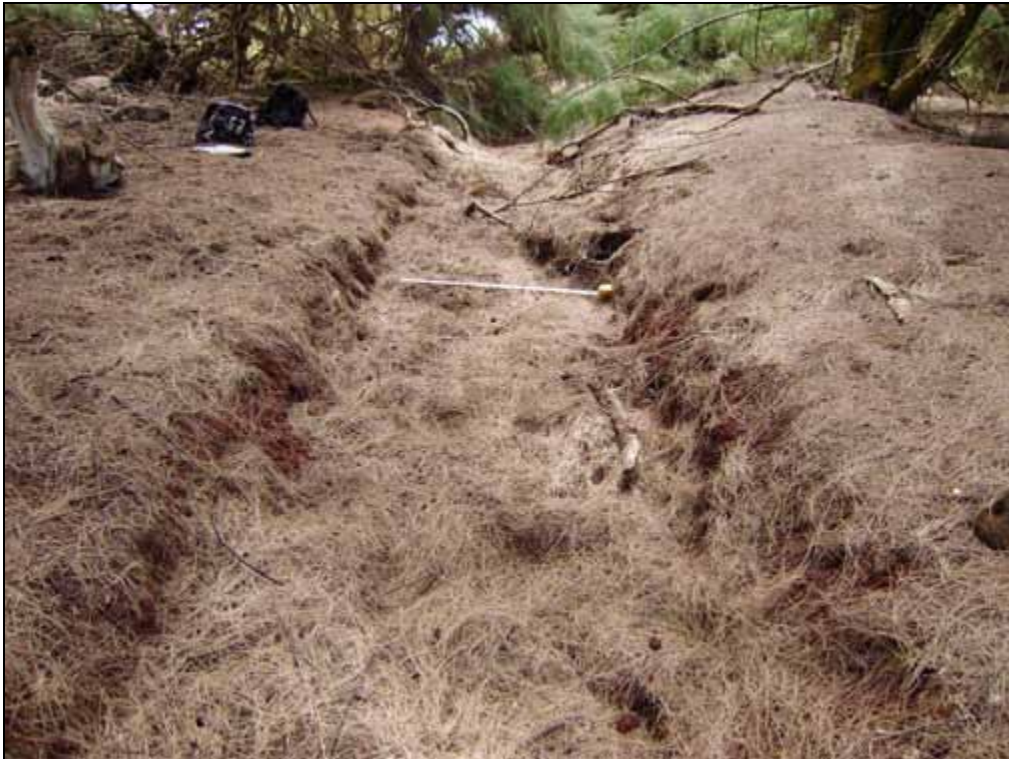
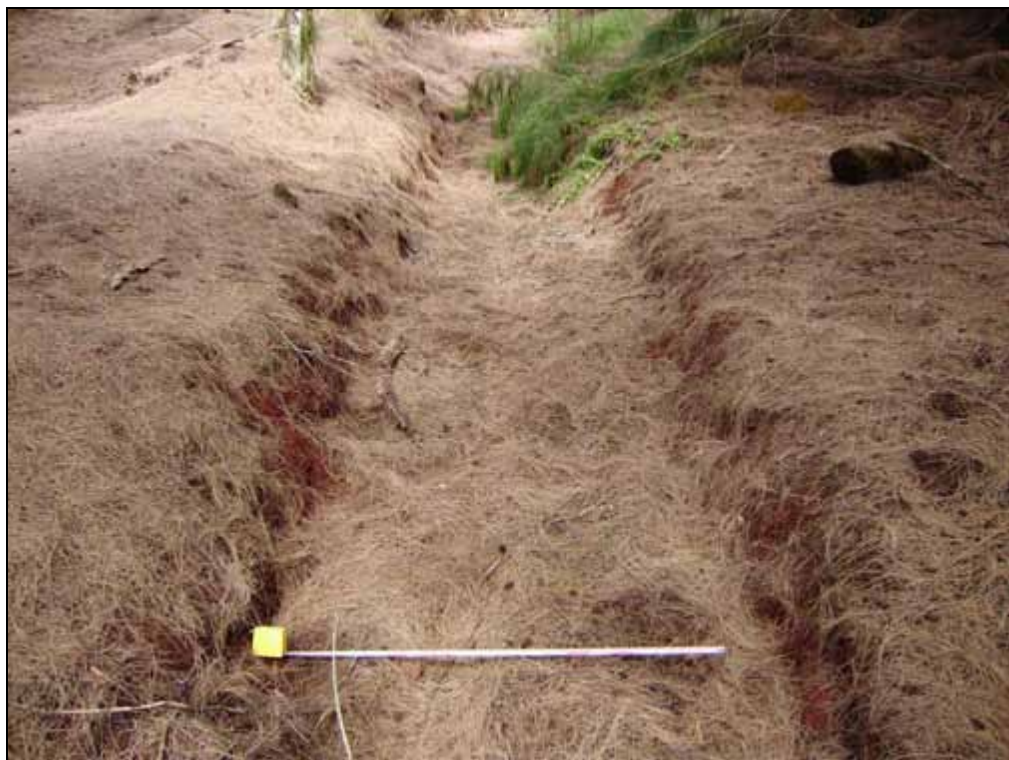
Figure 57. Site 50-30-11-2093 (CSH 11), view east

Site 50-30-11-2093 is a plantation-era, earthen drainage ditch measuring 61.7 m long and running roughly east-west (Figure 57 and Figure 58). This is likely a secondary ditch that may have originally connected to the main plantation ditch, which is present farther west, outside of the current project area. A portion of Site 50-30-11-2093 has been buried by a dirt road which allows for shore access, however, the ditch continues east, beyond the dirt road, and terminates approximately 15 m west of the ocean. The ditch width and depth vary from 0.60 m to 1.6 m wide and 0.48 to 0.60 m deep. Topography in the area is level-to-gently sloping and vegetation consists of *naupaka*, ironwood trees, *'ilima*, *pa'uohi'iaka*, and various types of grasses. The site is located approximately 46 m west of the *makai* project alignment and 22 m east of *mauka* project alignment

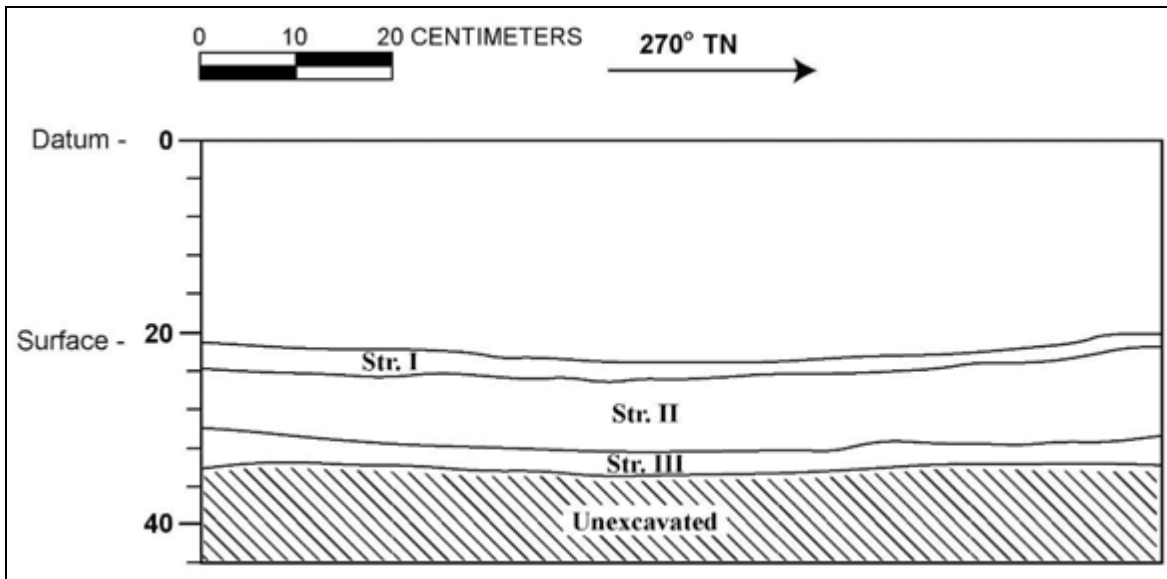
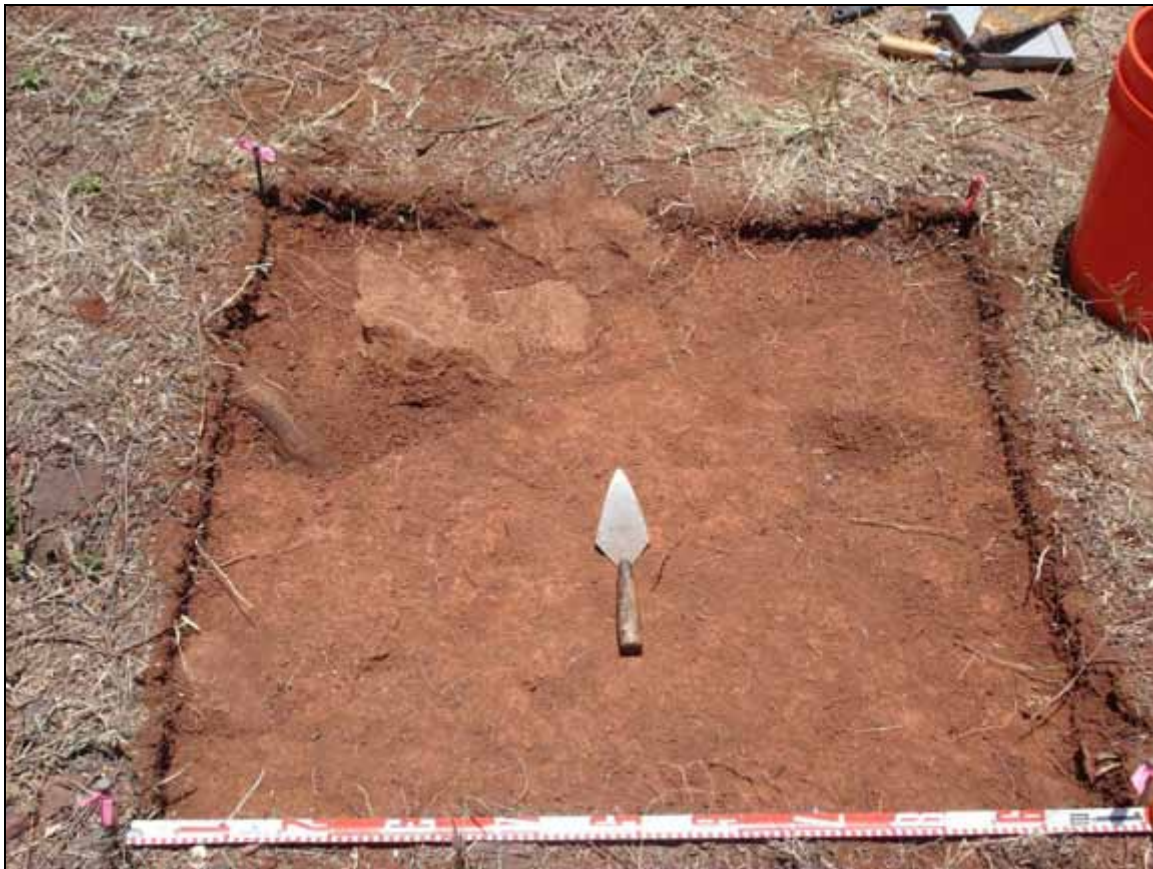
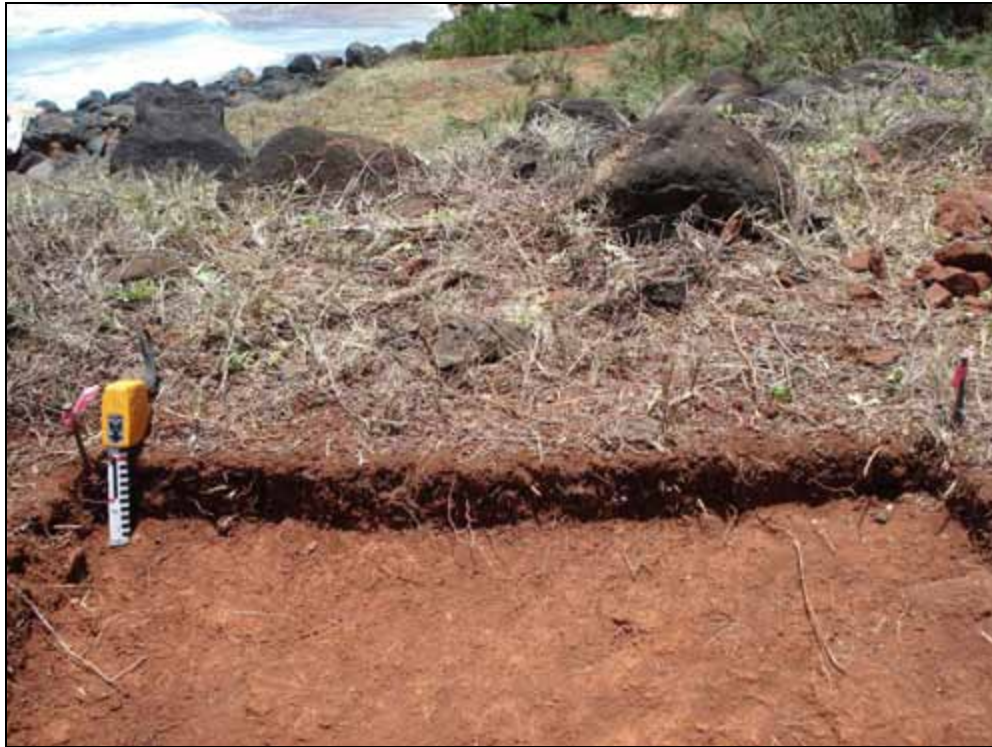
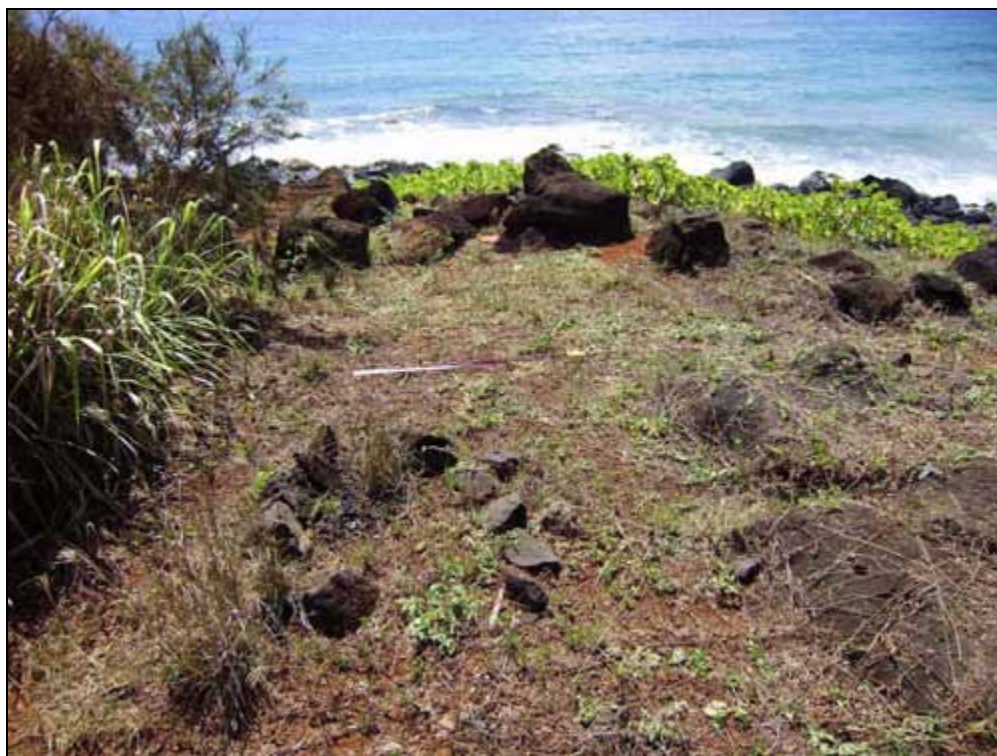
Figure 59. Plan view of Site 50-30-11-2094 (CSH 12)

Site 50-30-11-2094 is a pre-contact habitation site consisting of a terrace measuring 6.2 northeast-southwest by 5.0 m northwest-southeast (Figure 59-Figure 63). The terrace is constructed of basalt cobbles and boulders stacked one-to-two courses high to a maximum height of 0.35 m. The level interior surface of the terrace consists of soil with loose boulders and cobbles scattered throughout. A single *Cellana sp.* shell and a fragment of coral were observed in the northwestern portion of the interior surface, and a concentration of *Cellana sp.* marine shell was observed in the southern portion of the site, just south of the terrace. Modern trash and rusted metal were also observed on site. A modern firepit constructed of large basalt cobbles is present in the northeast portion of the site. Store bought charcoal was observed in the interior of the firepit. A total of 29 holes were also observed, drilled into the bedrock surrounding the site; their function is unknown. The topography in the area is level-to-gently sloping and vegetation consists of *naupaka*, ironwood trees, *'ilima*, *pa'uohi'iaka*, and various types of grasses.

Subsurface testing was conducted in the northwestern portion of the terrace to determine the extent of cultural material present. No significant cultural material was recovered. The style of construction, as well as the lack of significant cultural material present, indicates this site was likely used as a temporary habitation. Site 50-30-11-2094 is located approximately 5 m southeast of the *makai* project alignment.

Figure 60. Profile of the south wall of Test Unit 1, Site 50-30-11-2094 (CSH 12)

Figure 61. Site 50-30-11-2094 (CSH 12), Test Unit 1, post-excavation, view north

Figure 62. Site 50-30-11-2094 (CSH 12), Test Unit 1, south wall profile

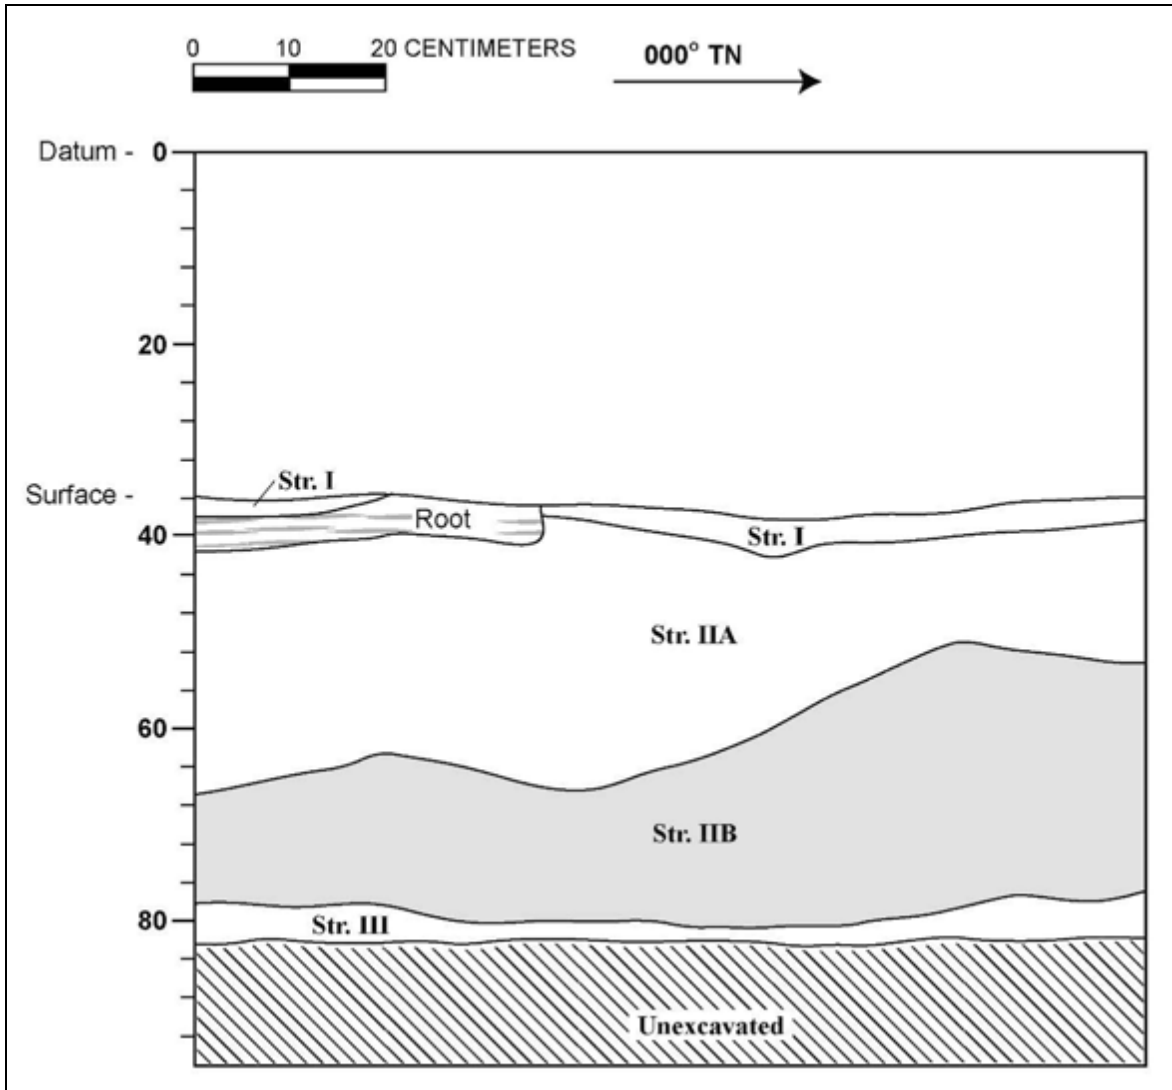
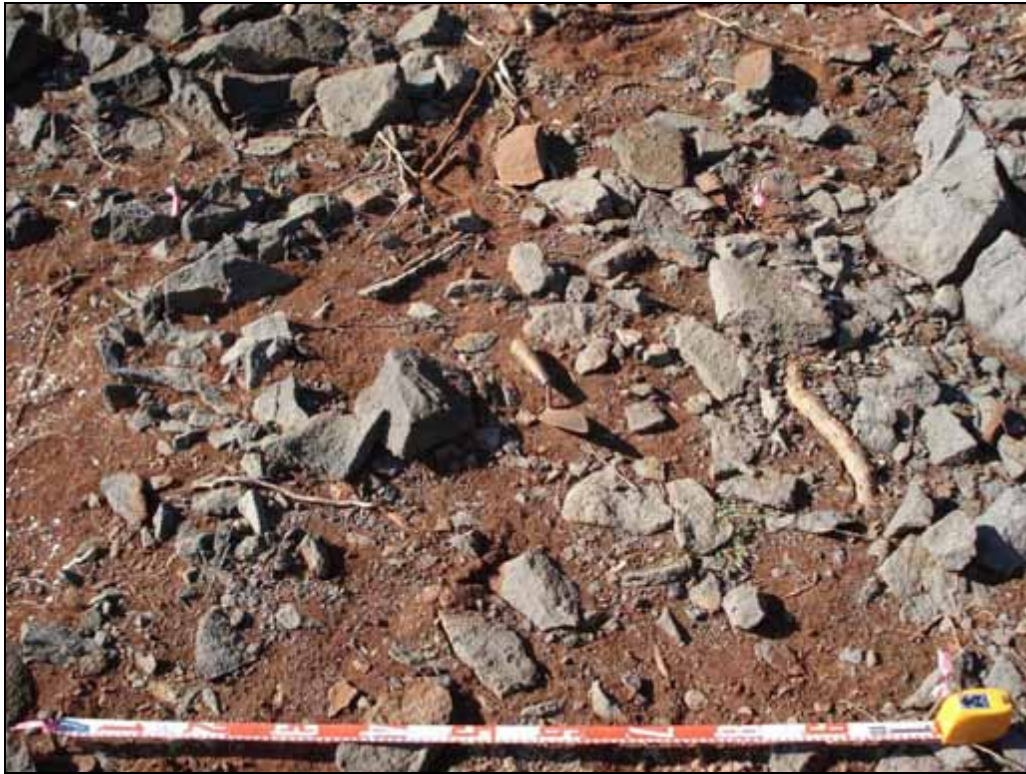
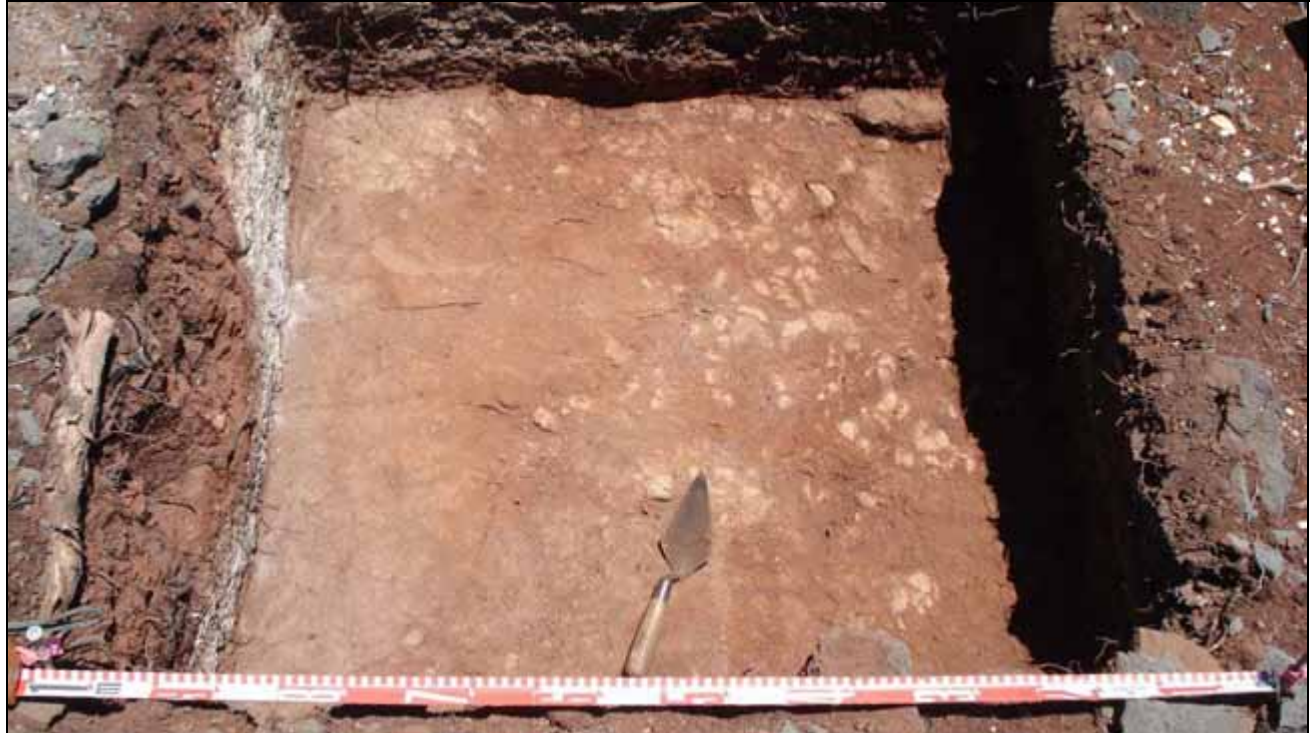
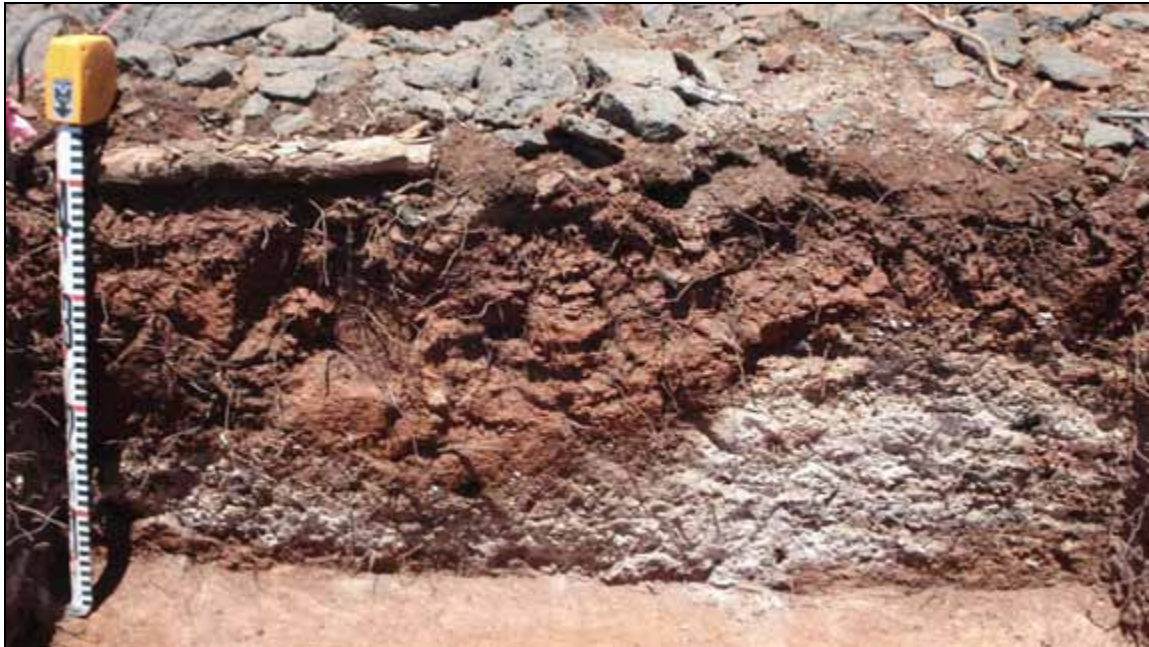
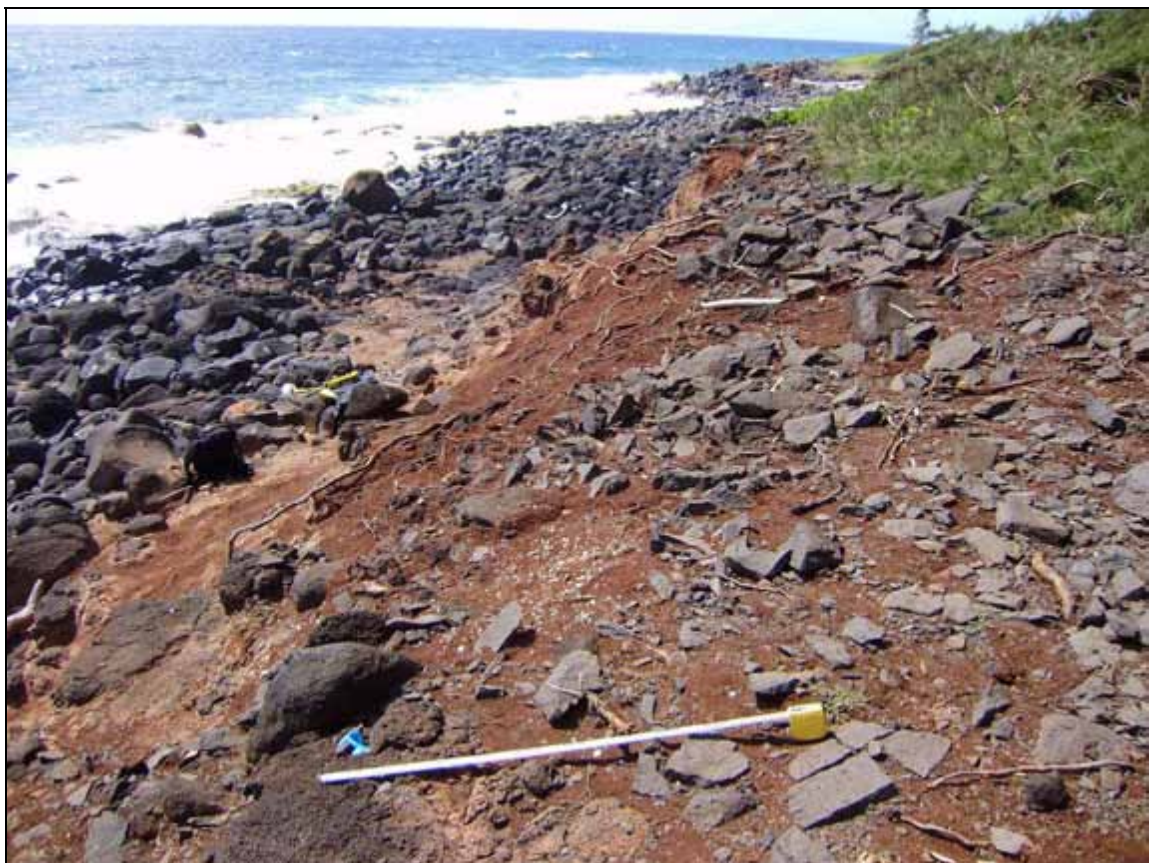
Figure 64. Profile of the west wall of Test Unit 1, Site 50-30-11-2095 (CSH 13)

Site 50-30-11-2095 is a scatter of cultural material measuring 5.1 m north-south by 2.6 m east-west (Figure 64-Figure 68). Cultural material observed on the surface includes marine shell midden consisting of Patellidae, Neritidae, Thaididae, Conidae, *Cellana sp.*, and *Cypraea sp.* Basalt cobbles and pebbles were also observed on the site surface. Subsurface testing was conducted to determine the extent of cultural material present. Approximately 18 kg of shell midden was systematically collected from the unit along with .7 kg of charcoal, which was recovered from Stratum IIb. Midden was present on the surface and extended through to a cultural layer (IIb) which was present from approximately 32 to 44 cmbs. The cultural layer contained a strong ash lens, along with a substantial amount of marine shell midden, however no defining firepit was identified. No other artifacts or features were observed on site.

Figure 65. Site 50-30-11-2095 (CSH 13), Test Unit 1 pre-excavation, view south

Figure 66. Site 50-30-11-2095 (CSH 13), Test Unit 1 post-excavation, view north

Figure 67. Site 50-30-11-2095 (CSH 13), Test Unit 1, profile of west wall
