Section 4 Results of Fieldwork

4.1 Survey Findings

This archaeological inventory survey was conducted under archaeological permit number 09-20 issued by the Hawai'i State Historic Preservation Division (SHPD), Department of Land and Natural Resources (DLNR), per Hawai'i Administrative Rules (HAR) Chapter 13-282. CSH archaeologists Gerald K. Ida, B.A., Nancine 'Missy' Kamai, B.A., Kaipo Akana, and Kendy Altizer, B.A. Fieldwork was conducted intermittently between May 21 and February 16, 2010, under the general supervision of Hallett H. Hammatt, Ph.D. (principal investigator). The field work required approximately 29 person-days to complete.

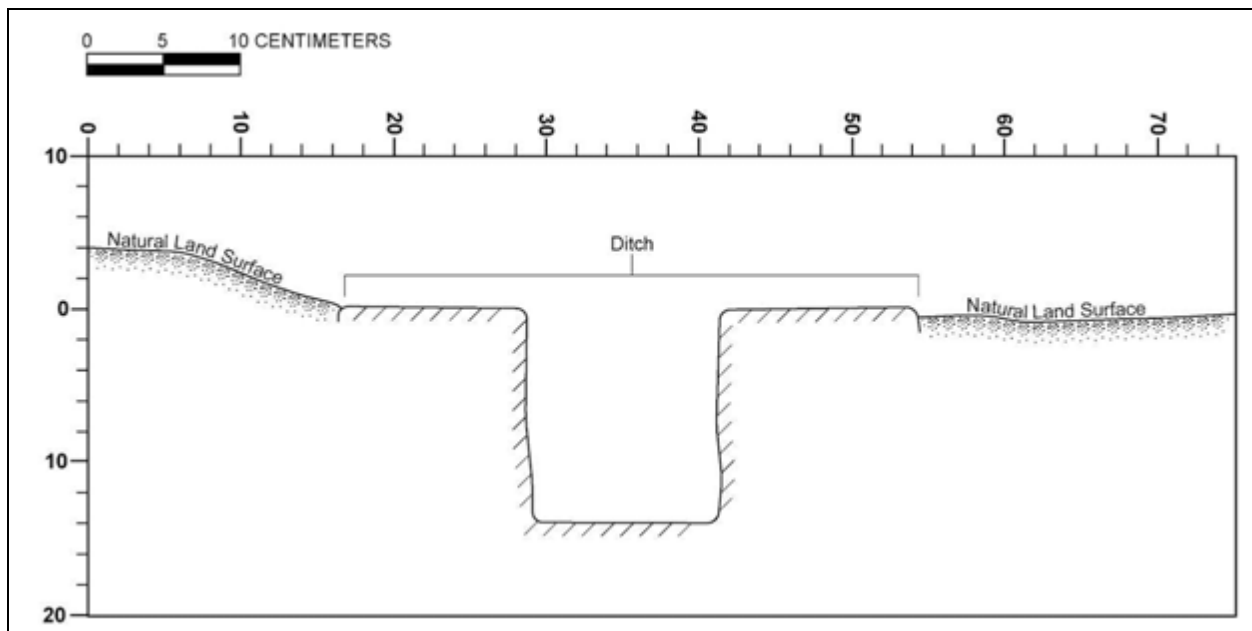
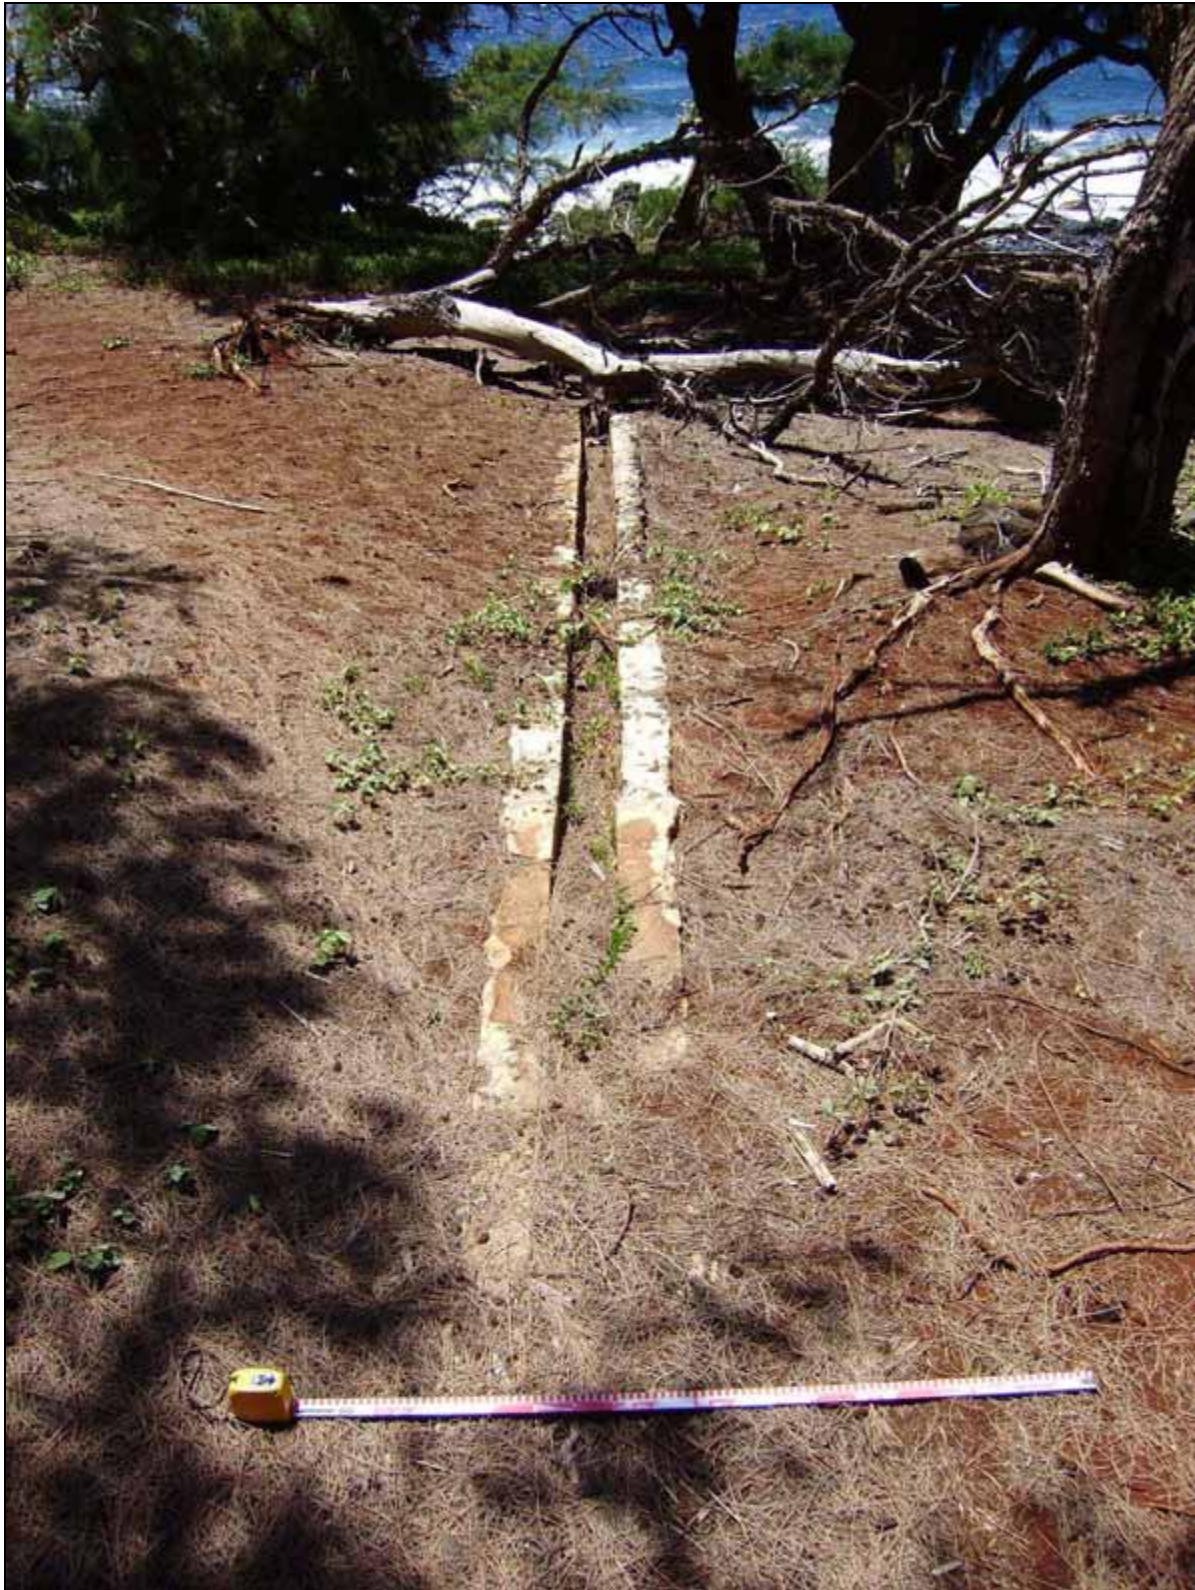
Figure 69. Plan view of Site 50-30-11-2096 (CSH 14)

Site 50-30-11-2096 is a concrete ditch measuring 20.20 m long by 0.38 m wide and running in a northwest-southeast direction (Figure 69 and Figure 70). The concrete contains a large amount of gravel and small cobbles. No cultural material was observed, however a good amount of modern trash was present during recording. Because of its size and style of construction, the ditch is likely the remnant of a residential structure and may be related to the Ahukini Plantation Camp.

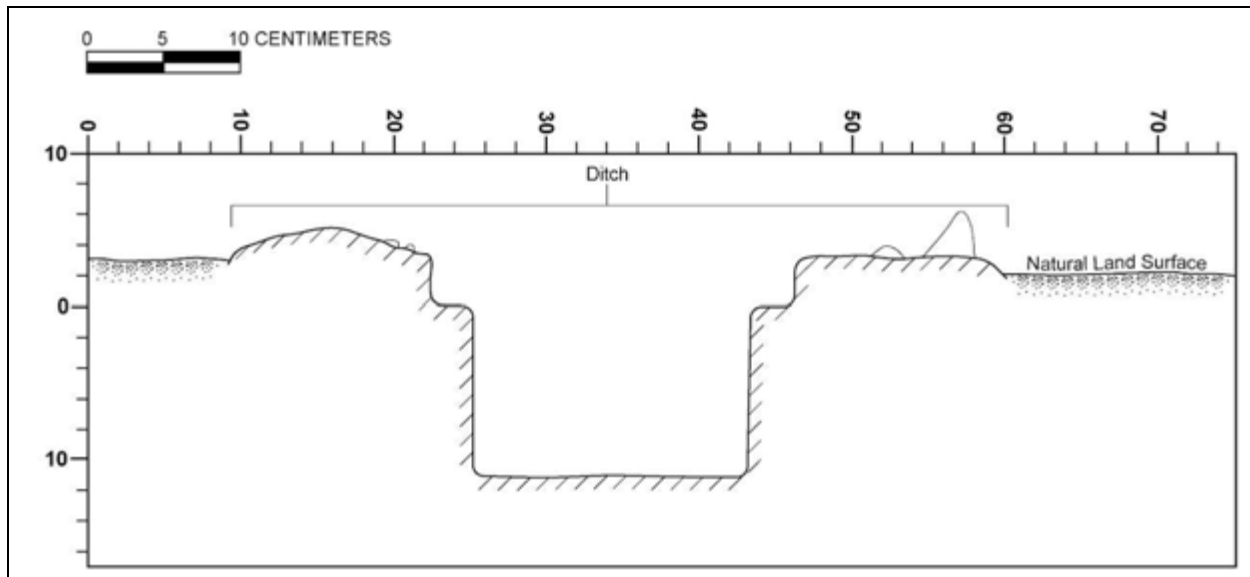
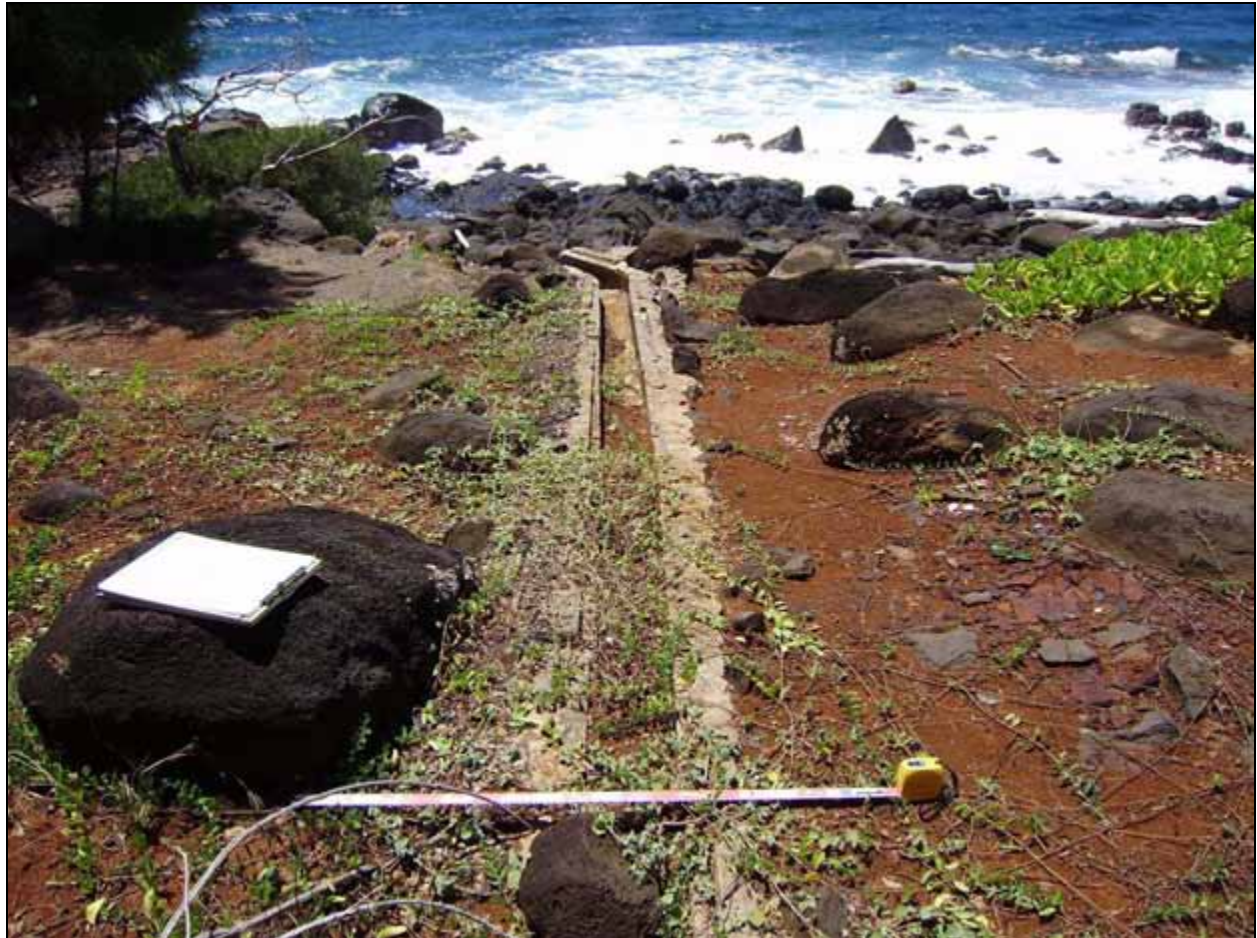
Figure 71. Plan view of Site 50-30-11-2097 (CSH 15)

Site 50-30-11-2097 is a concrete ditch measuring 15.10 m long by 0.55 m wide by 0.15 m deep and running in a northwest-southeast direction (Figure 71 and Figure 72). The concrete contains a large amount of gravel and small cobbles. A lip is present on the exterior of both sides of the ditch indicating a cover may have been present at one time. No cultural material was observed, however a good amount of modern trash was present during recording. Because of its size and style of construction, the ditch is likely the remnant of a residential structure and may be related to the Ahukini Plantation Camp.

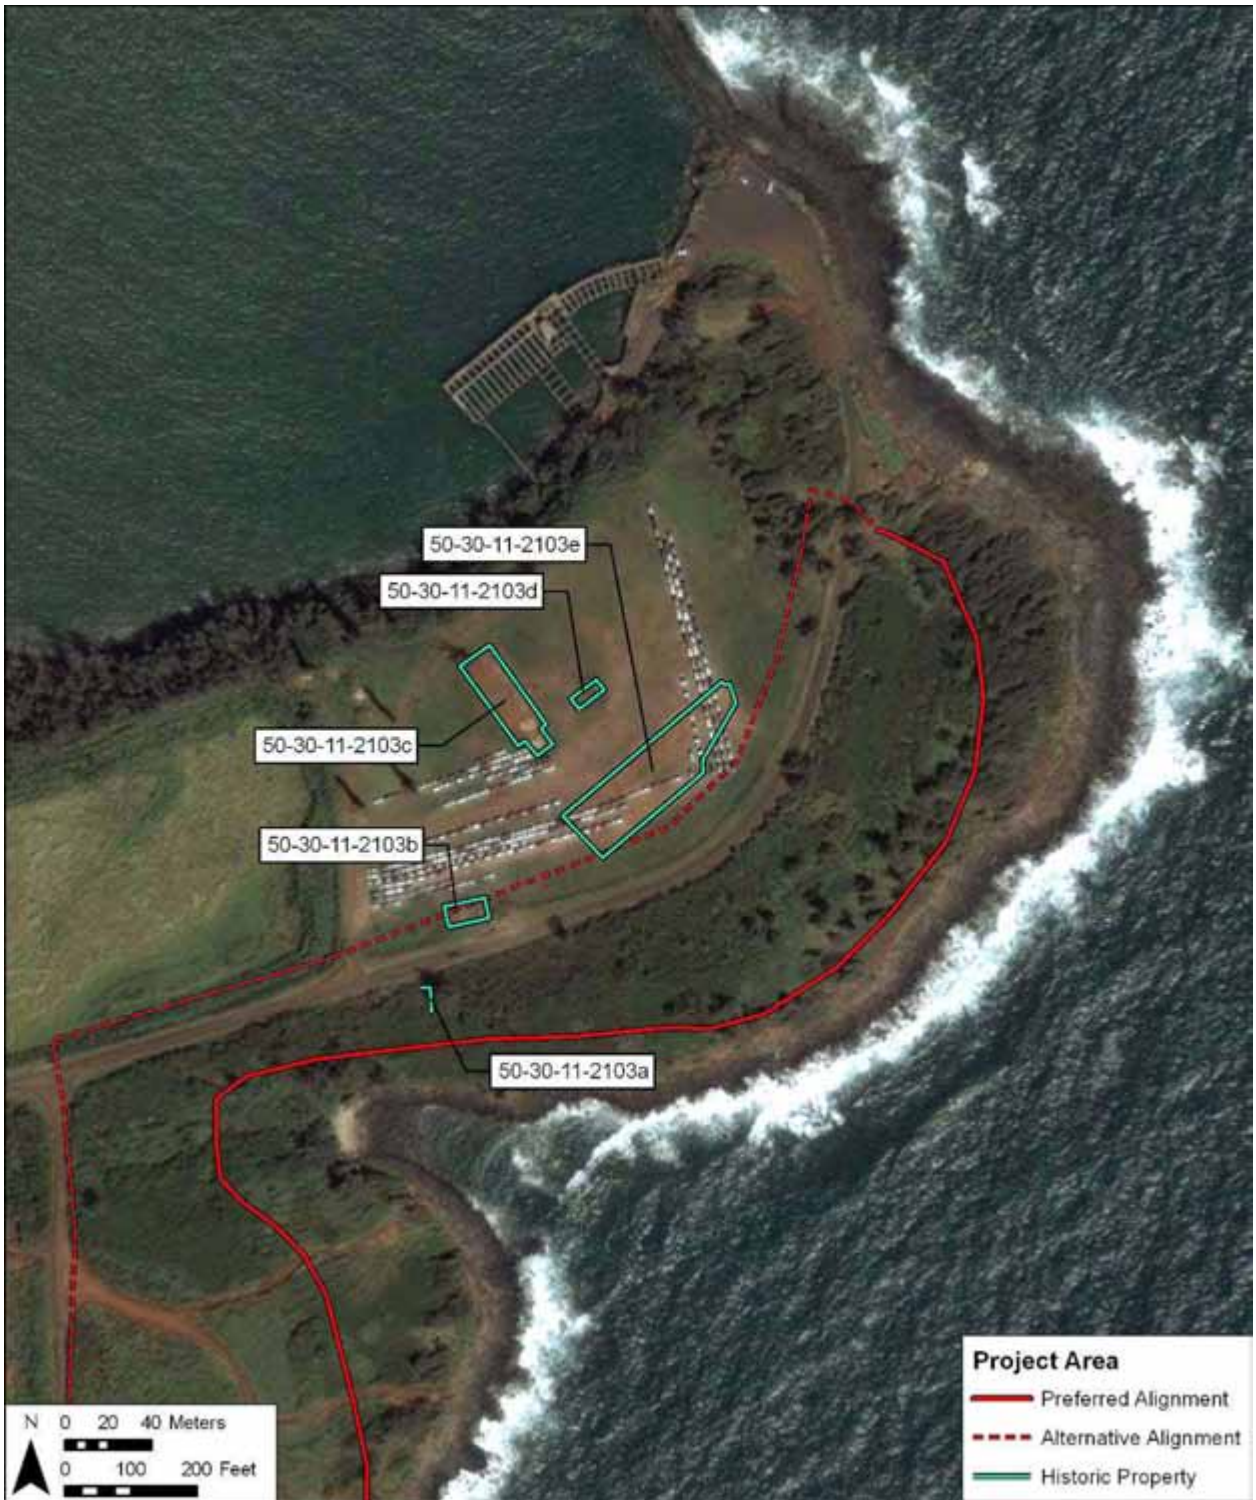
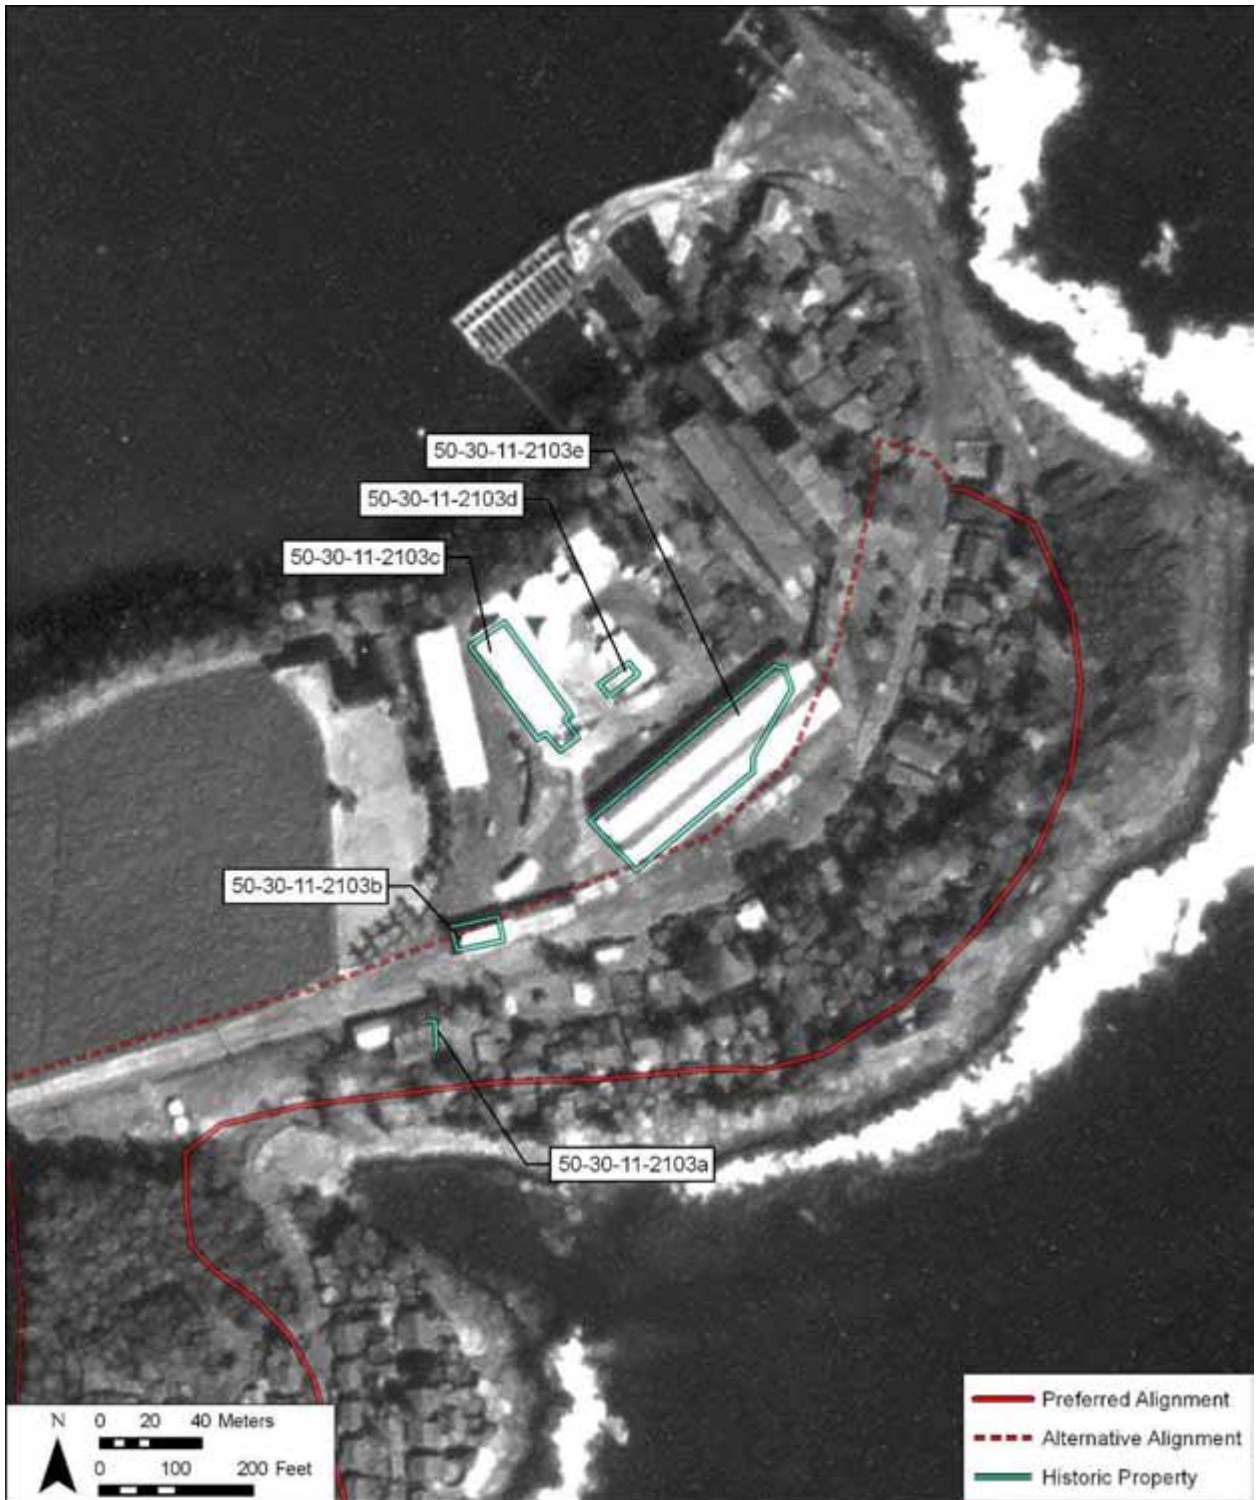
Figure 73. 2009 Google Earth aerial photo showing the location of SIHP # 50-30-11-2103

Site 50-30-11-2103 consists of five features related to the historic industrial complex near Ahukini Landing (Figure 73). The complex was built to support Ahukini Landing and also housed Standard Oil, which supplied petroleum-based products to the eastern half of Kaua'i in the first part of the 20th century. The features present are in remnant condition and consist of concrete slabs and walls. Features A-D are present on the 1927 Sanborn fire Insurance map (Figure 74) and 1953 aerial photo (Figure 75), while Feature E is notably absent from the Sanborn Fire Insurance map, but appears in the 1953 aerial photo as two rectangular structures resembling warehouses.

Figure 74. 1927 Sanborn Fire Insurance map with Site 50-30-11-2103 and current project area overlay

Figure 75. 1953 aerial photo of Site 50-30-11-2103 (R.M. Towill Corporation)

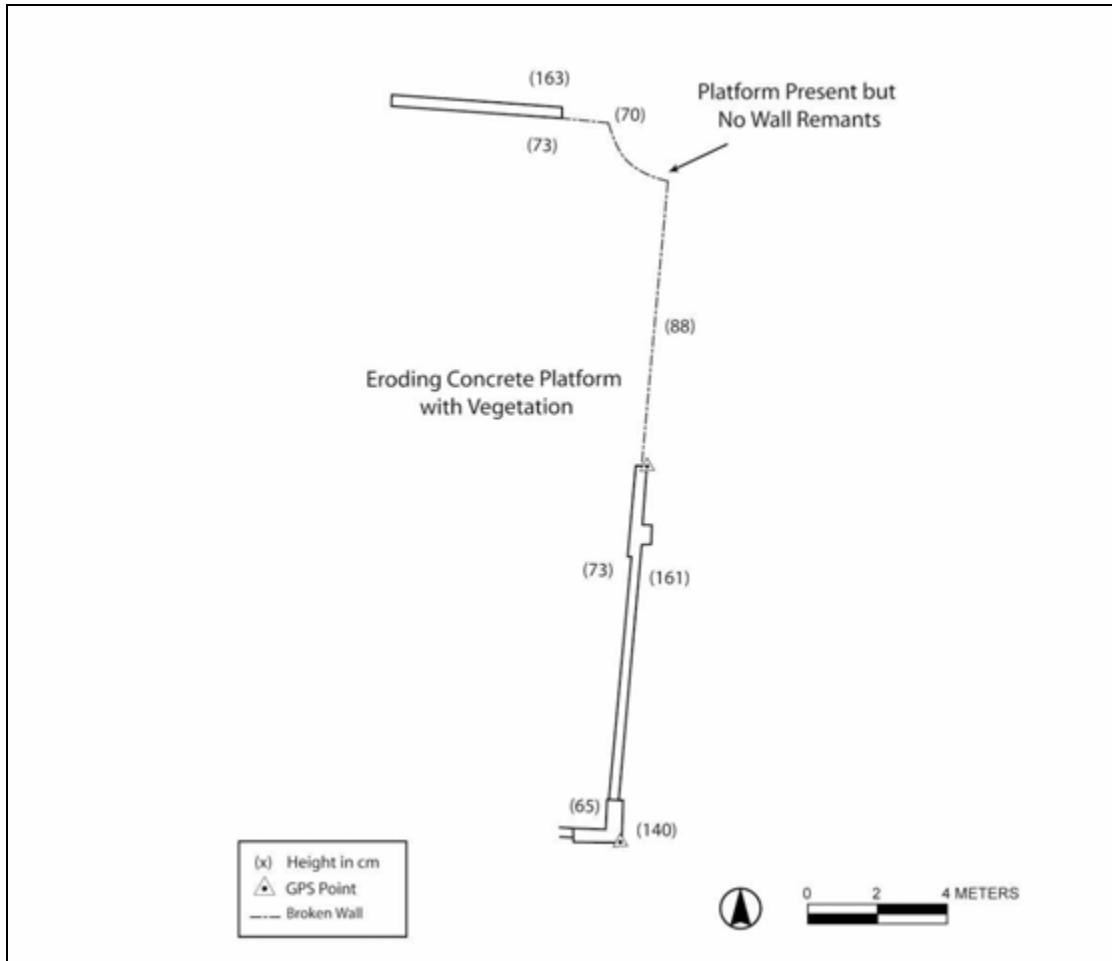
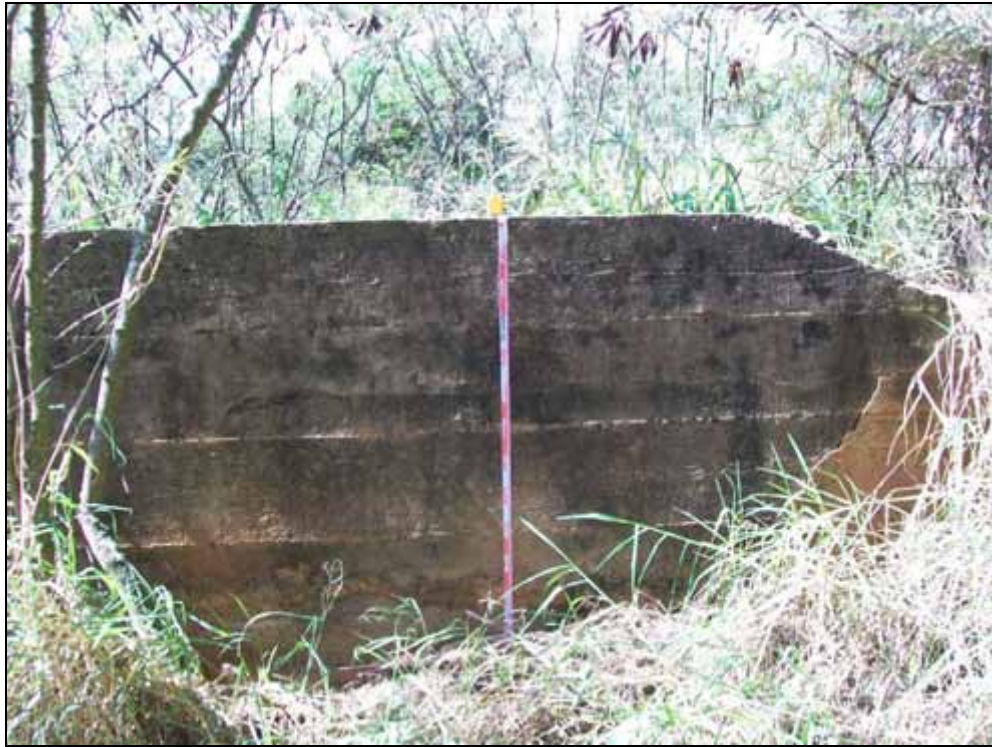
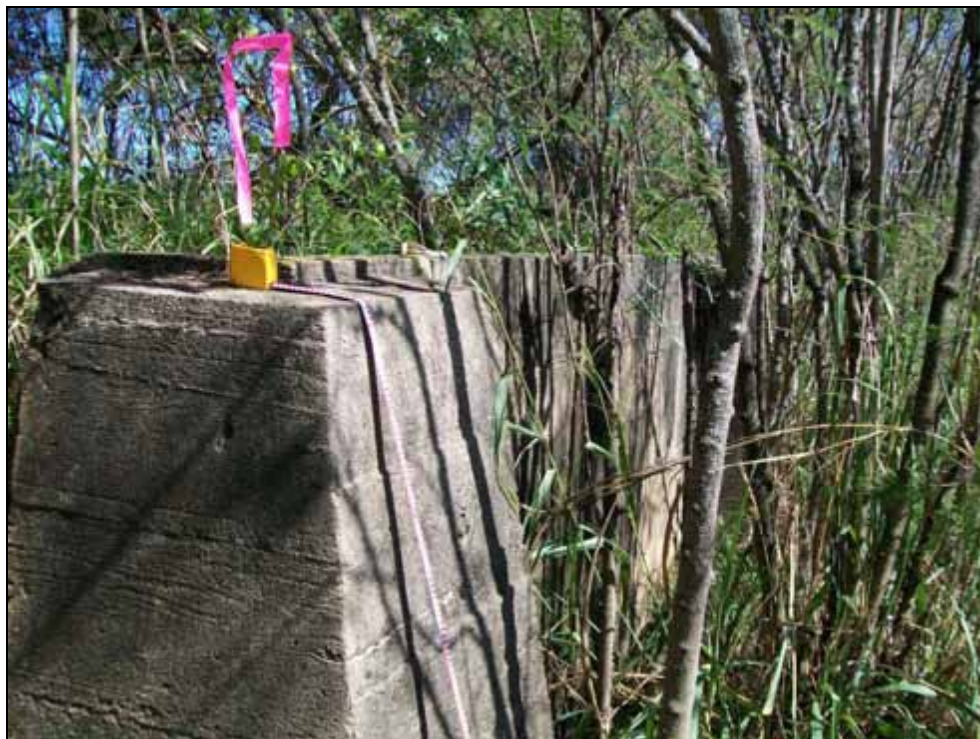
Figure 76. Site 50-30-11-2103 Feature A, remnants of fertilizer storage facility

Feature A is the remnants of a fertilizer storage facility (see Figure 73 and Figure 74; Figure 76-Figure 78). Most of the structure was absent at the time of documentation. All that remained were portions of the north and east walls, and part of the platform. The platform and partial wall measured approximately 18.3 m long on the north side. The wall remnants were between 20 and 30 cm thick. No other defining characteristics were present. Feature A was overgrown by *haole koa*, vines, and exotic grasses at the time of documentation. The preferred project alignment passes just south of this foundation remnant.

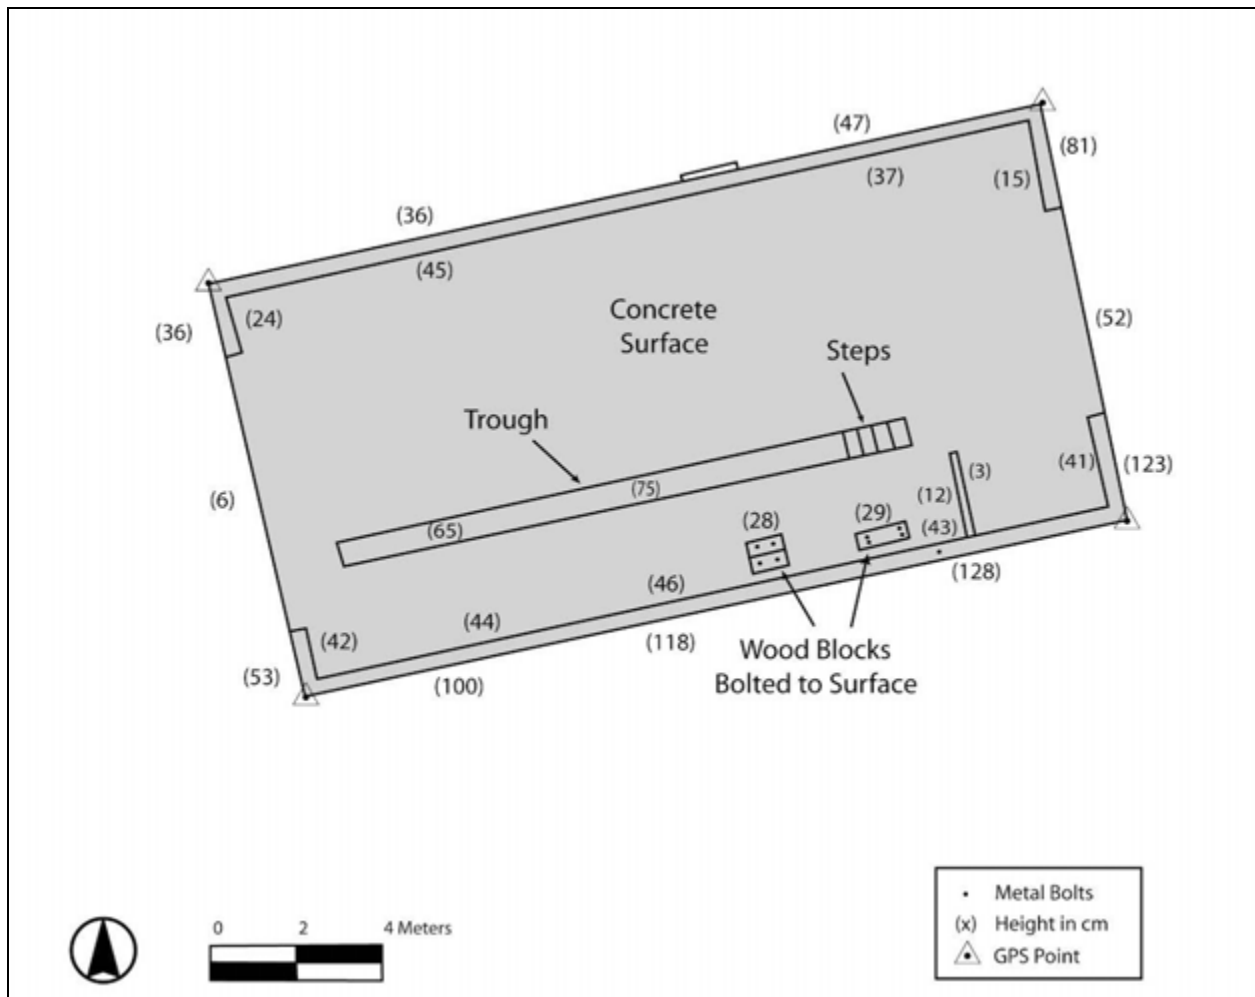
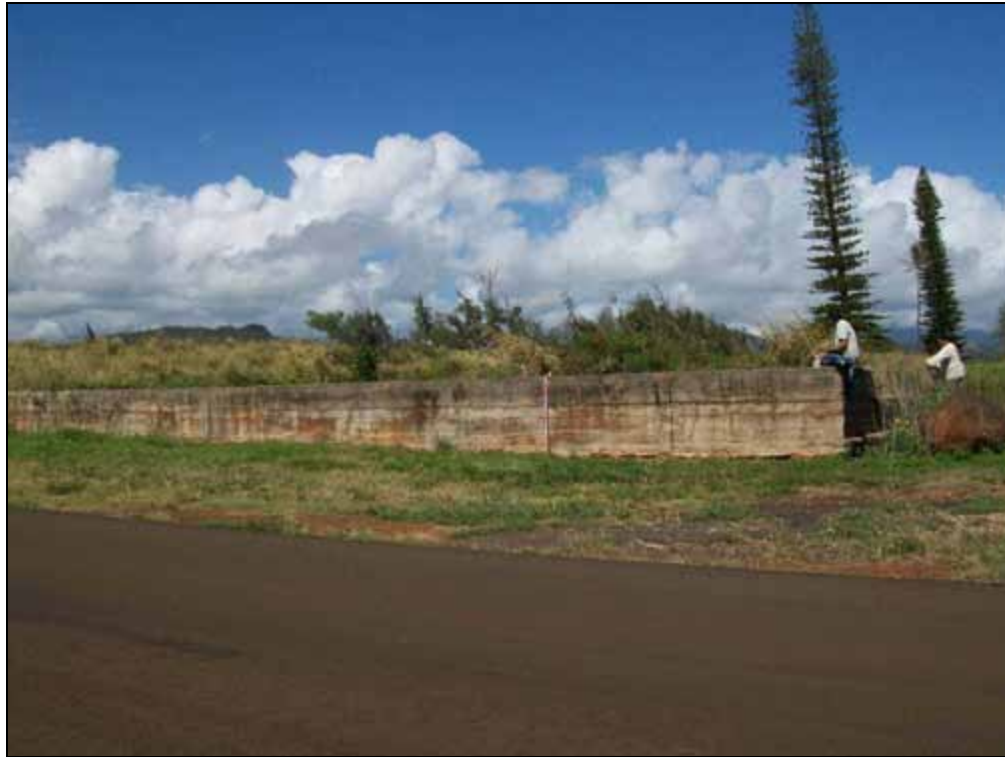
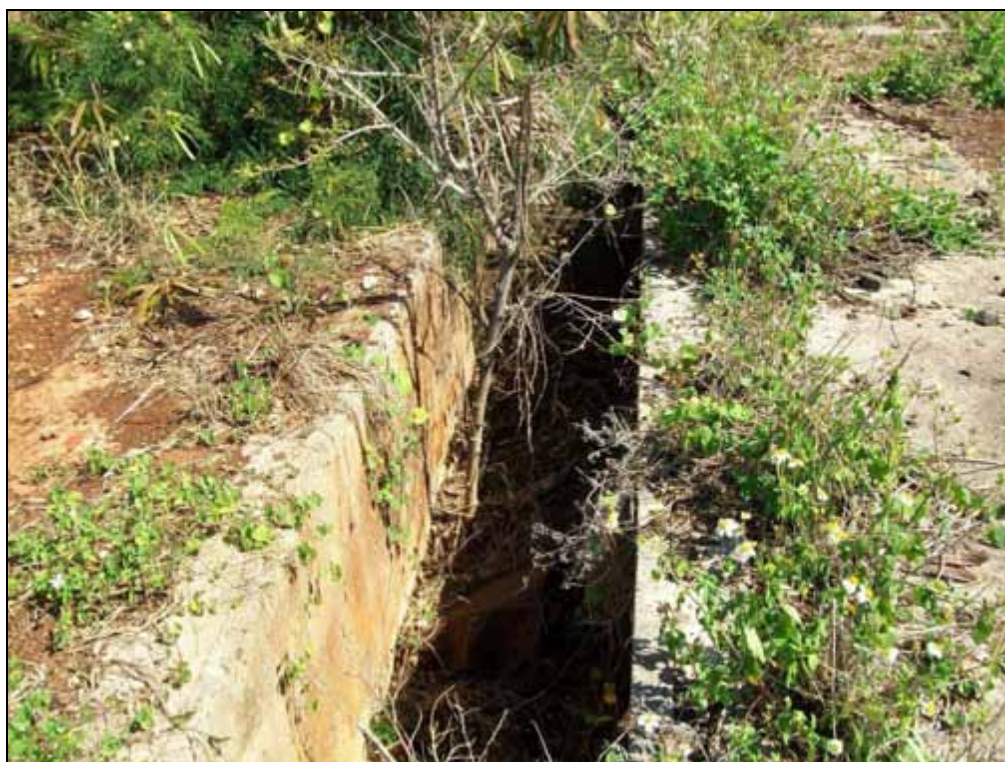
Figure 79. Site 50-30-11-2103, Figure B, roundhouse foundation

Feature B is the remnants of a building foundation labeled a roundhouse on the 1927 Sanborn Fire Insurance map (see Figure 73 and Figure 74; Figure 79-Figure 81). The foundation footprint is intact and elevated above the current ground surface. A trough is present in the south-central portion of the foundation, and remnants of steps are also visible. Wooden blocks are bolted to the south-central portion of the foundation, between the trough and the south wall. They appear to be sections of railroad ties; however their original function is unknown. While Feature B is labeled a roundhouse on the Sanborn Fire Insurance map, no railroad tracks or other diagnostic features were observed during site documentation. The foundation was partially overgrown by vines and exotic grasses. The alternative project alignment passes through the northern side of the foundation remnant.

Figure 80. Site 50-30-11-2103 Feature B, roundhouse foundation remnant; view northwest

Figure 81. Site 50-30-11-2103 Feature B, trough; view east

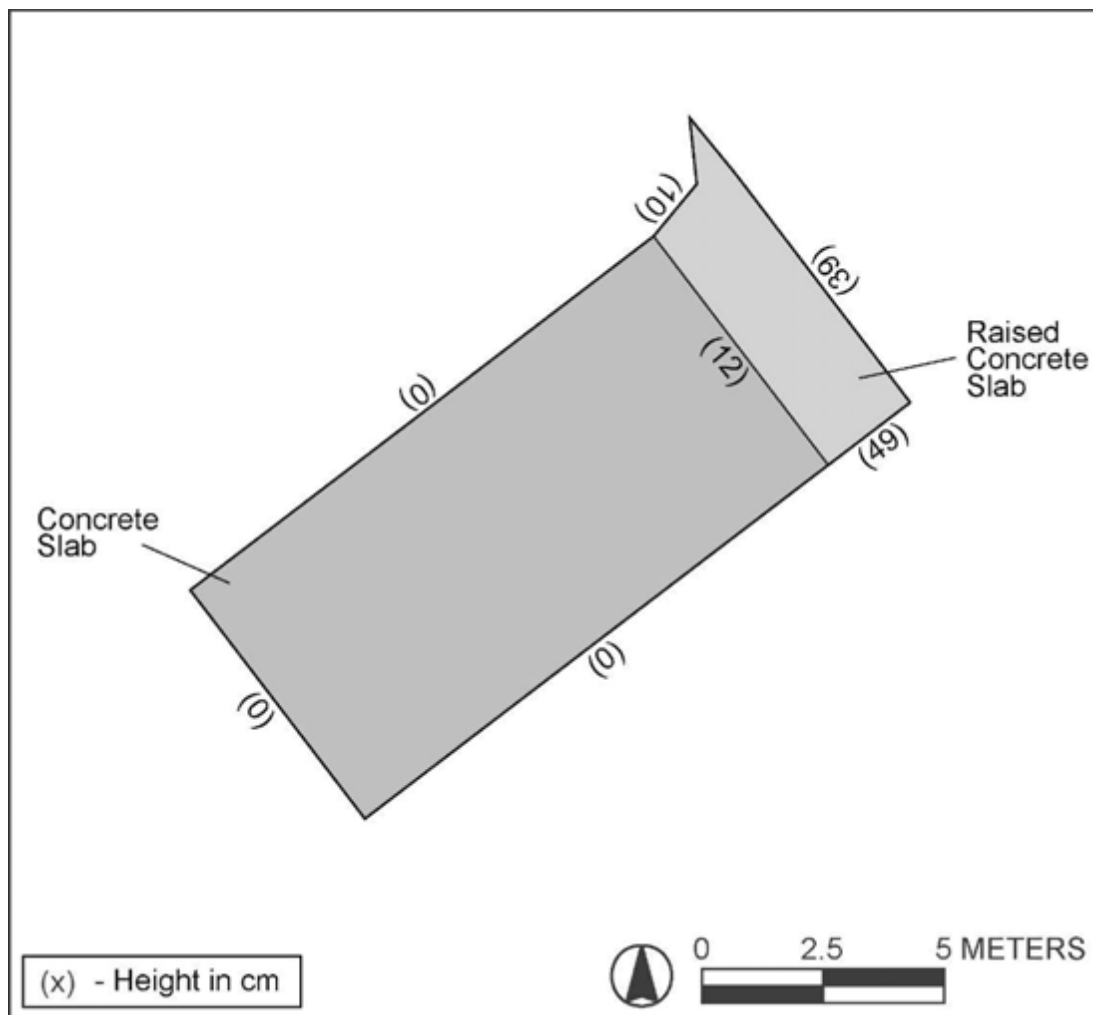
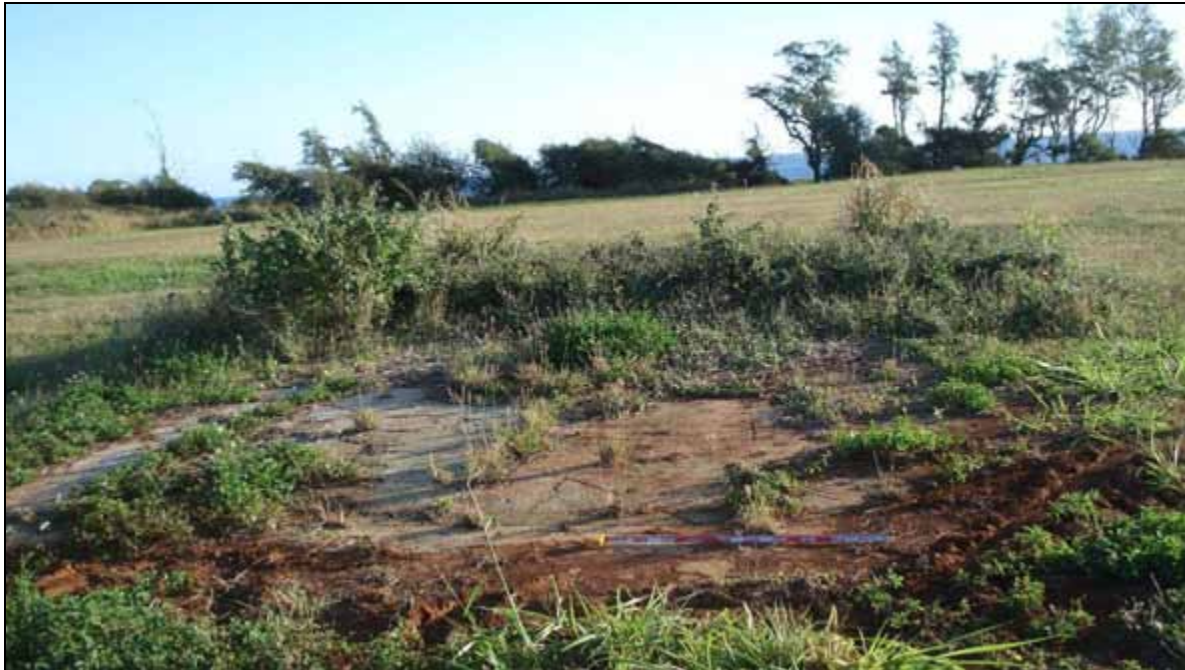
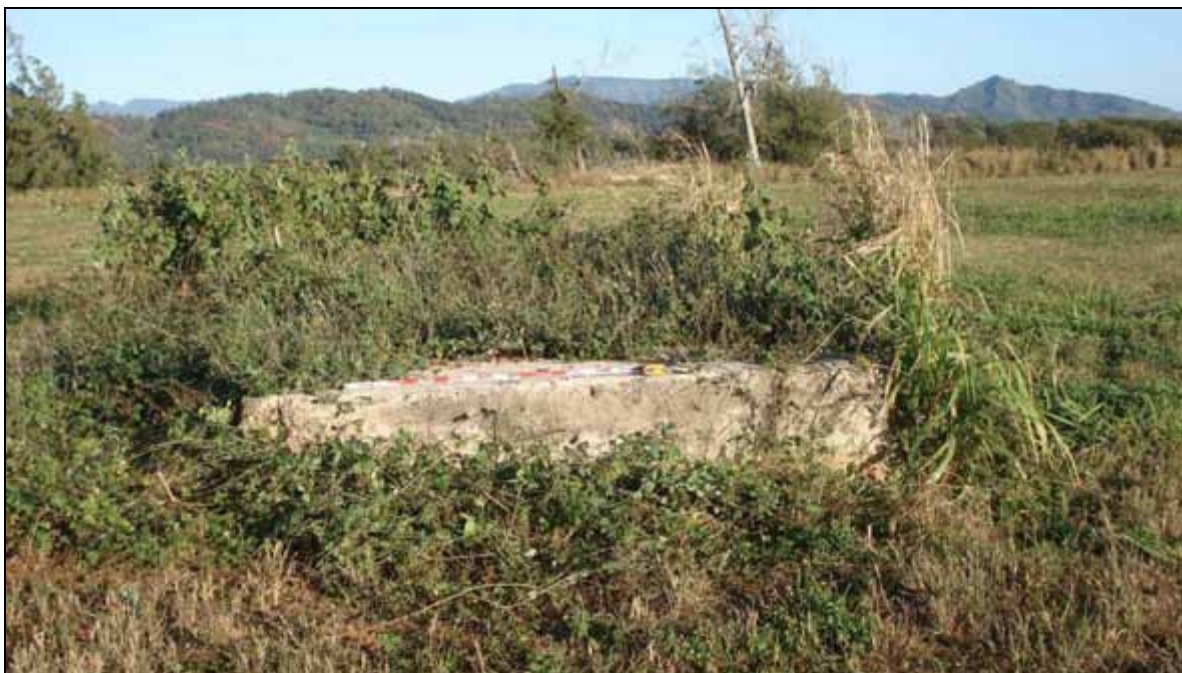
Figure 82. Site 50-30-11-2103, Feature C, remnant of Standard Oil storage facility

Feature C is a remnant of the Standard Oil storage facility present on the 1927 Sanborn Fire Insurance map (see Figure 73 and Figure 74; Figure 82-Figure 84). The foundation consists of two concrete slabs. The northeastern slab is smaller and elevated approximately 12 cm higher than the southwestern slab. The northeastern slab measures approximately 2 m NE-SW by 6 m NW-SE. The adjacent southwestern slab is flush with current ground surface and measures approximately 11 m NE-SW by 6 m NW SE. There are no additional defining characteristics of this feature.

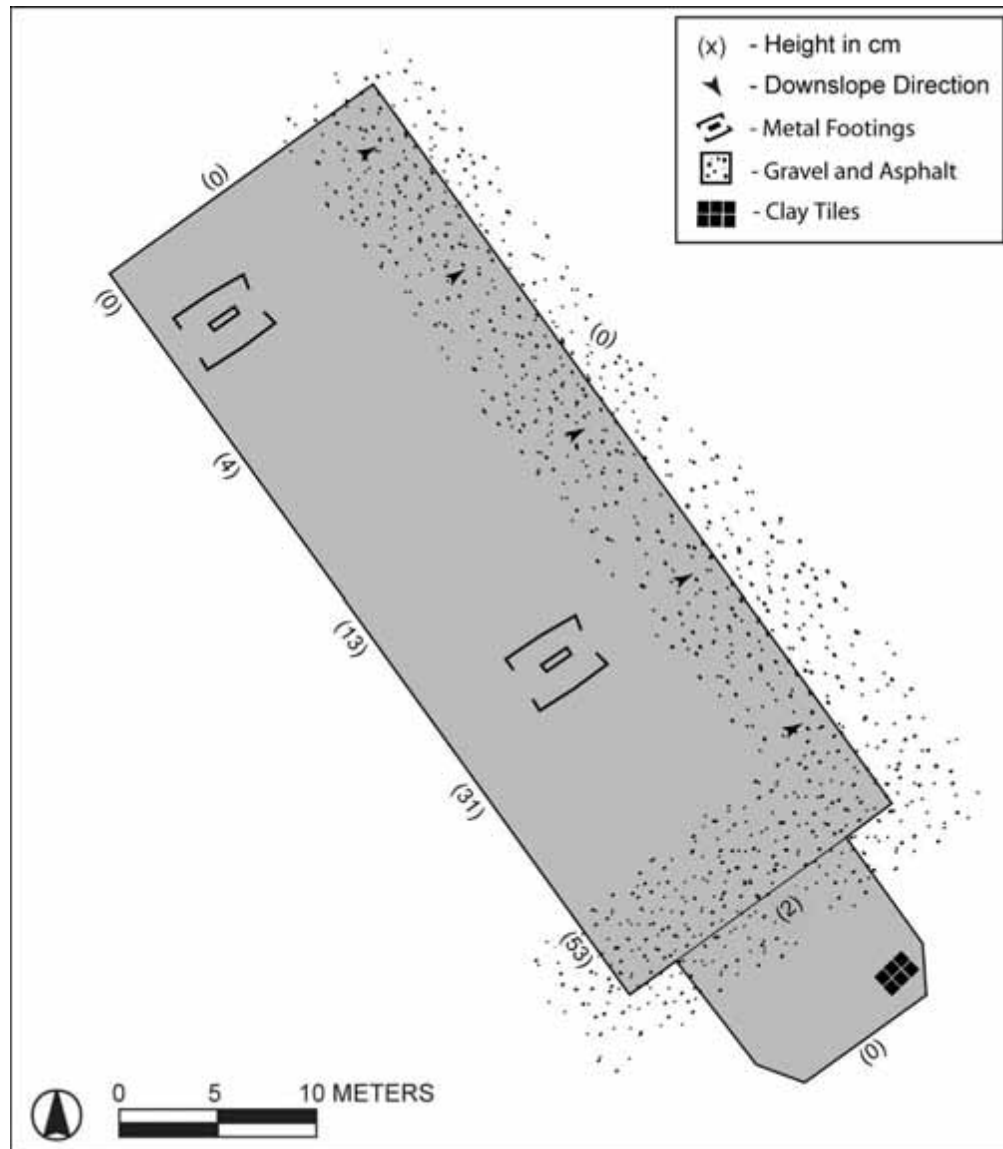
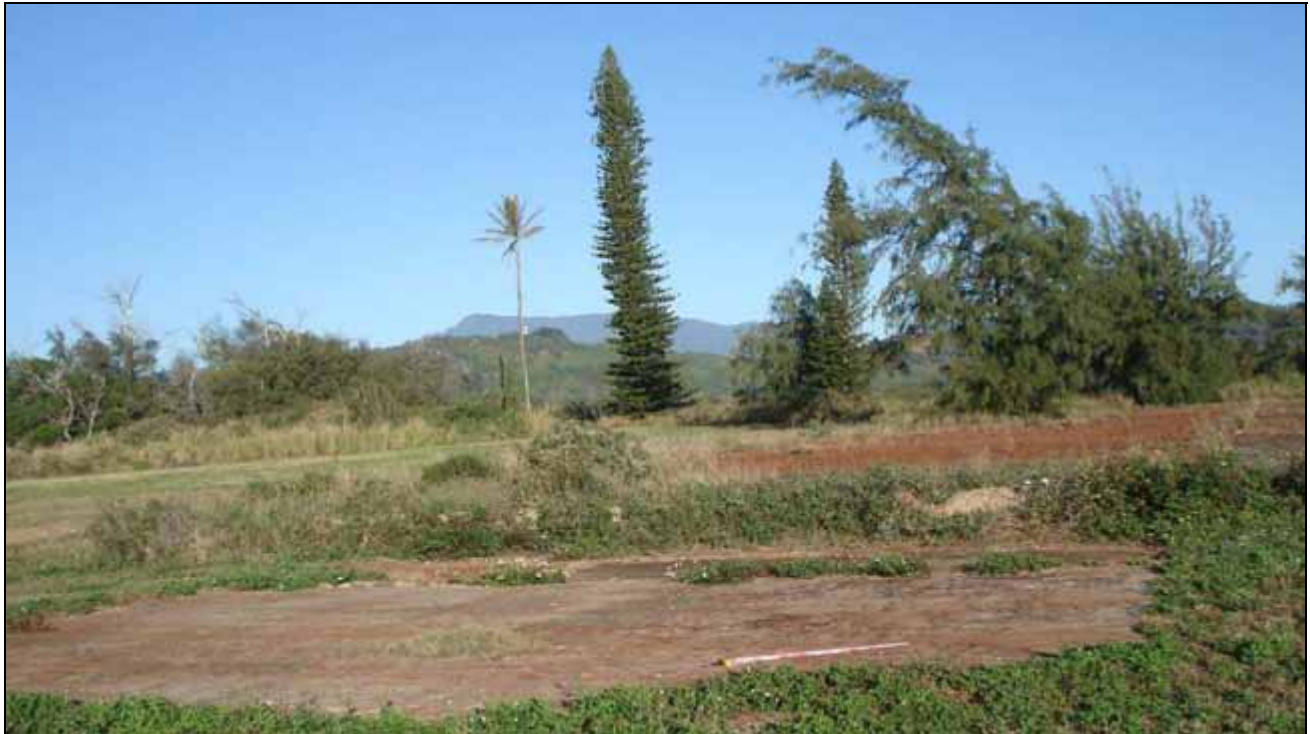
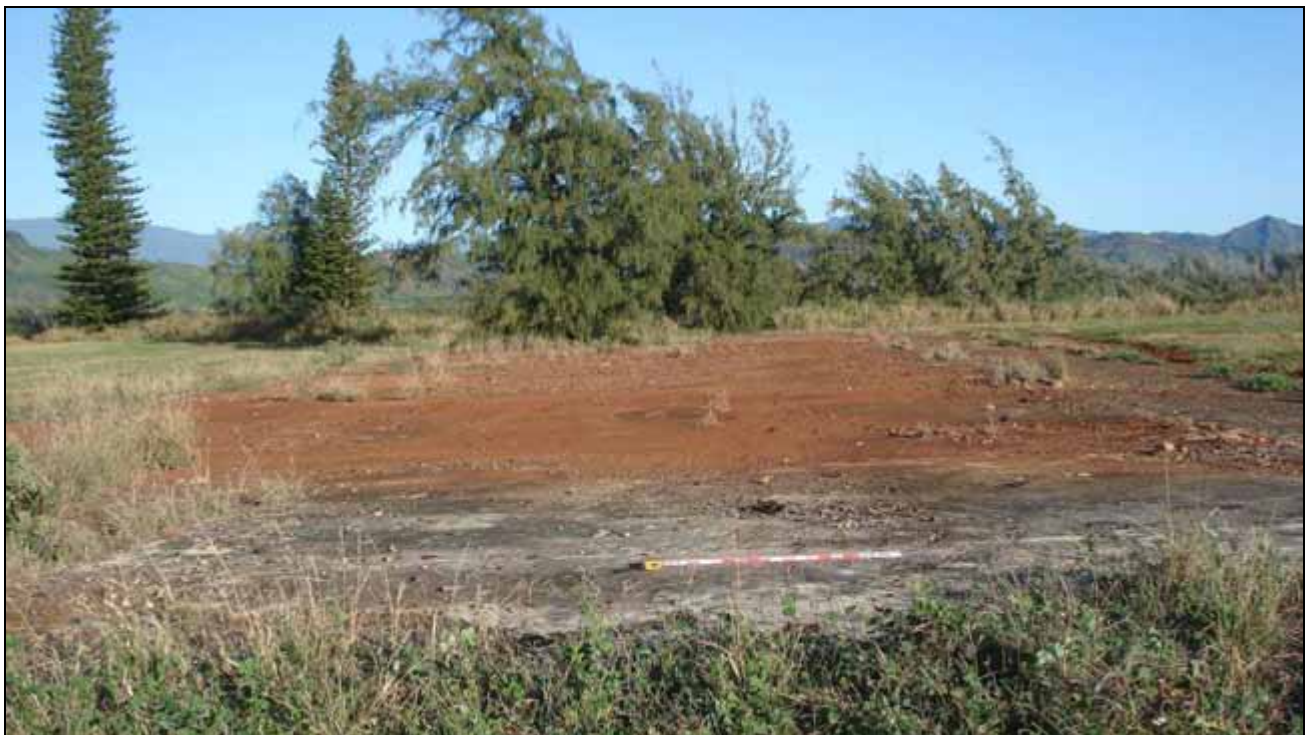
Figure 85. Site 50-30-11-2103, Feature D, remnant of Standard Oil storage facility

Feature D is also a remnant of the Standard Oil storage facility on the 1927 Sanborn Fire Insurance map (see Figure 73 and Figure 74; Figure 85-Figure 87). The foundation remnant consists of two adjacent concrete pads, is overgrown by low grasses, and appears to be eroding in some portions. Gravel and asphalt are present along the northeastern side of the larger concrete pad and there are two sections of embedded metal footing remnants on the southwestern side. Gravel and asphalt is also present on the northwestern side of the smaller concrete pad. The larger concrete pad of Feature D measures approximately 45.0 m NW-SE by 12.5 m NE-SW, while the smaller adjacent concrete pad measures approximately 8.5 M NW-SE by 7.0 m NE – SW. No other defining characteristics were observed.

Figure 87. Site 50-30-11-2103, Feature D, raised concrete foundation; view northwest
