Section 4 Results of Fieldwork

4.1 Survey Findings

This archaeological inventory survey was conducted under archaeological permit number 09-20 issued by the Hawai'i State Historic Preservation Division (SHPD), Department of Land and Natural Resources (DLNR), per Hawai'i Administrative Rules (HAR) Chapter 13-282. CSH archaeologists Gerald K. Ida, B.A., Nancine 'Missy' Kamai, B.A., Kaipo Akana, and Kendy Altizer, B.A. Fieldwork was conducted intermittently between May 21 and February 16, 2010, under the general supervision of Hallett H. Hammatt, Ph.D. (principal investigator). The field work required approximately 29 person-days to complete.

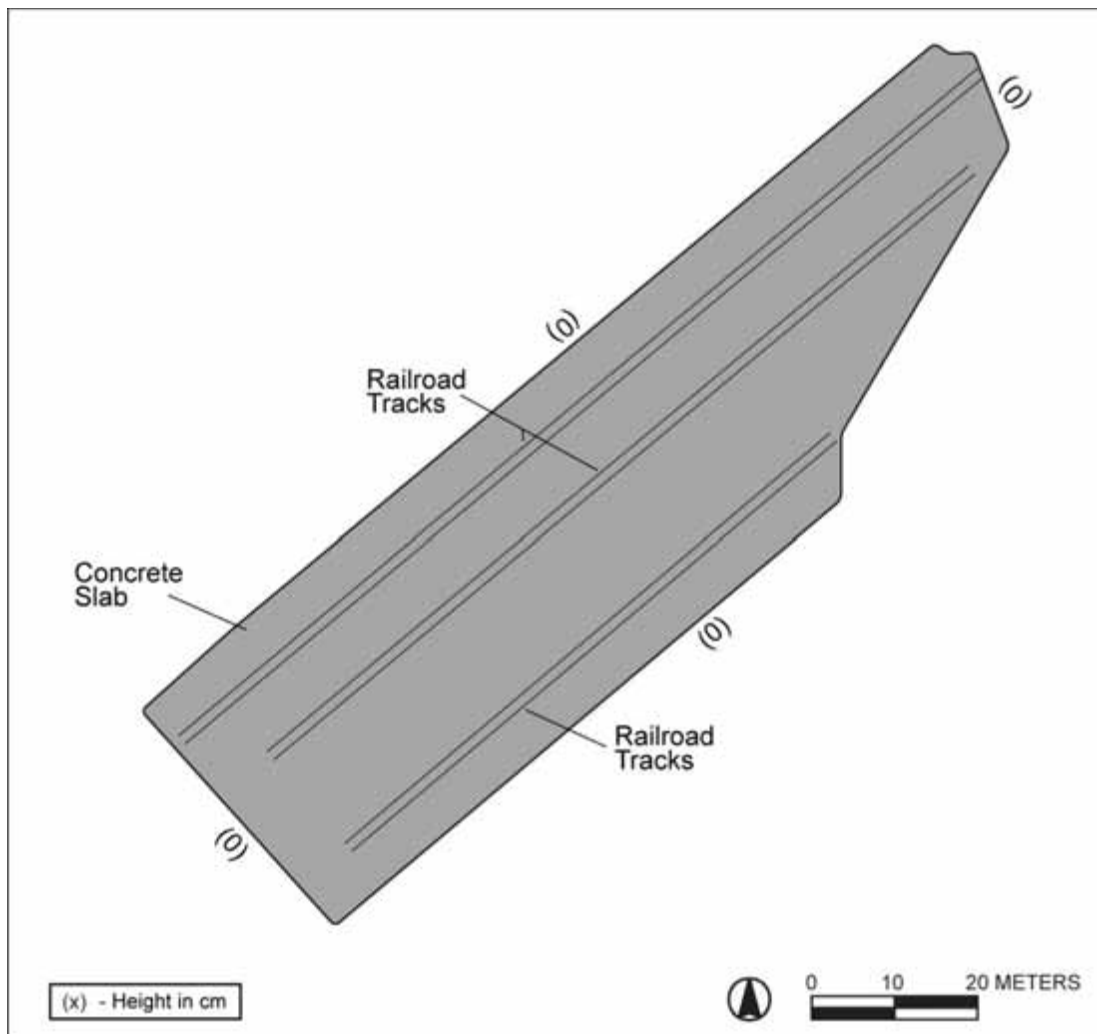
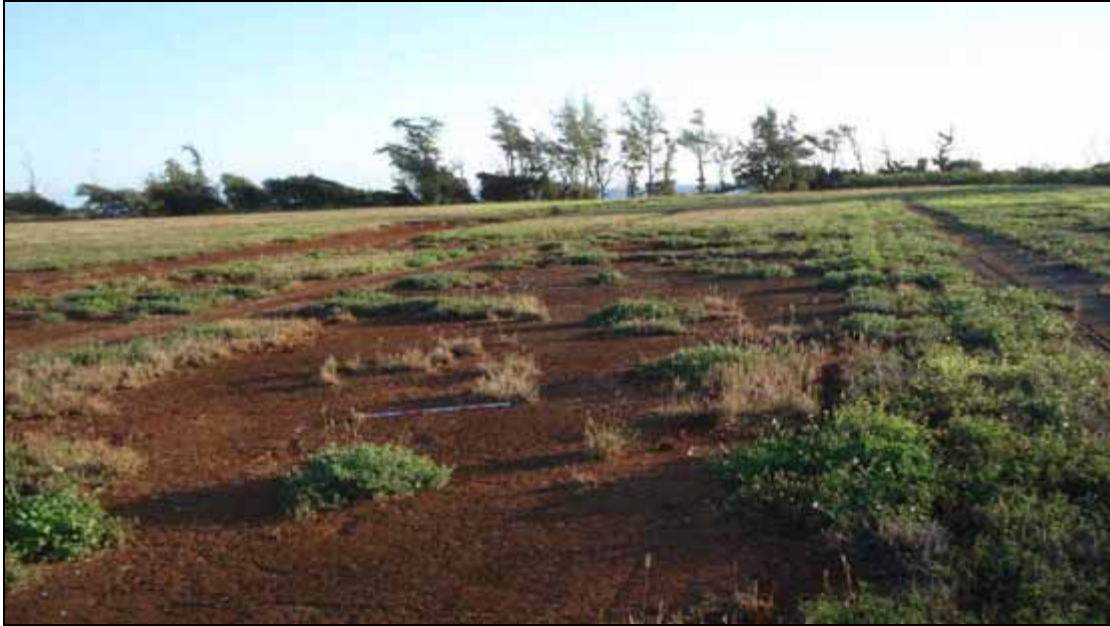
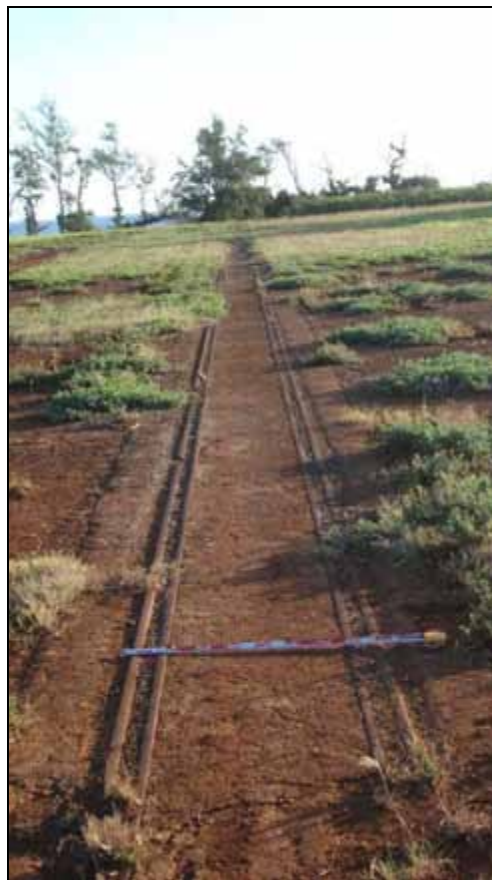
Figure 88. Site 50-30-11-2103, Feature E, railroad track remnants

Feature E is the remnants of three sets of narrow gauge tracks imbedded in a concrete slab that is flush with the current ground surface (see Figure 73; Figure 88-Figure 90). This feature appears in the 1953 aerial photo as two rectangular structures resembling warehouses (see Figure 75). The concrete slab is eroding away and appears to be sediment in some places. No berm or railroad ties are present. The track sets are placed approximately 84 cm apart and the tracks themselves are 12 cm thick. The slab measures approximately 95 m NE-SW by 27 m NW-SE. No other defining characteristics were observed. The alternative project alignment passes through the southeastern corner of the concrete slab.

Figure 90. Site 50-30-11-2103 Feature E, railroad tracks; view northeast
