APPENDIX B

**ARCHAEOLOGICAL CONDITION REPORT FOR
AHUKINI-LYDGATE SEGMENT
OF THE KAUA`I PATHWAYS PROJECT
KAUA`I ISLAND, HAWAII**

AHUKINI LANDING TO LYDGATE PARK STRUCTURAL STATUS REPORT

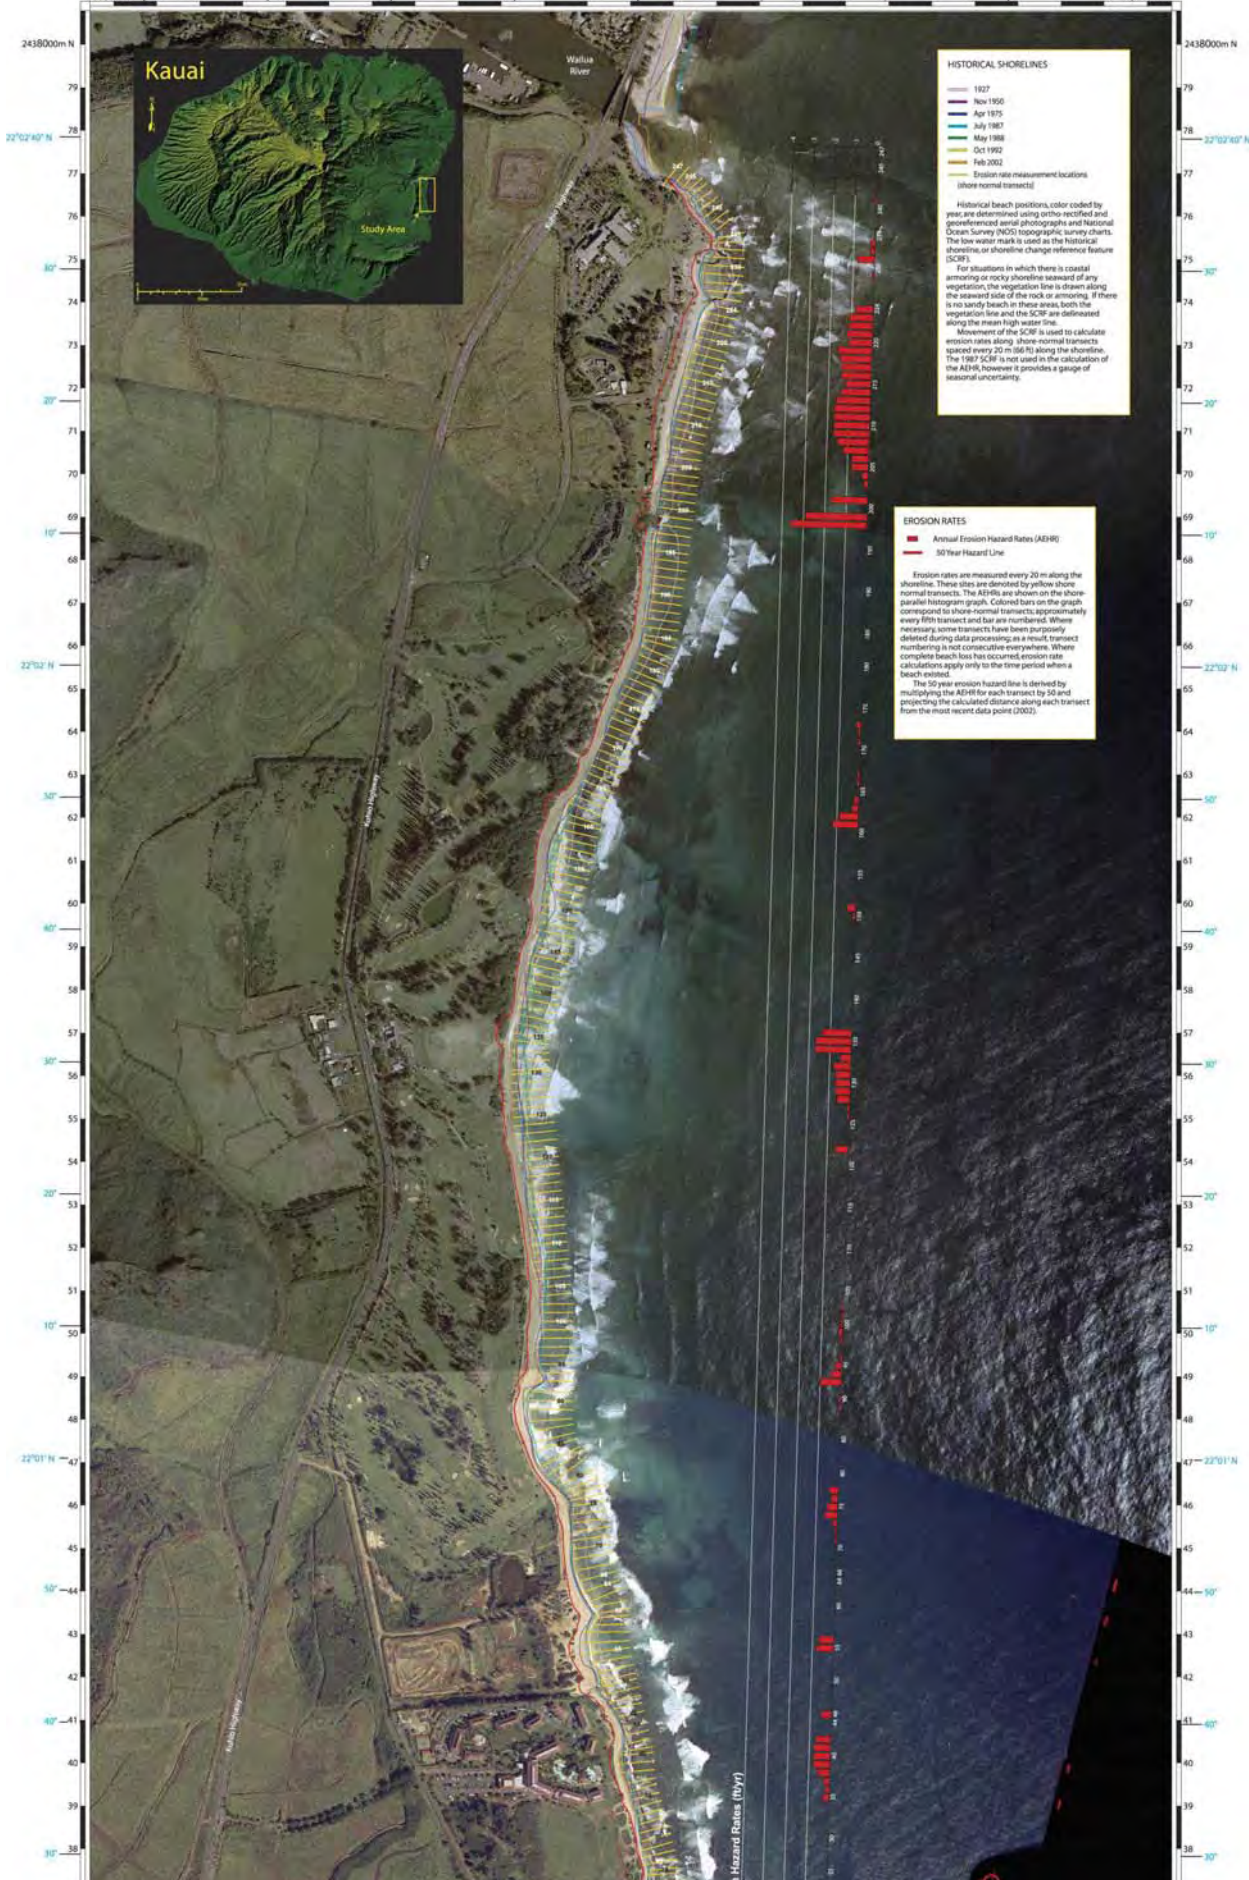
HISTORICAL SHORELINES

- 1927
- New 1952
- Apr 1975
- July 1987
- May 1988
- Oct 1992
- Feb 2002
- Erosion rate measurement locations (shore normal transects)

- Annual Erosion Hazard Rates (AEHR)
- 50 Year Hazard Line

The 50 year erosion hazard line is derived by multiplying the AEHR for each transect by 50 and projecting the calculated distance along each transect from the most recent data point (2002).

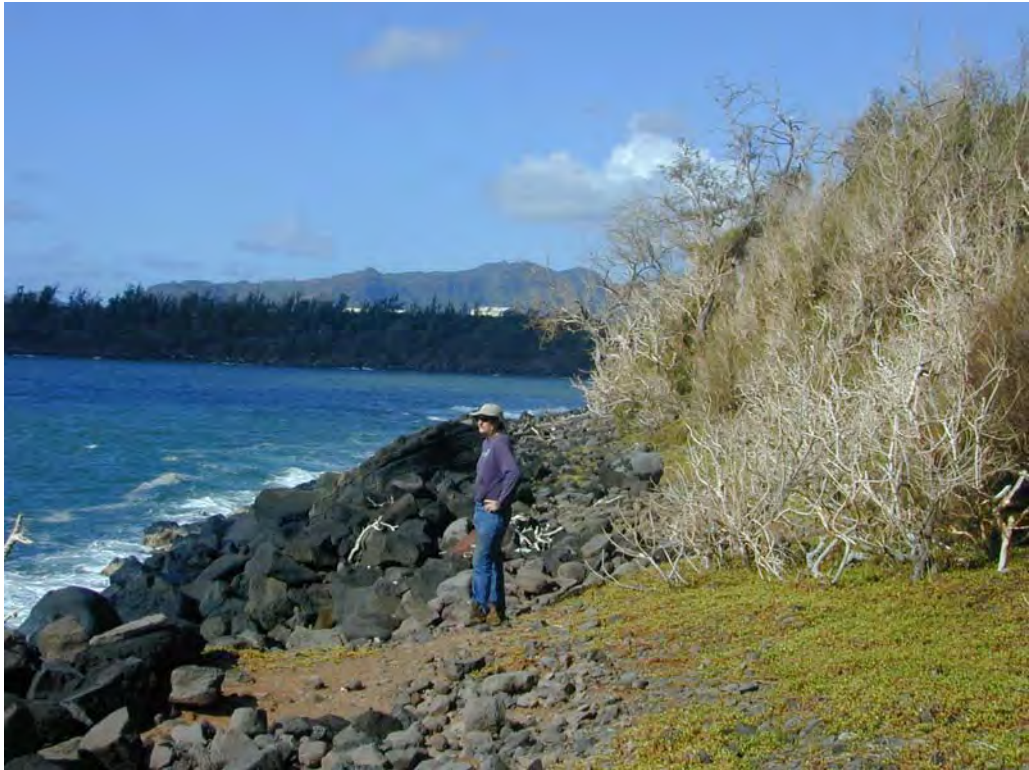
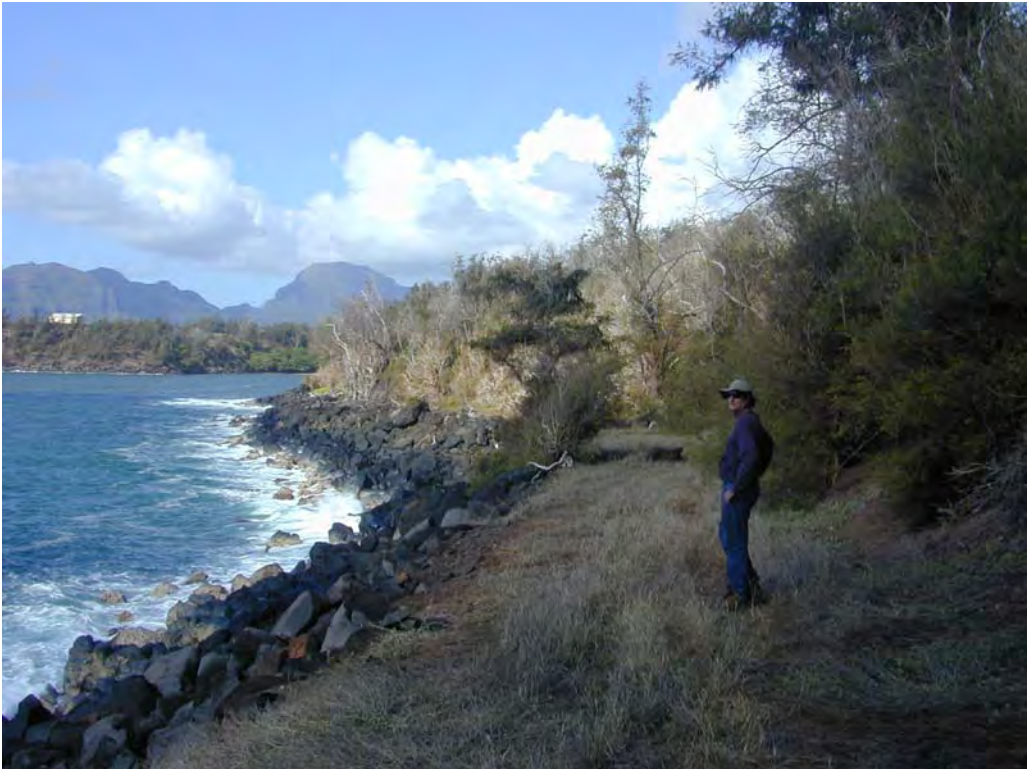
The photo(s) below illustrates where it would be problematic to permit a pathway on the upper most boulders and seaward of the vegetation – the path will need to be located within the vegetation zone and well (~20ft) landward of the uppermost boulder zone. Exact location of the pathway in this section would be best performed with a coastal expert, a chainsaw, and flagging ribbon. In the bottom photo, the location of the old road/railbed does not exactly represent the optimal location. The bike path would be best located mauka of the road, or at least on the mauka edge of this feature.

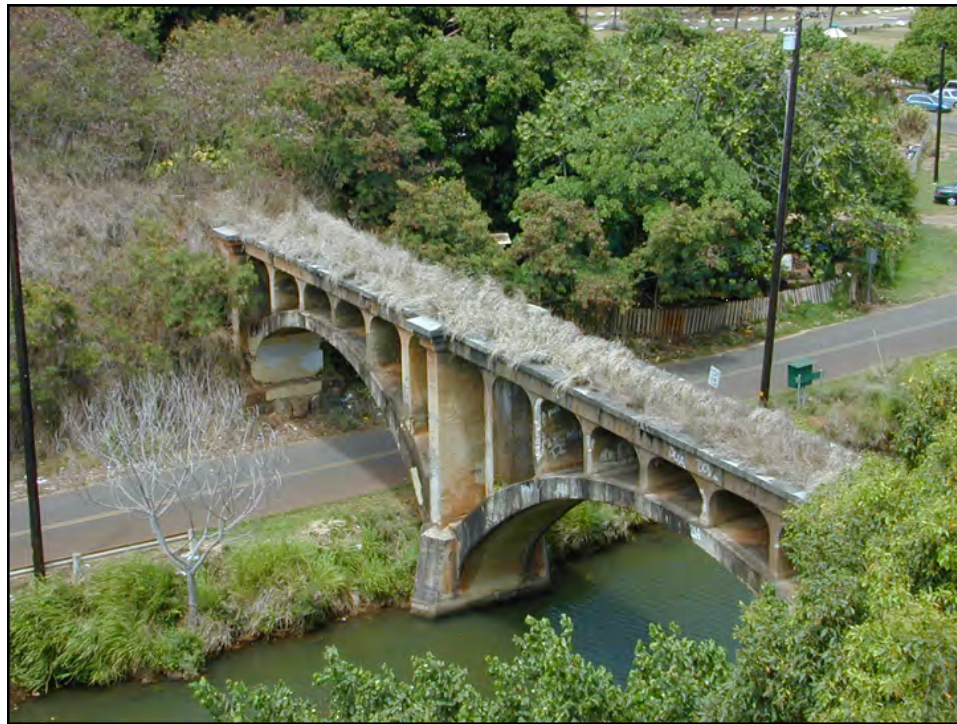
Photo of the Hanama’ulu Railroad Bridge

The bridge appears to be in very good condition considering its age and ocean front exposure. Several site visits have been conducted. At this time, no exploratory evaluations such as coring and concrete sampling have been performed. Several minor spalled areas are visible from the ground. The top “trough” which formed the original roadway for the railway was filled with dirt and debris. Once cleaned, additional concrete damage can be expected due to constant moisture from the organic material. It is expected that these concrete defects can be readily repaired using conventional chip-and-patch methods. (See Section “E”)

An original plantation drawing was available indicating dimensions but containing very little other information regarding reinforcing steel or the foundation piles. The bridge was modeled using a STRUDL finite element program neglecting any reinforcing steel. Loading from the proposed, new concrete deck used to widen the path was included. The structure, with smaller secondary arches supported on longer span primary arches, was found to be completely in compression. Concrete compressive stresses were in the 500-psi range. This would partially explain the few observed spalls as the absence of tensile cracks has allowed the concrete to continue to protect the reinforcing steel.
